LEGISLATIVE APPROVAL FORM/CERTIFICATE OF ACCEPTANCE

A Resolution of the Council of the City of Harrisburg to approve the adoption of updated Historic District Design and Preservation Guidelines.

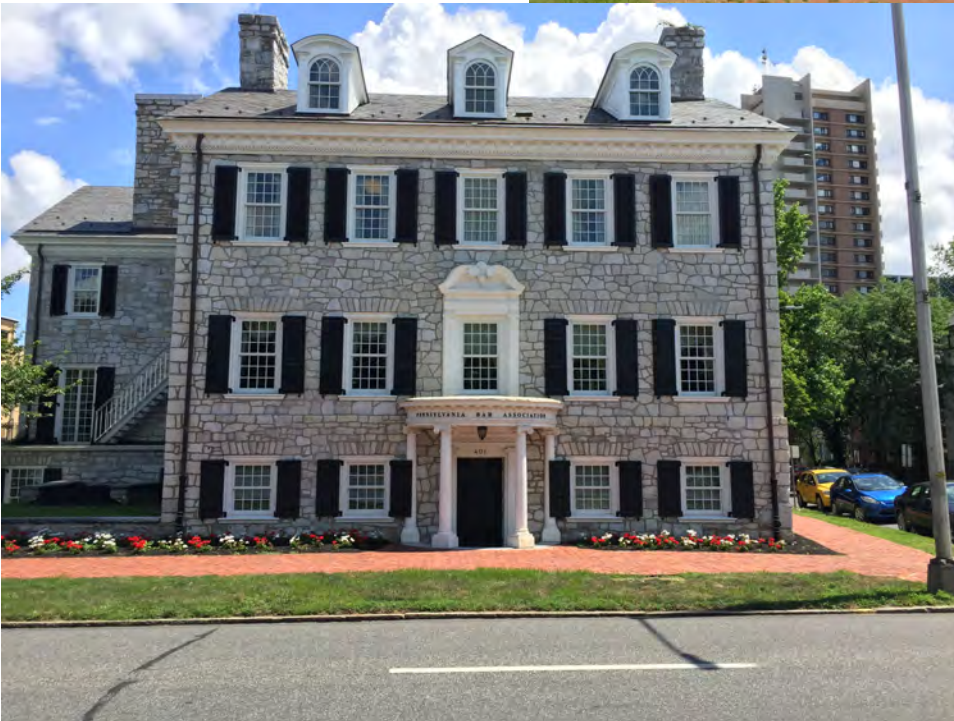
Constructed in 1792, William Maclay's home is an example of Georgian architecture from the 18th century. Although modified, it has retained many of its character defining features.

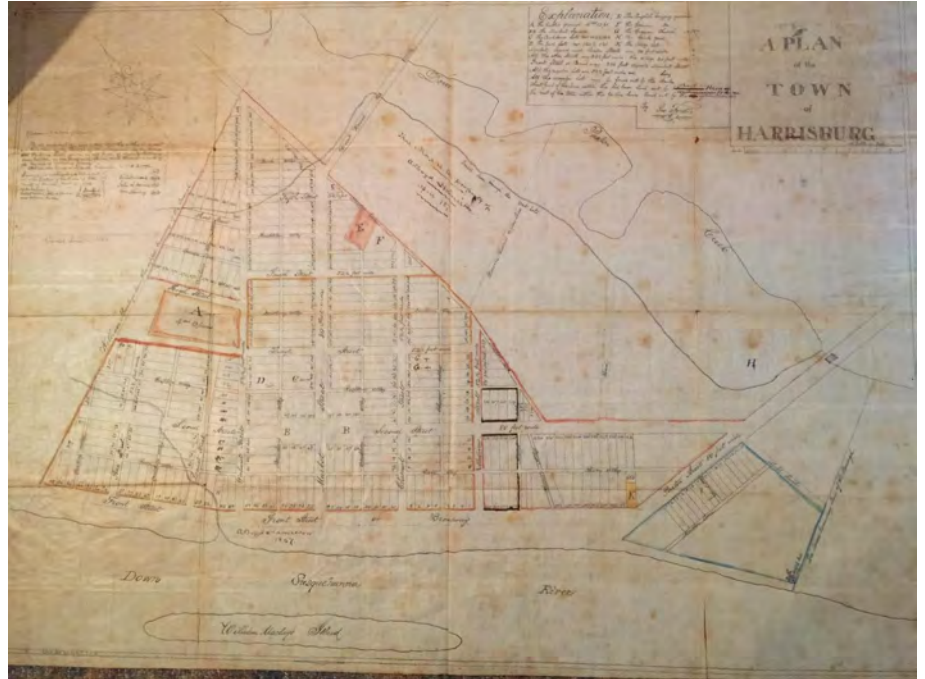
The earliest known town plan of Harrisburg. Drawn in 1796 by William Maclay, Pennsylvania's first Senator.

Commonwealth to use as a seat of government. Harris then sold all the land between South and North Streets to Maclay and in 1792 he built his Georgian style home at the corner of South and Front Streets. Much of this area was once known as "Maclaysburg" for he had platted 54 lots to be sold for development⁹. Maclay incorporated the idea of reserving this hillside for "public grounds" and incorporated this into his town plan. This original town plan was platted in 1796 with ink on linen and is one of the City Archives most important documents.

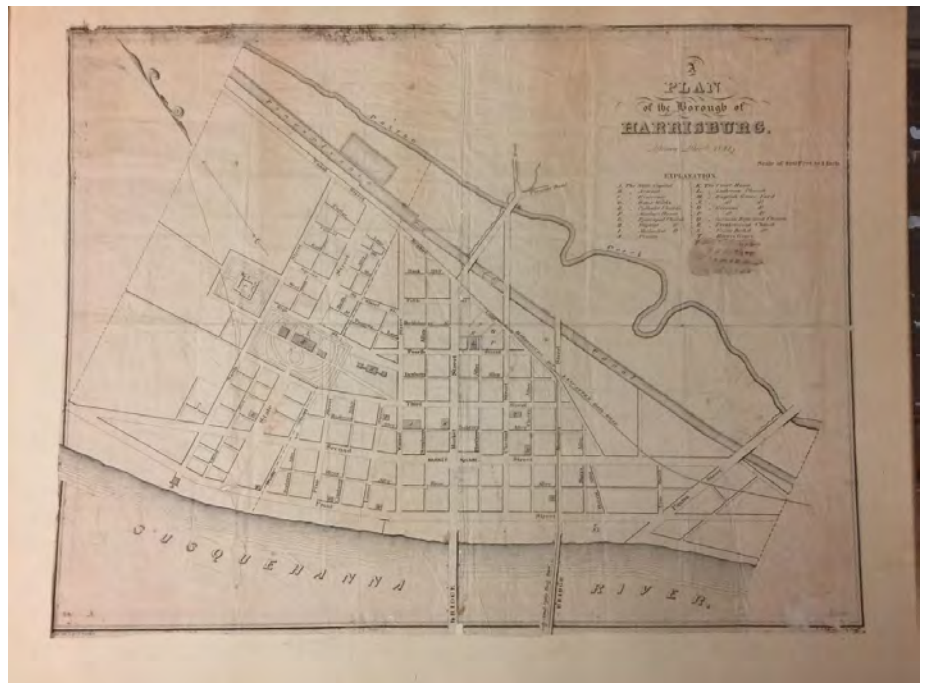
A plan for the Borough of Harrisburg from 1844.

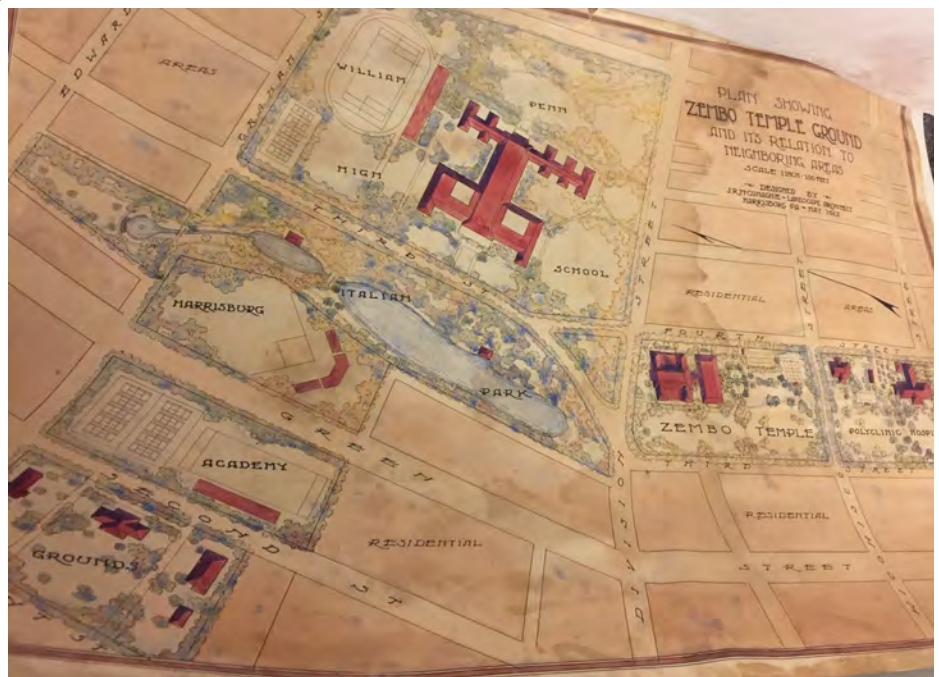
Plans dated May 1925 showing the spatial relationships in the Academy Manor neighborhood. The planning of this neighborhood was heavily influenced by the City Beautiful movement of the early 20th century. It is important to preserve these relationships between significant buildings, parks, and residential housing stock.

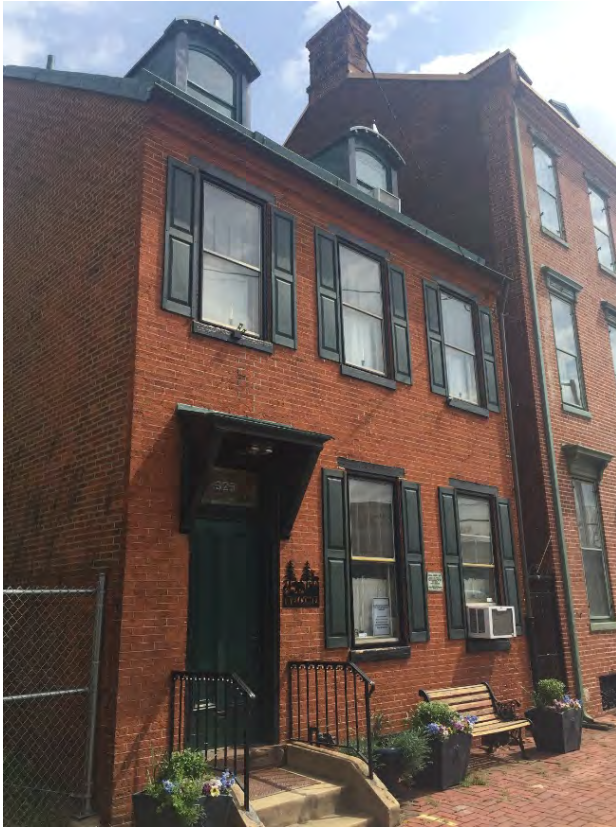
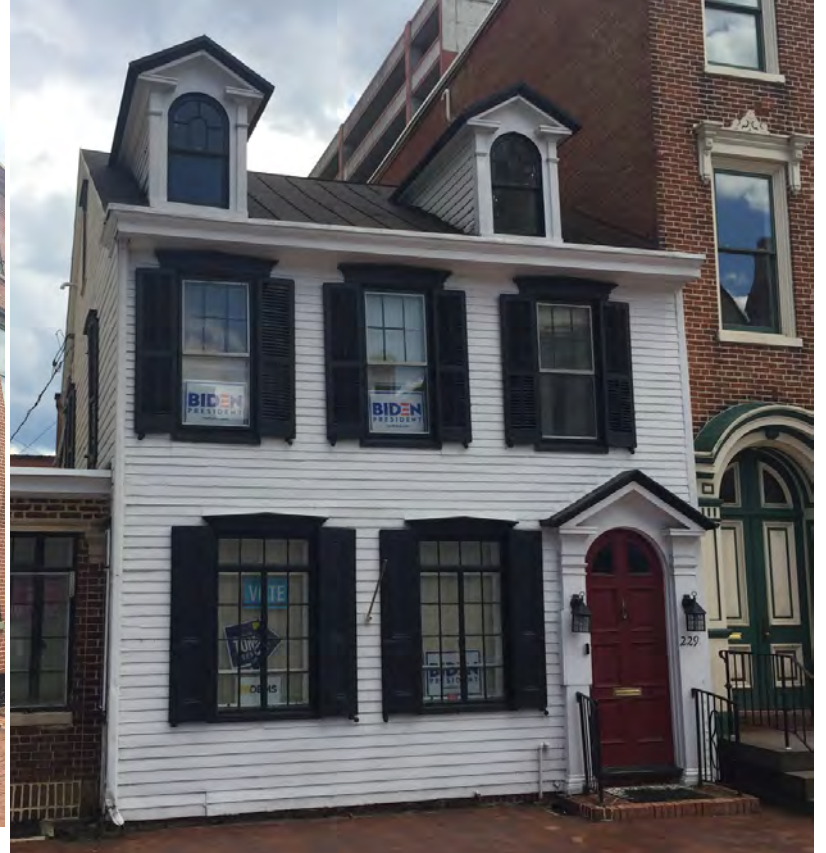
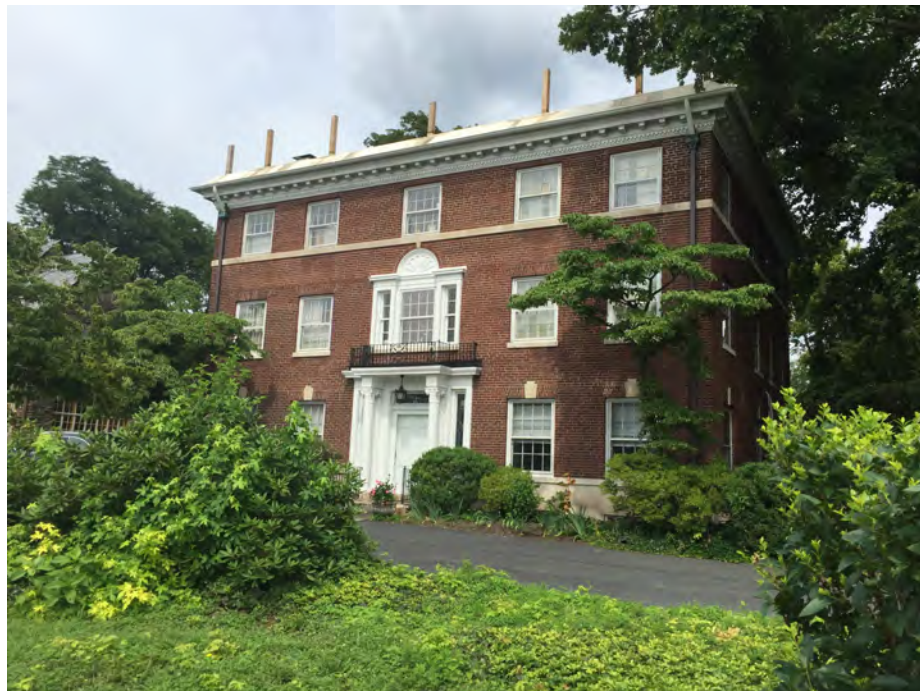
Federal or Adam (1780-1820)

Federal is a style of architecture with symmetrical fenestration, gabled roofs with dormers, masonry or wood exteriors, and metal or shingle roofing. The style is executed in both high style and vernacular form as row homes in many of Harrisburg's Historic Districts. Vernacular styles of the federal style form were constructed throughout the 19th century in the City.

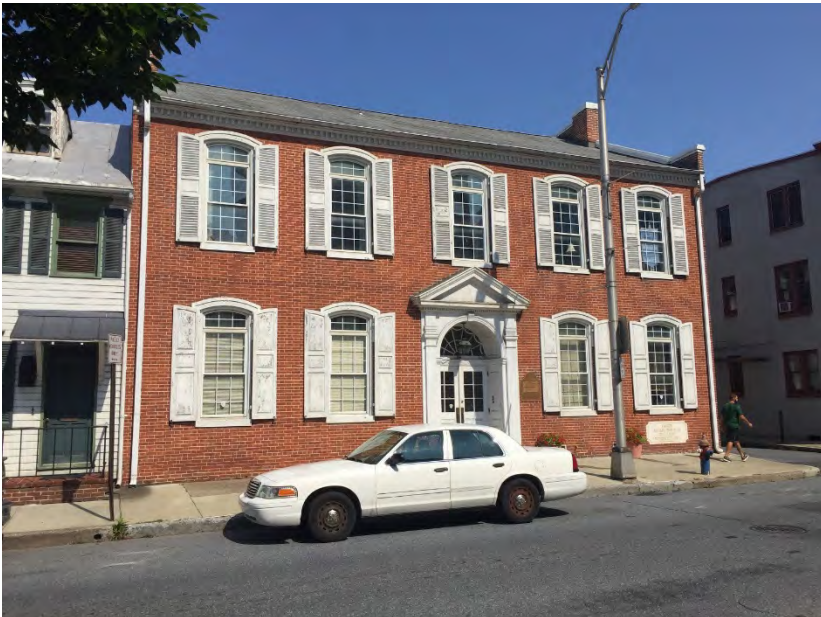
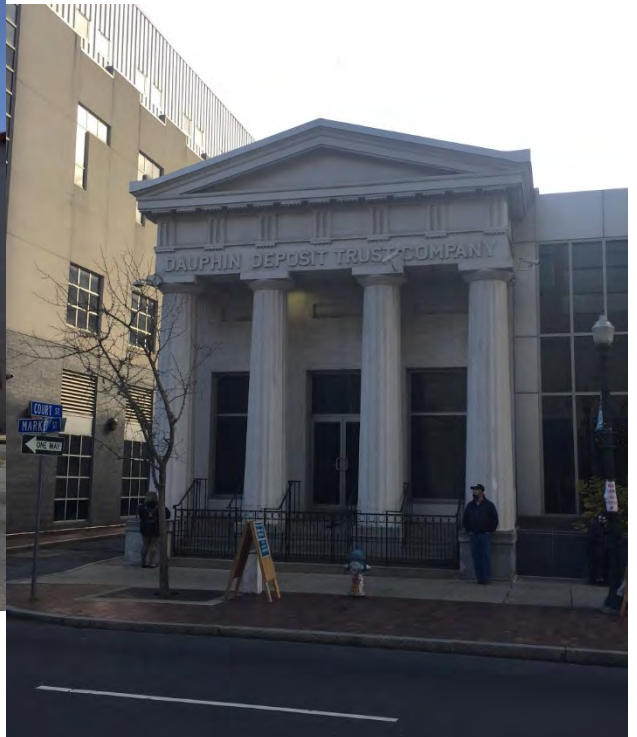
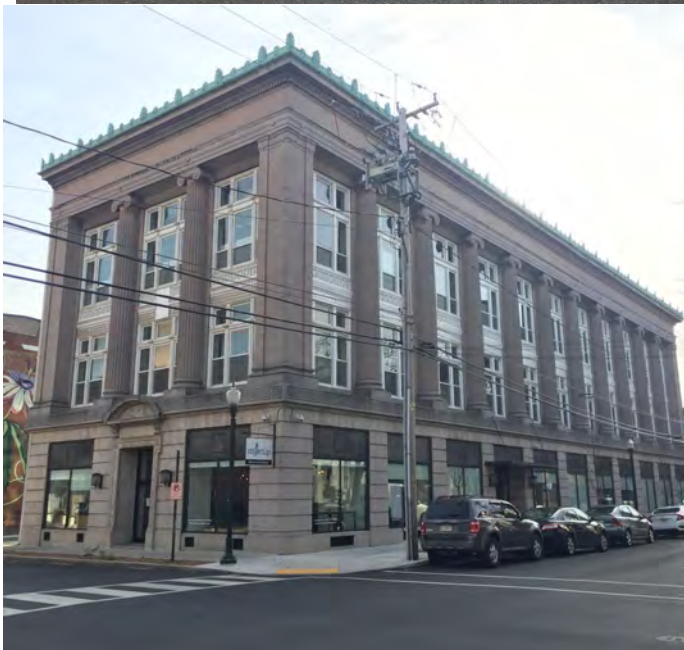
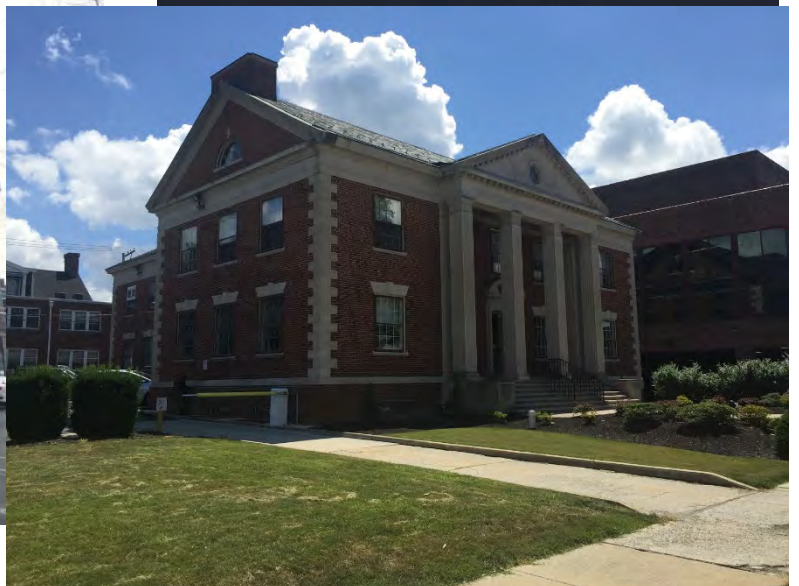
Classical Revival/Neoclassical (Early period 1770-1850 & Late Period 1895-1950)

There are two distinct periods for this type of architecture. The early period of this architectural style is the earlier predecessor of the greek revival style. The neoclassical style imitates the architectural symmetry, balance, and proportions of ancient Greek buildings. They commonly have six over six windows, central entrances and a dentiled cornice. The example to the left is located in the Harrisburg Historic District downtown. Known as the Fager School building, it was originally built in 1842 and remodeled in 1868. Finer examples have columns, porticos, and box gabled roofs. This style was often the form used for schools, banks, courthouses, and other institutional buildings.

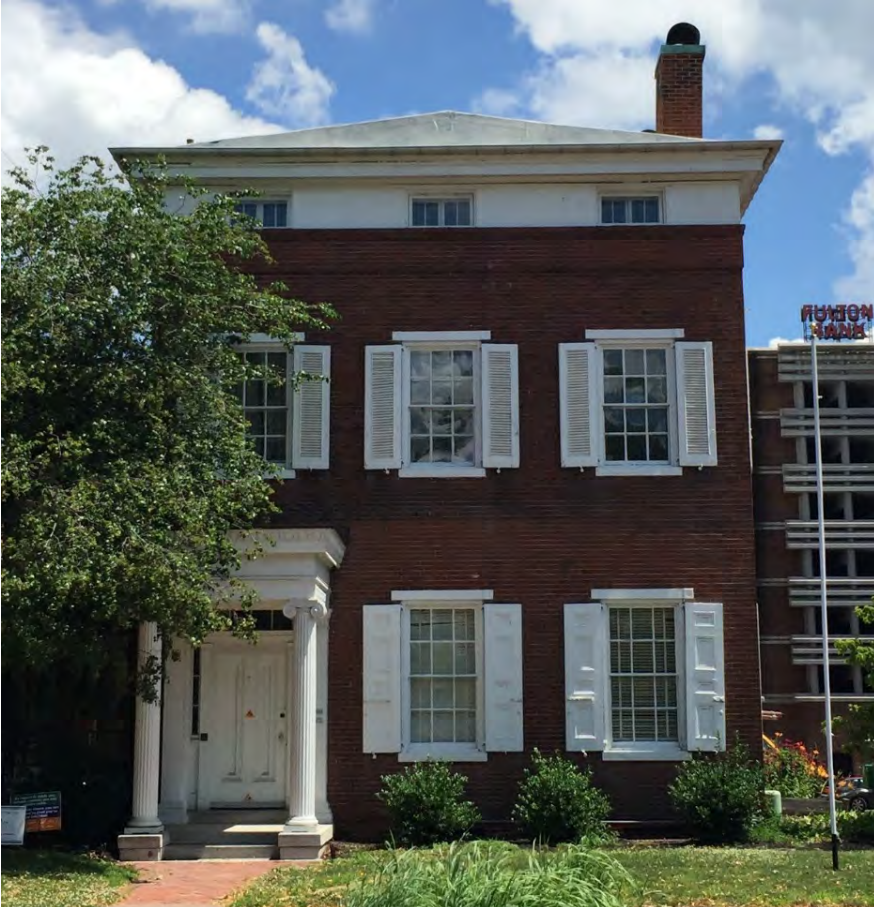
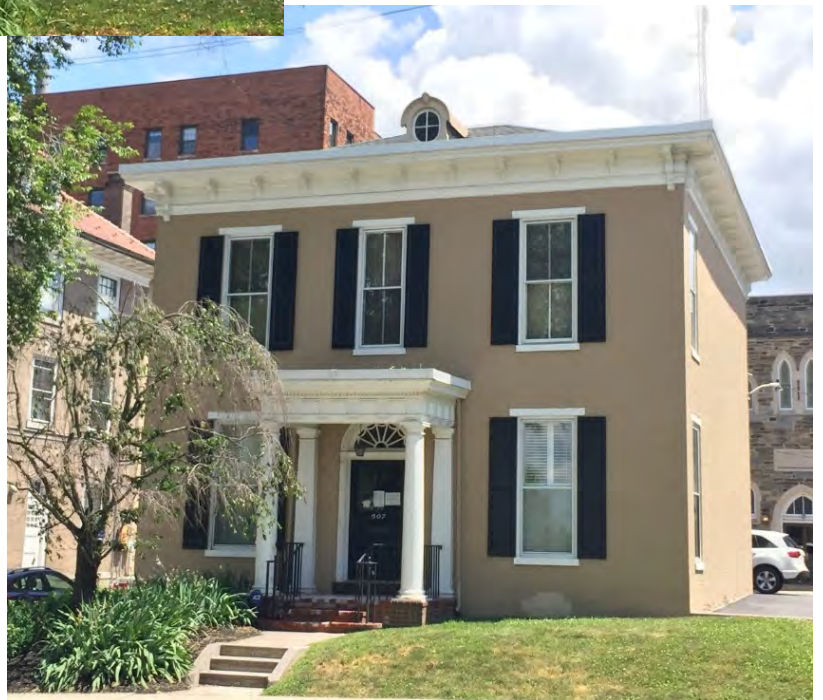
Greek Revival (1825-1860)

Greek Revival was the dominant architectural style in the early decades of the 19th century. Based upon the principles and styling of ancient Greece and Rome, the resurrection of this building type was an ode to the new constitutional republic government in the United States. Several defining features of this type of architecture include gabled or hipped roofs, porches with columns, and strong cornice lines.

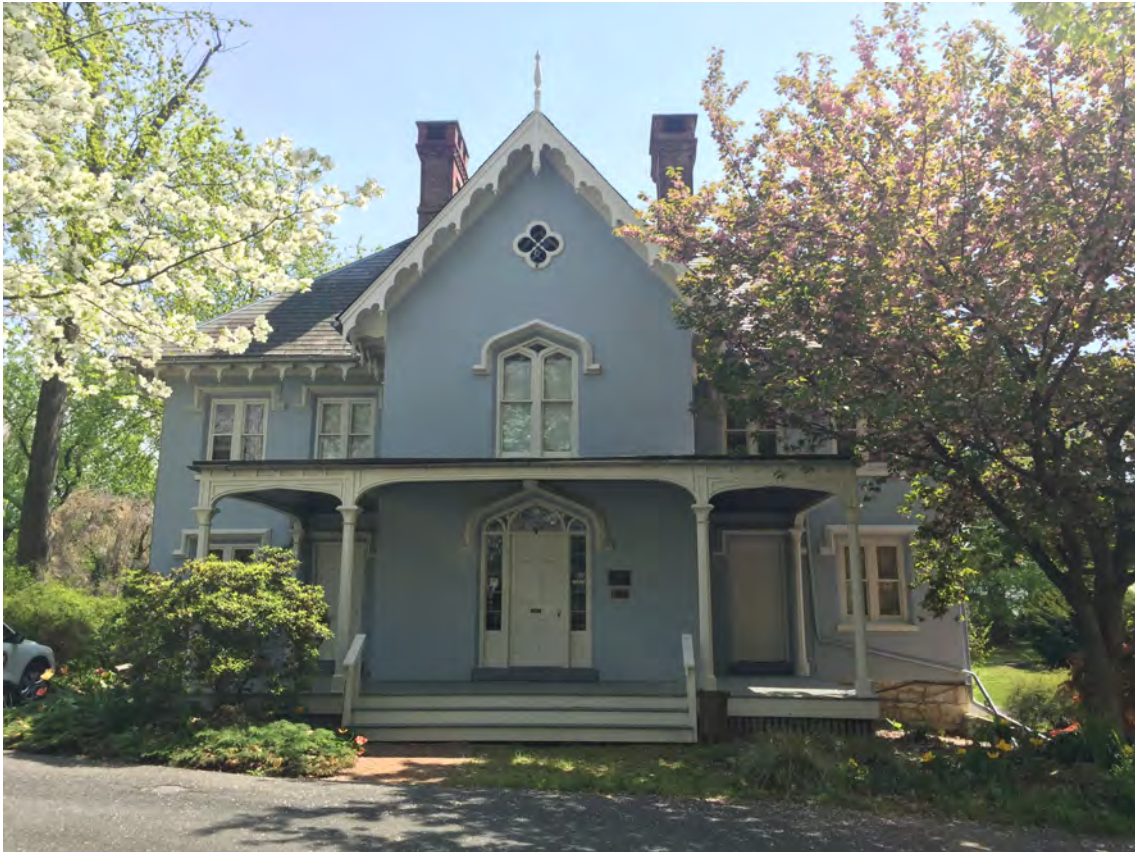
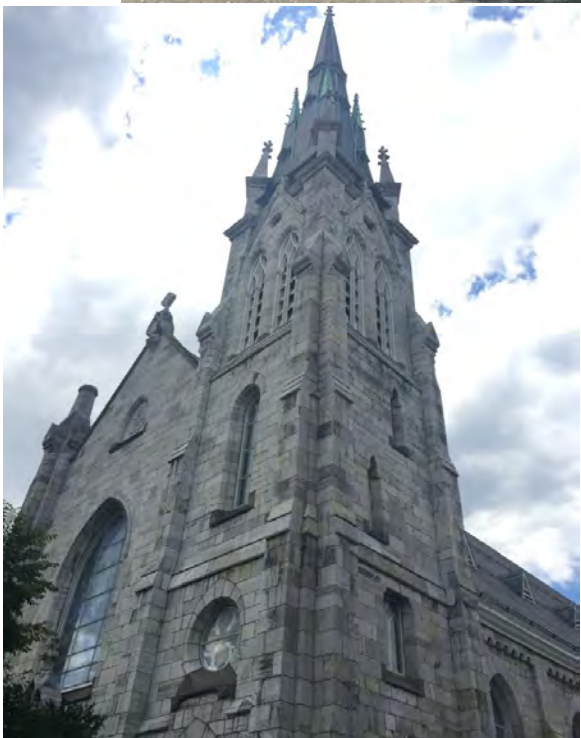
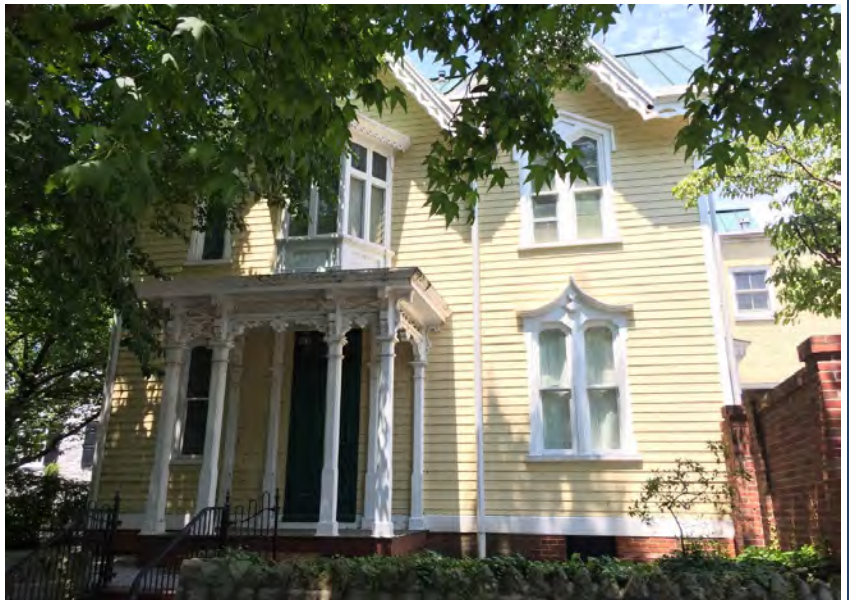
Gothic Revival (1840-1880)

Gothic Revival was inspired by medieval cathedrals of Europe. There are very few Gothic Revival style houses in Harrisburg as it was an architectural style designed for rural homes. However many of Harrisburg's churches are in the Gothic Revival style. This style have have steep gabled roofs, gothic arched windows, and often adorned with decorative millwork, gable trim, and cantilevered or oriel windows.

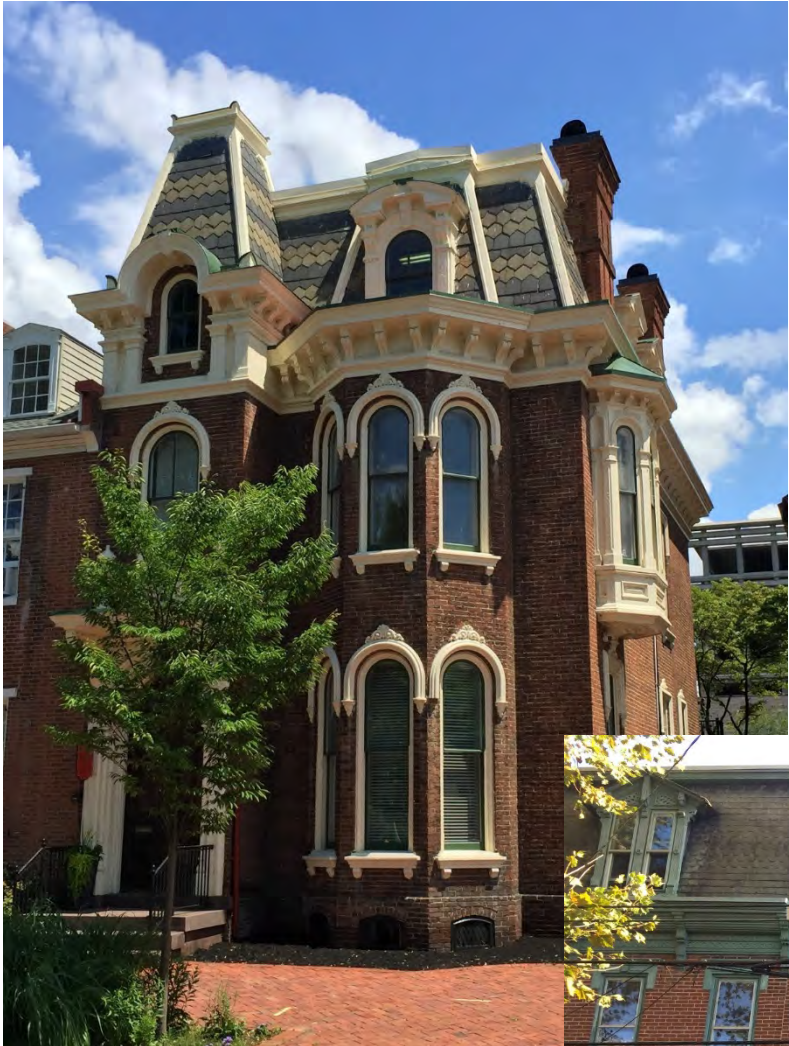
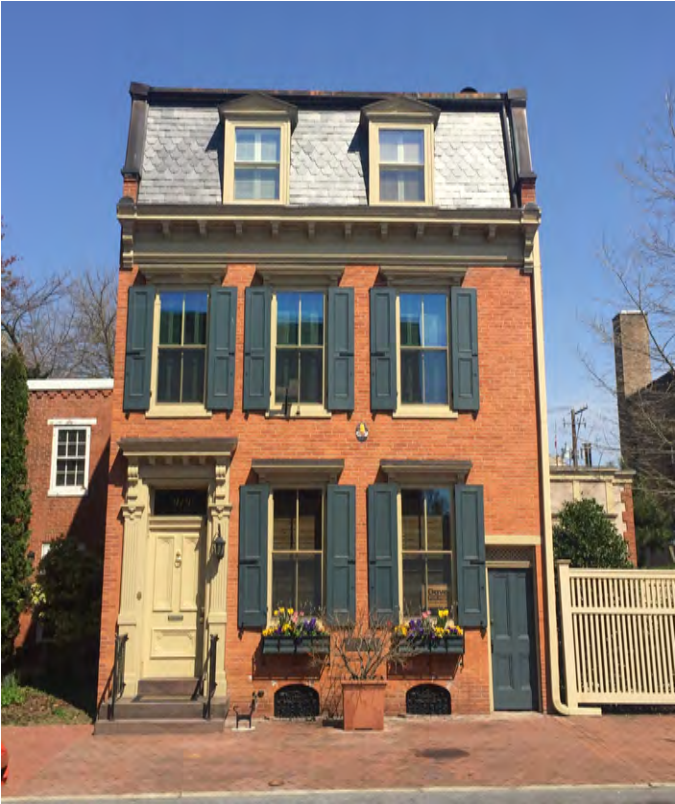
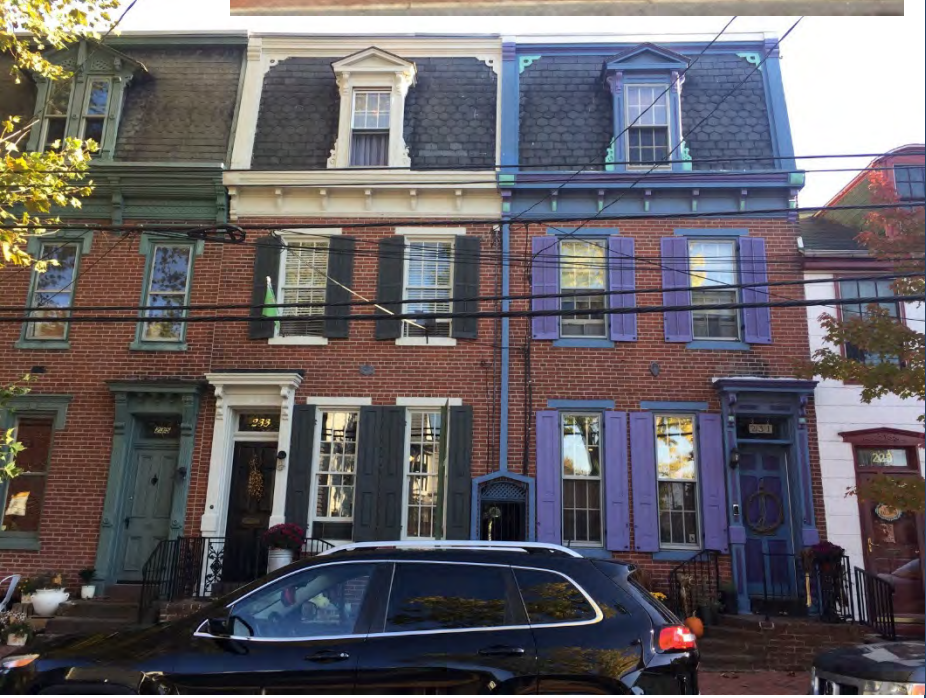
Second Empire (1855-1890)

Named after the French Second Empire of Napoleon III (1852-1870), this is a common architectural style throughout Harrisburg's Historic Districts. The style is distinguished by slate mansard roofs, dormers, detailed millwork, bay windows, and double wooden front doors. Most examples of Second Empire buildings in Harrisburg have masonry exteriors. The style is sometimes called Mansard Style because of the dominance of the roof. Mansard roofs often have patterned slate, as this was the roofing material of choice in the late 19th and early 20th centuries.

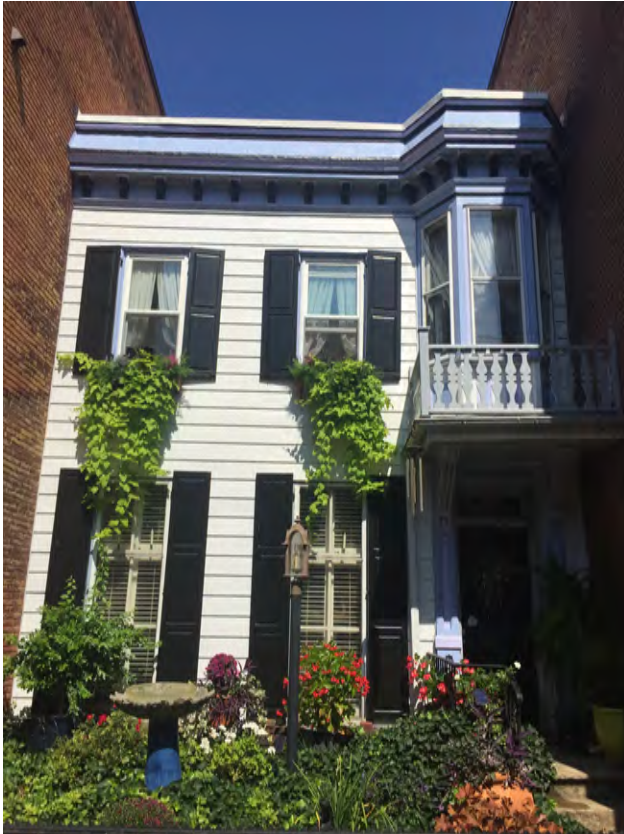
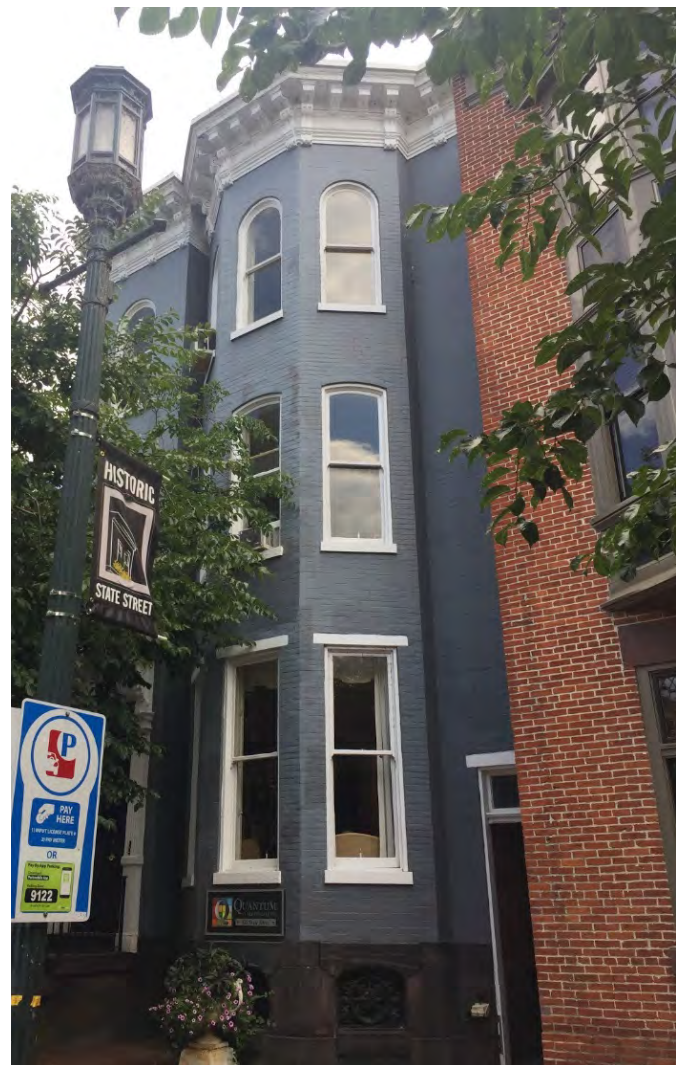
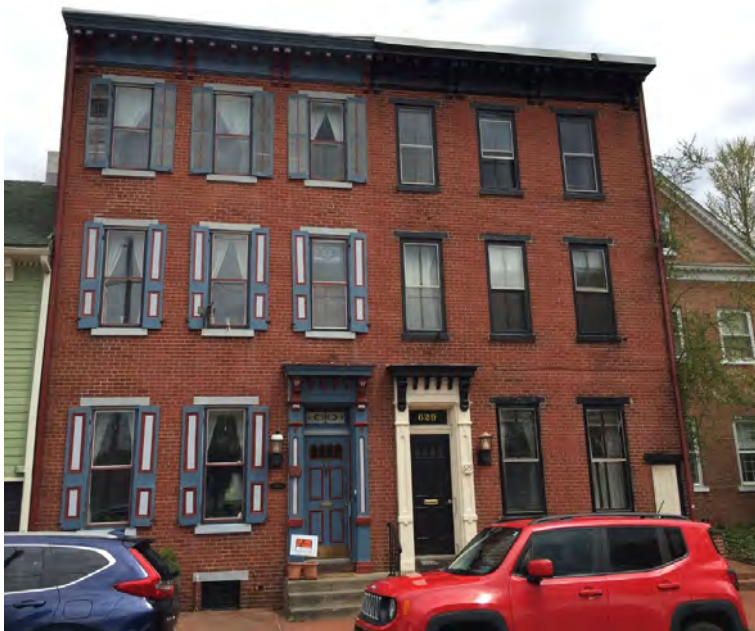
Italianate (1840-1890)

This architectural style was inspired by the villas of Italy and was popular from the mid-1800's to the turn of the century. It is defined by prominent cornices, single or paired brackets, and vertically strong windows. Italianate buildings often have two-over-two double-hung windows with curved tops and decorative lintels. Flat or hipped roofs are the typical roof style. Italianate was a popular style for both residential and commercial buildings. Italianate buildings can be either frame, or constructed of brick, as is often the case in Harrisburg.

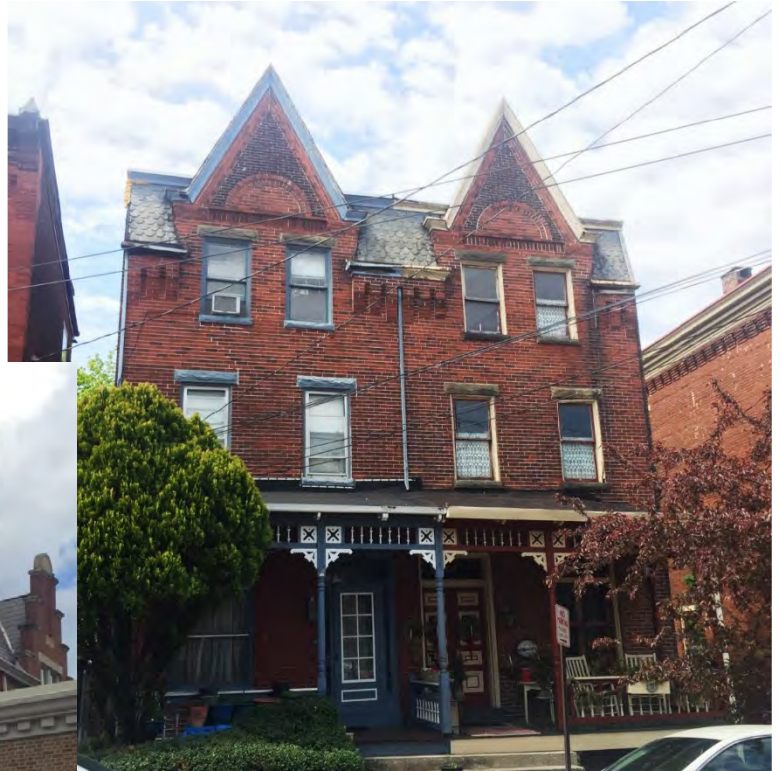
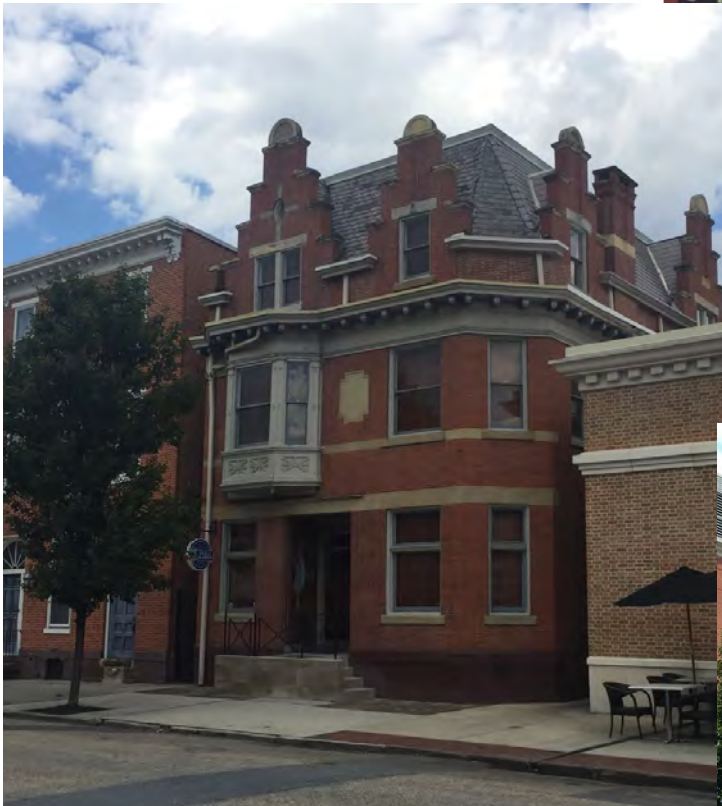
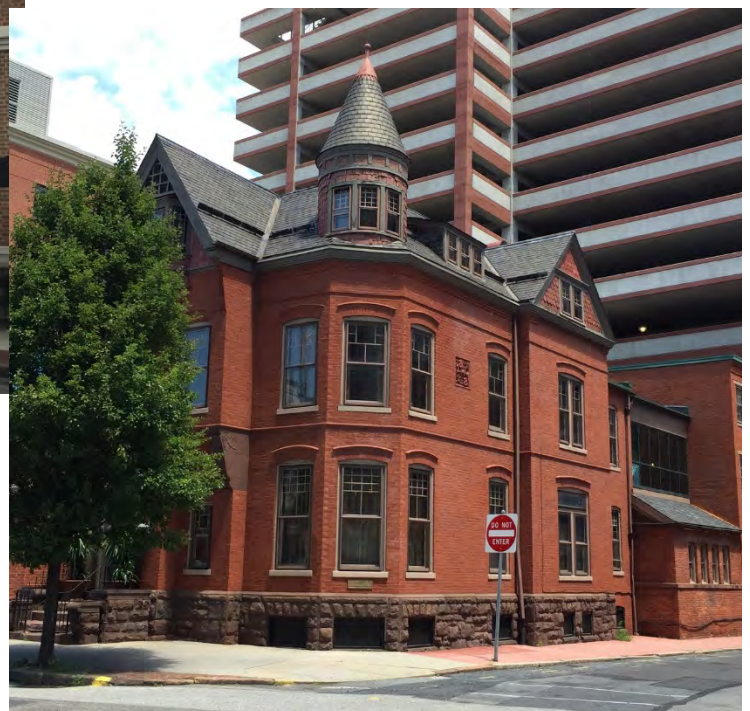
Queen Anne (1880-1915)

Queen Anne was a popular style of residential architecture from 1880 to the 1910's. It is an imaginative form of architecture with elaborate details and millwork. Queen Anne style buildings can have either a wood or brick exterior. They often have turrets, multi-gabled roofs, dormers, decorative millwork ornamentation, and expansive front porches with decorative brackets, balustrades, and posts. They also typically have bay windows and feature wooden double-hung windows and paneled doors. Many Queen Anne structures in the City also have elements of Shingle style architecture.

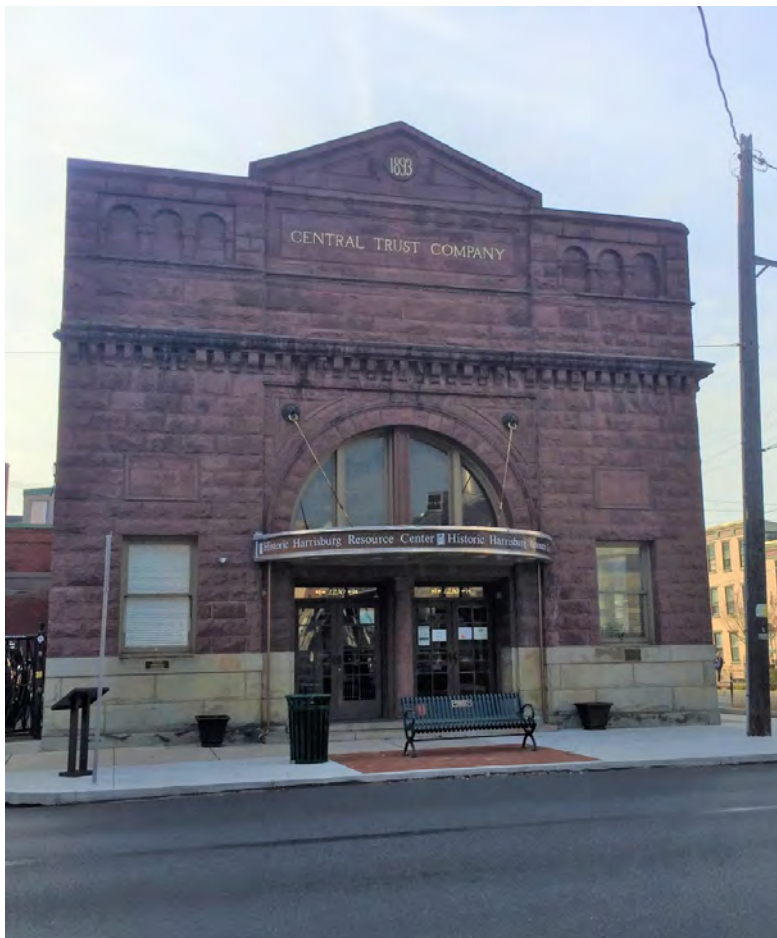
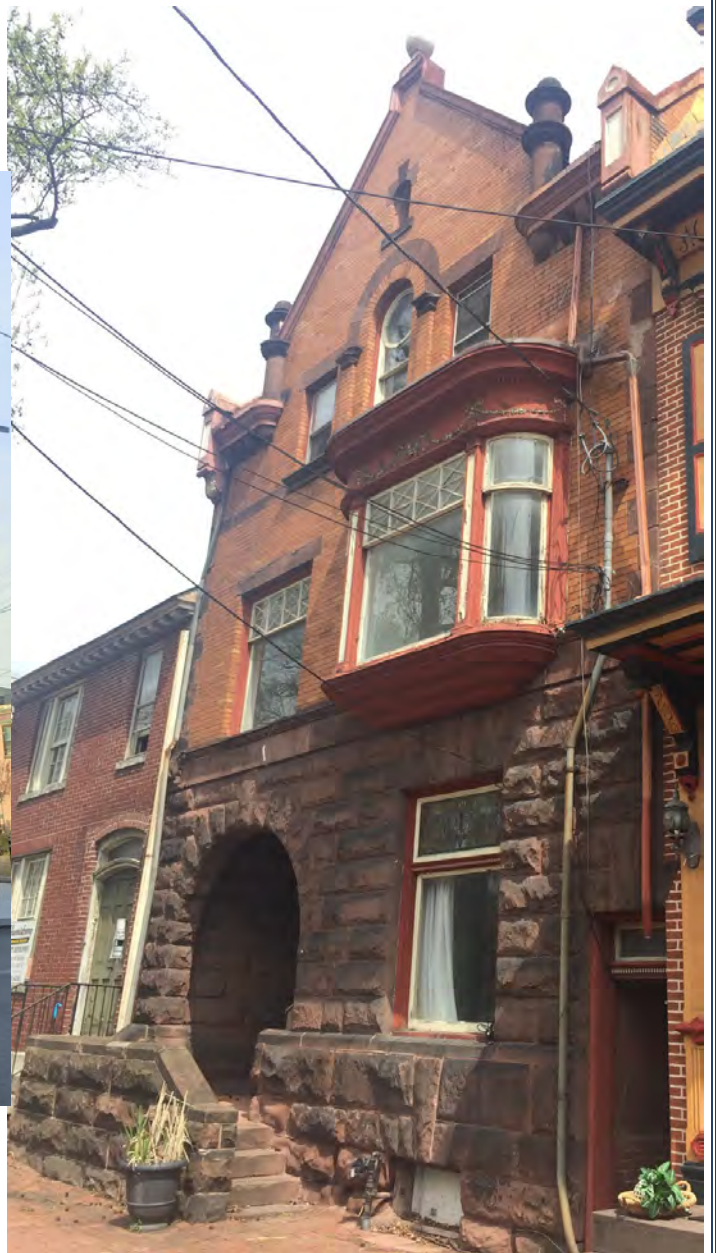
Romanesque Revival (1880-1900)

Rough stone exteriors with dramatic arches inspired by ancient Rome define the Romanesque Revival style of architecture. The architect Henry Hobson Richardson and the subsequent “Richardsonian Romanesque” is the source of the style’s development with the construction of his designs for the Allegheny Courthouse in Pittsburgh and Trinity Church in Boston. Romanesque buildings were most often institutional or public buildings. The style was only adopted by the wealthy for residential construction due to the substantial cost of stone.

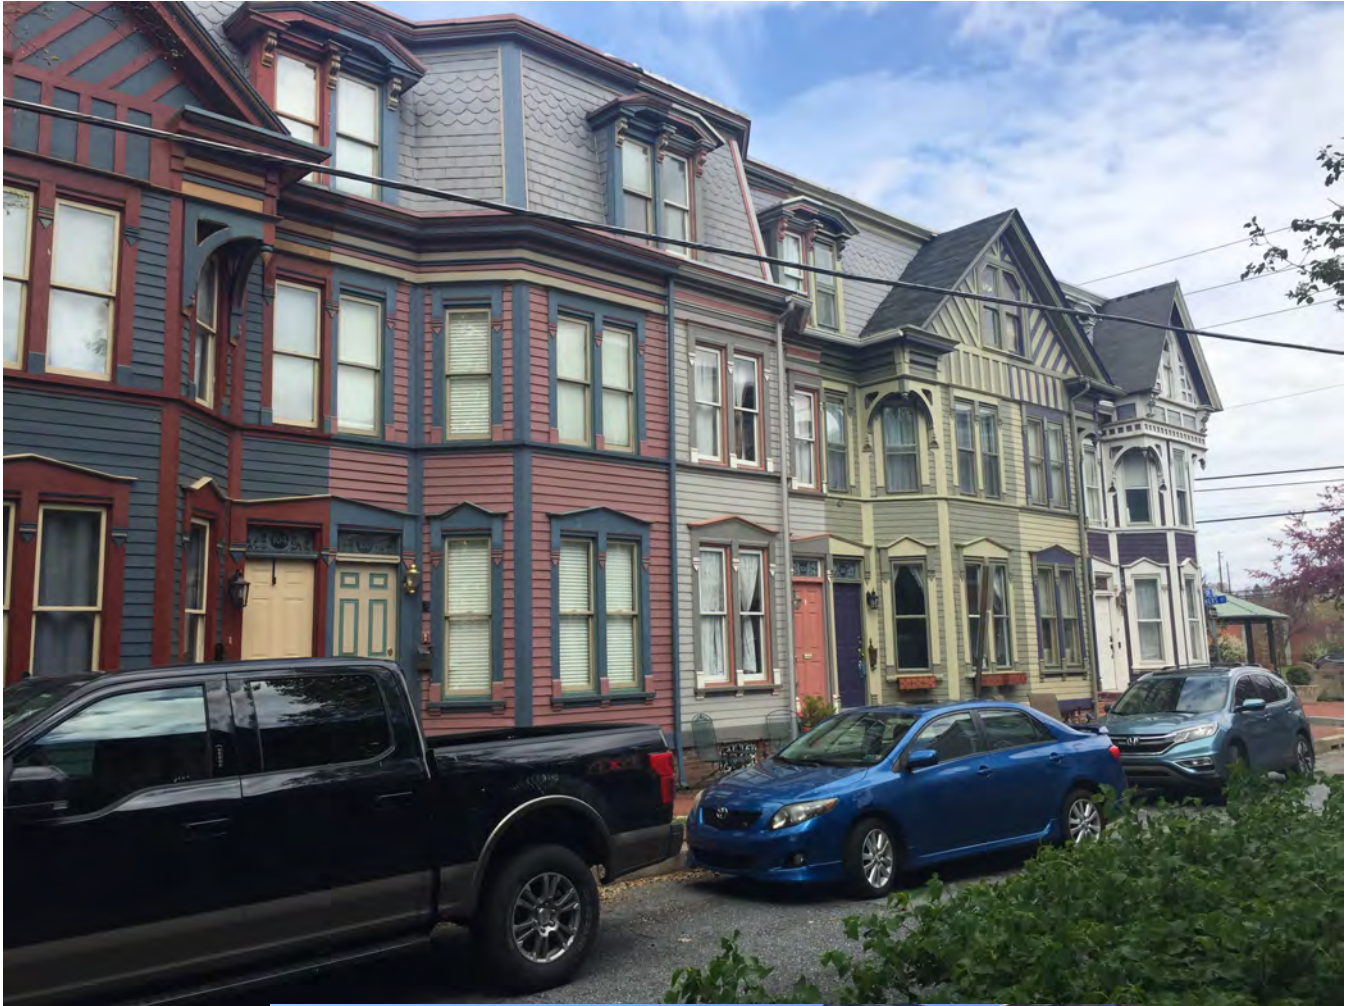
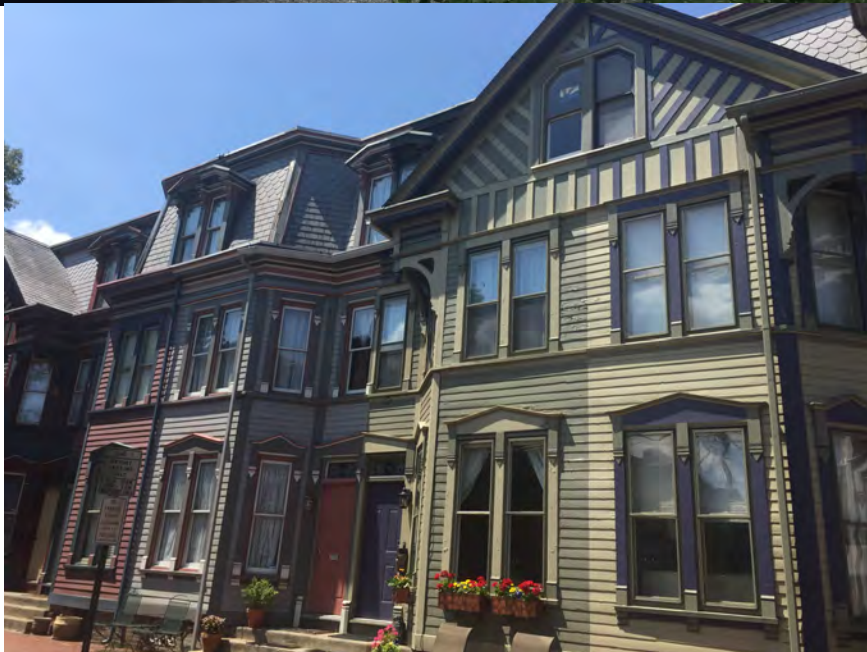
Stick (1860-1890)

Stick is a type of Victorian architecture that incorporates Queen Anne elements but is entirely done with wood. They often have the look of half-timbering like Tudor style buildings, but not with stucco, only wood clapboards or "sticks." The result is a highly textured and ornate exterior.

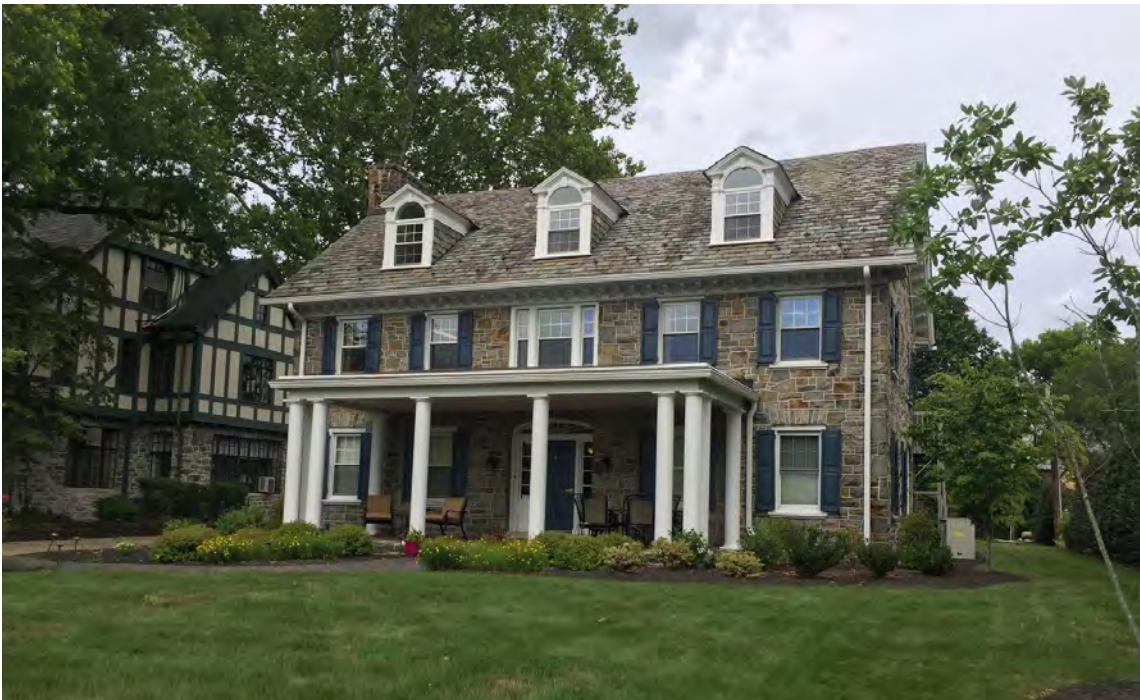
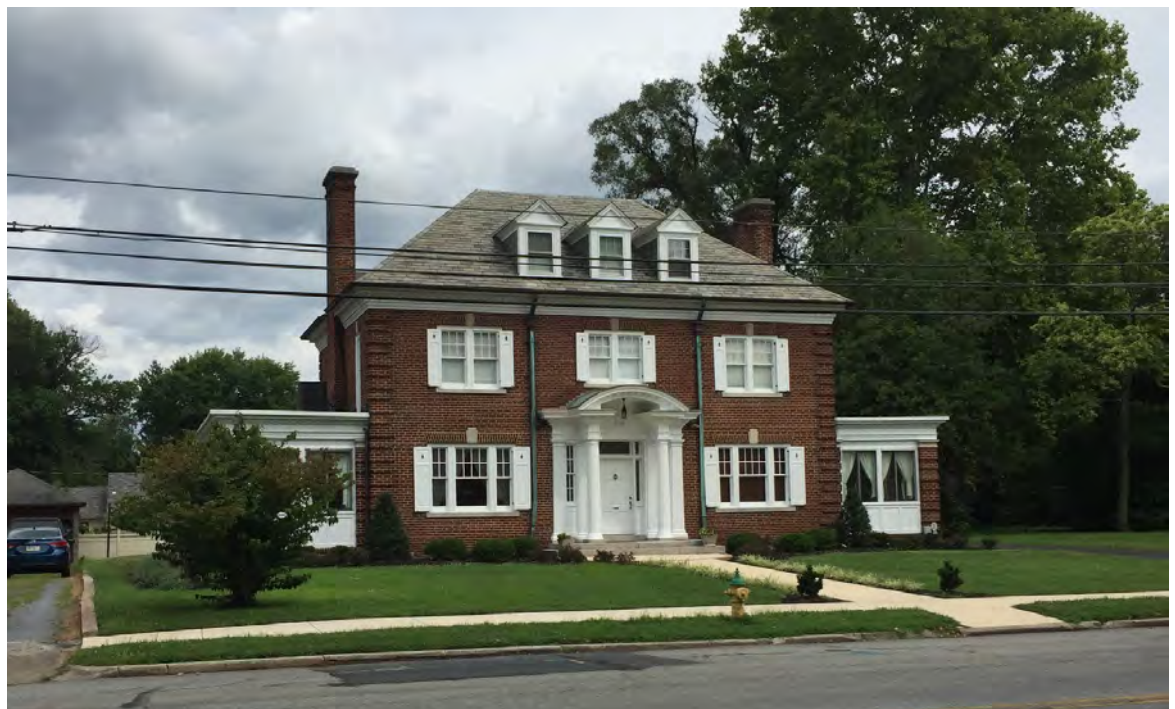
Colonial Revival (1880-1960)

Colonial Revival was a popular style at the end of the 19th and well into the 20th Centuries. The style uses Georgian and colonial designs to create symmetrical facades with a central entrance and classical detailing. Palladian style windows are often used for accent, but otherwise windows are all of uniform size and evenly spaced. The example shown are located in the Academy Manor Historic District, where the style is common.
