LEGISLATIVE APPROVAL FORM/CERTIFICATE OF ACCEPTANCE

A Resolution of the Council of the City of Harrisburg to approve the adoption of updated Historic District Design and Preservation Guidelines.

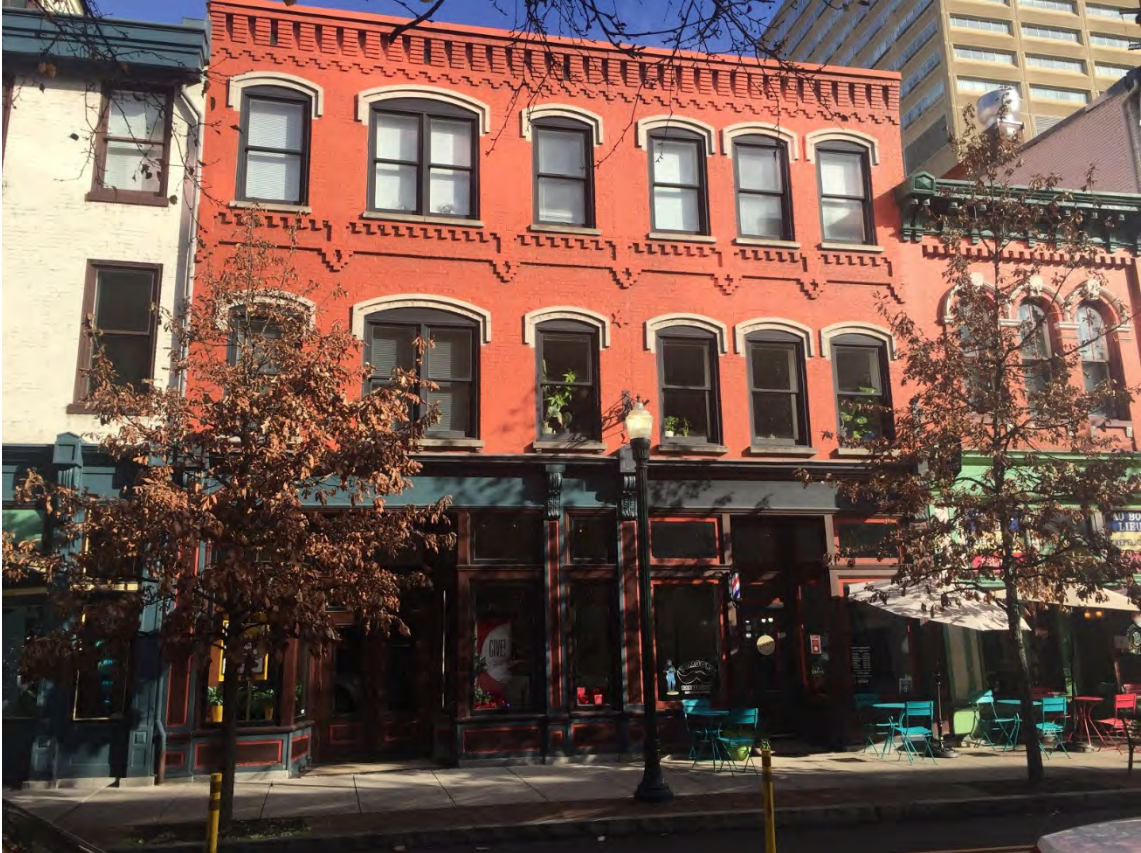
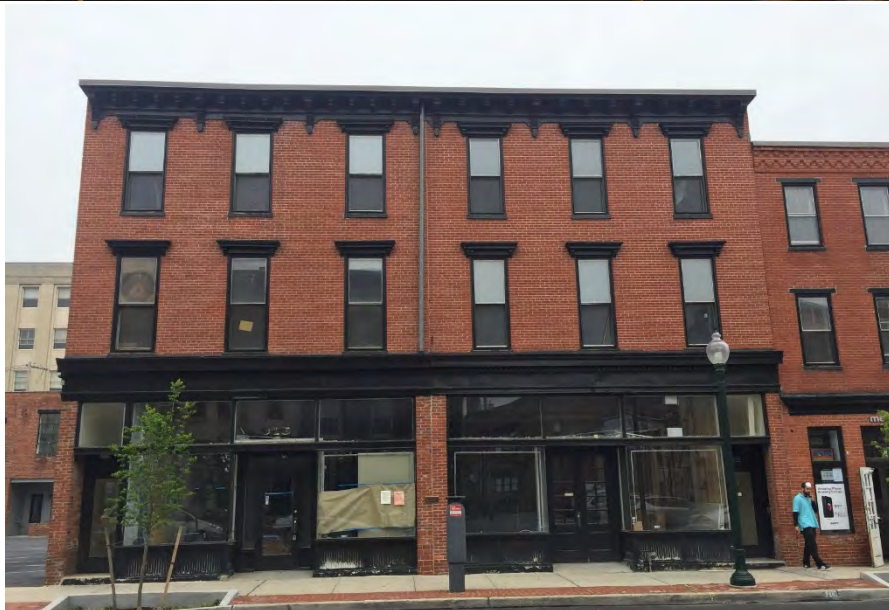
Commercial (1850-1920)

Commercial style is a type of architecture constructed for mixed uses along primary streets which included storefronts, showrooms, and restaurants. Commercial style architecture is defined by large storefront windows usually topped with a decorative entablature, symmetrical window patterns, and a strong cornice. Buildings are typically constructed with brick, but can be composed of wood or stone. Many of the commercial style structures in Harrisburg were constructed between 1860-1900 with Italianate architectural styling. There is usually residential housing above the storefront in the 2nd and 3rd floors.

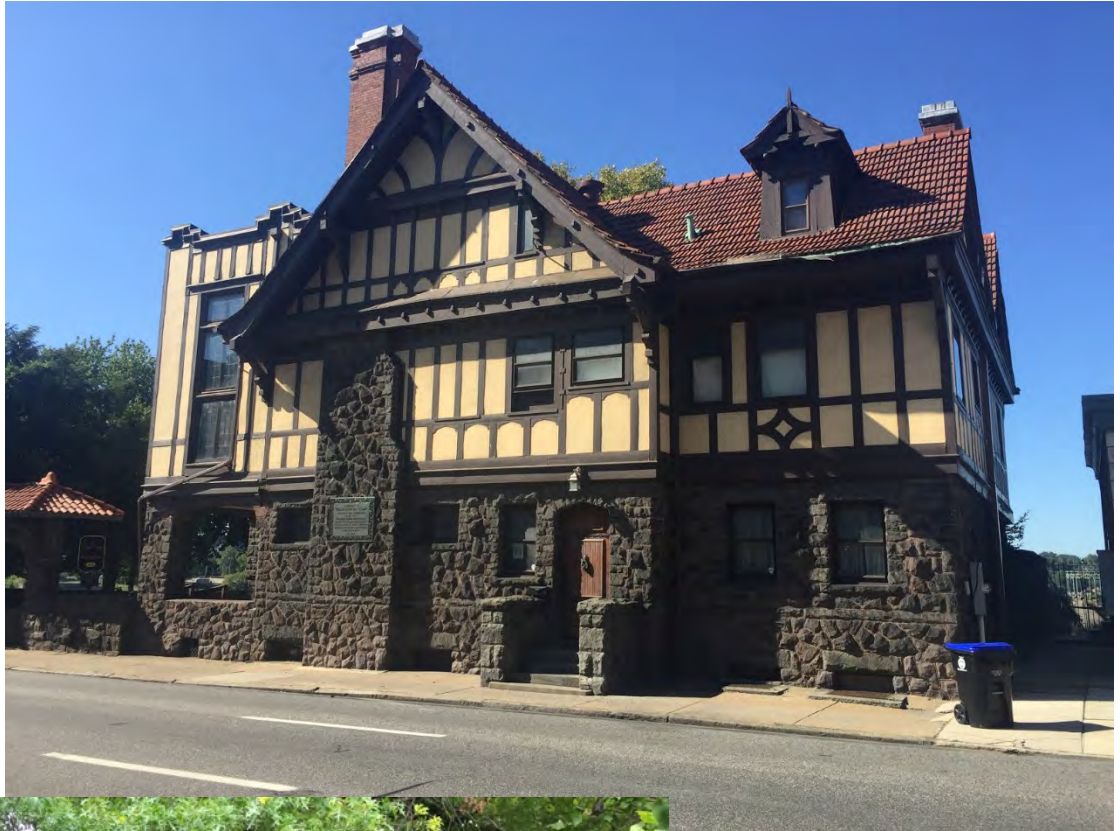
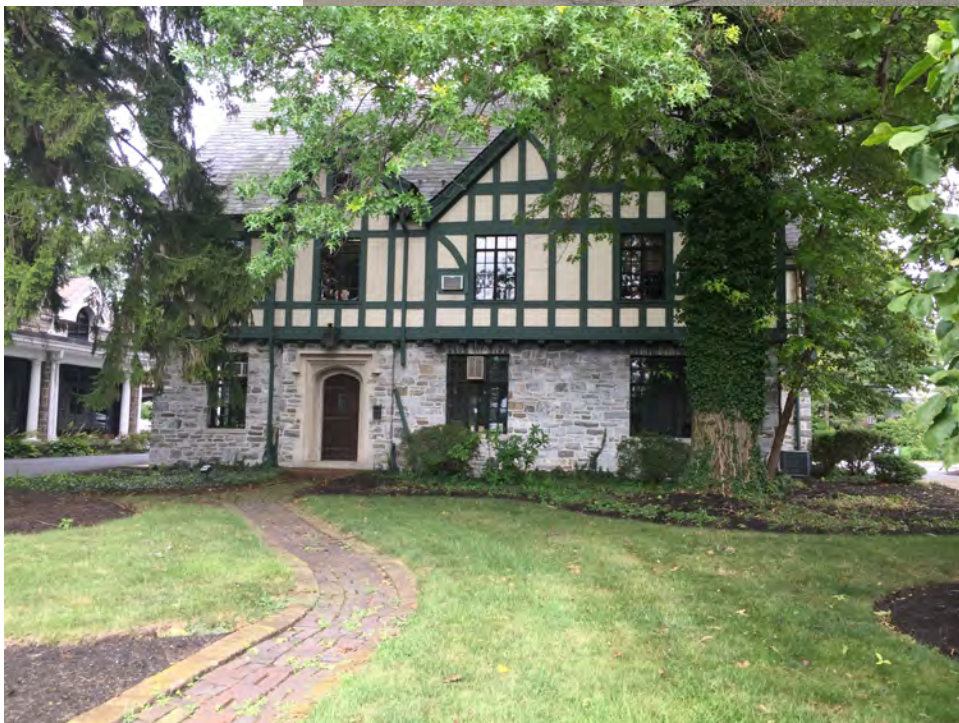
Tudor Revival (1890-1940)

The Tudor style of architecture is a revival style derived from medieval structures found in England. Tudor style is defined by half-timbers combined with stucco to create a patterned exterior. They typically have ornate chimneys, masonry exteriors on the first level, steep (often cross-gabled) roof lines, and multi-paned windows.

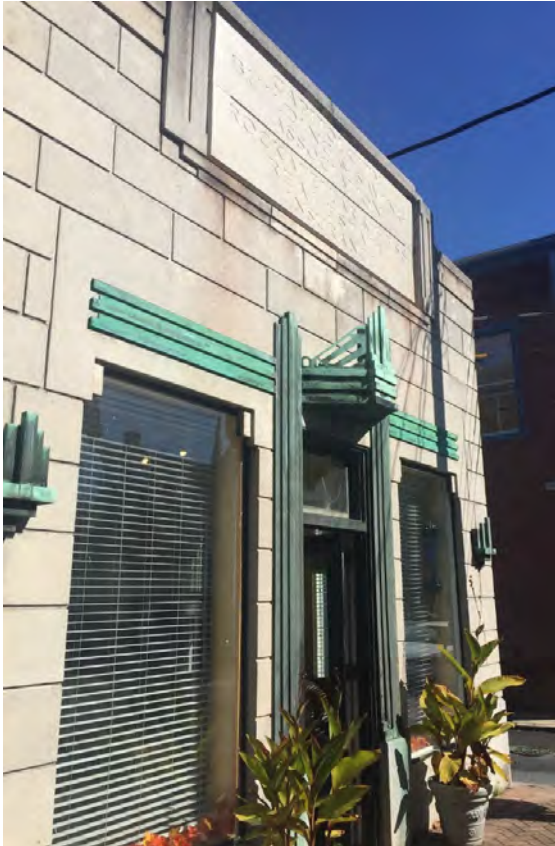
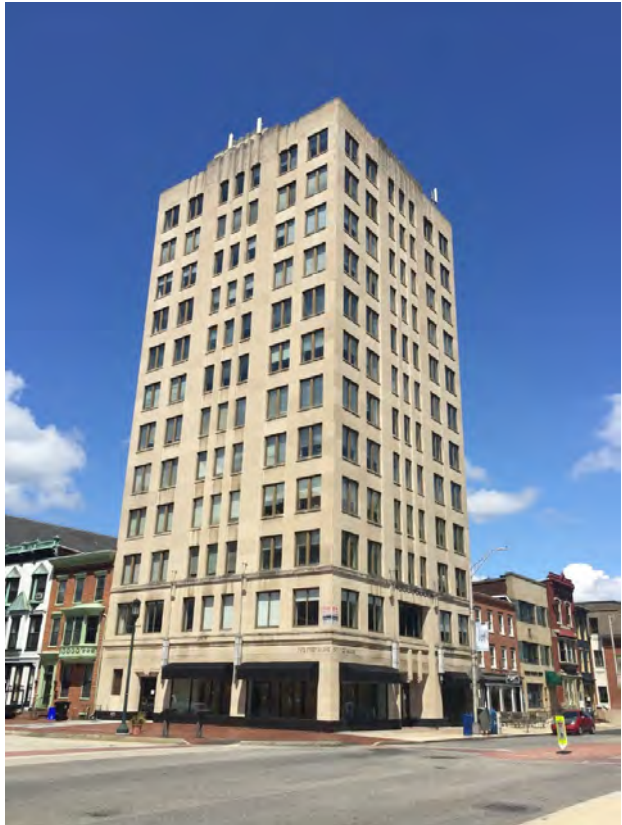
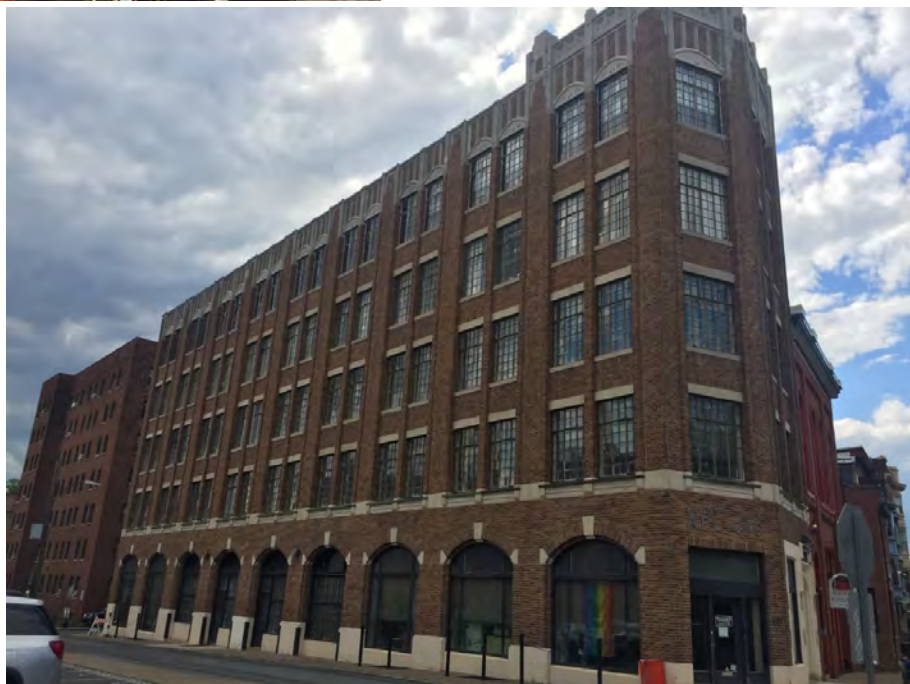
Art Moderne/ArtDeco/Streamline Moderne (1910-1940)

These three styles are technically different, but are often categorized together as they have similar characteristics. These styles were truly “modern” in that they utilized the most current materials and methods of construction. The heavy use of metals, concrete, and porcelain emphasized a new modern age. The use of egyptian, nautical, and cubist motifs can be found in the design of these styles. Unfortunately, these styles were short lived as WWII caused a disruption in architectural expression. These styles were the precursors to the International Style. The City has several examples of Art Deco and Moderne style architecture.

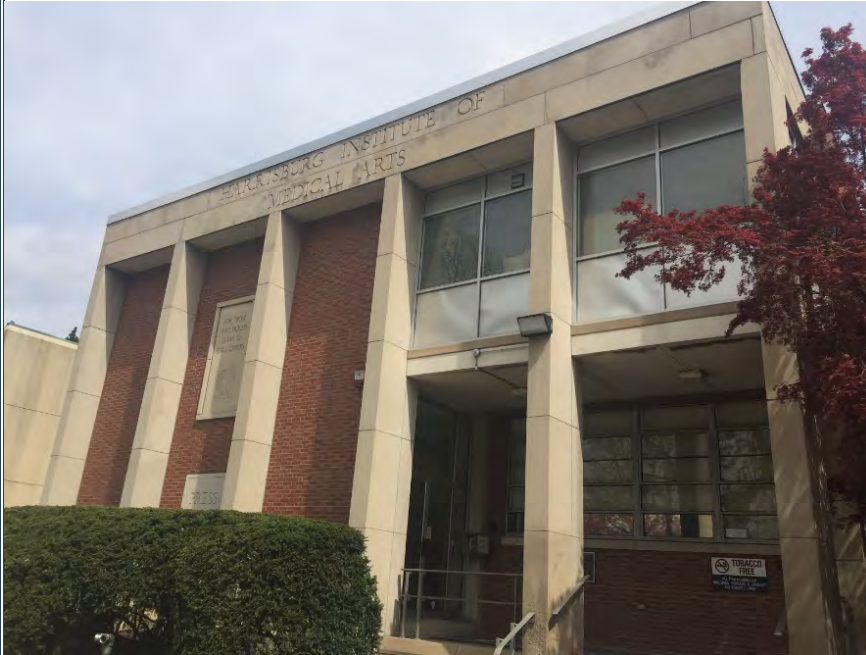
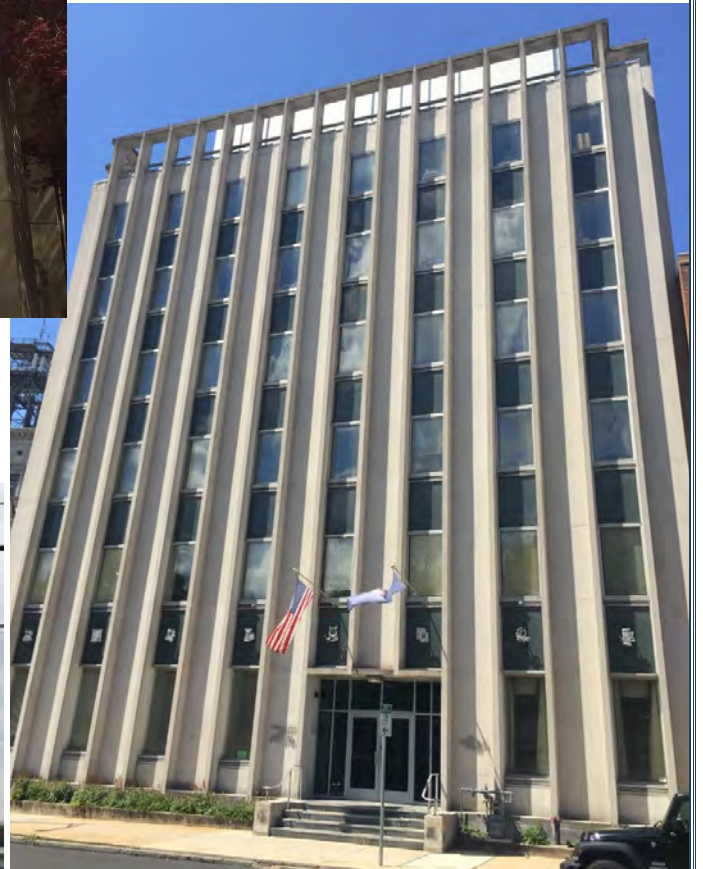
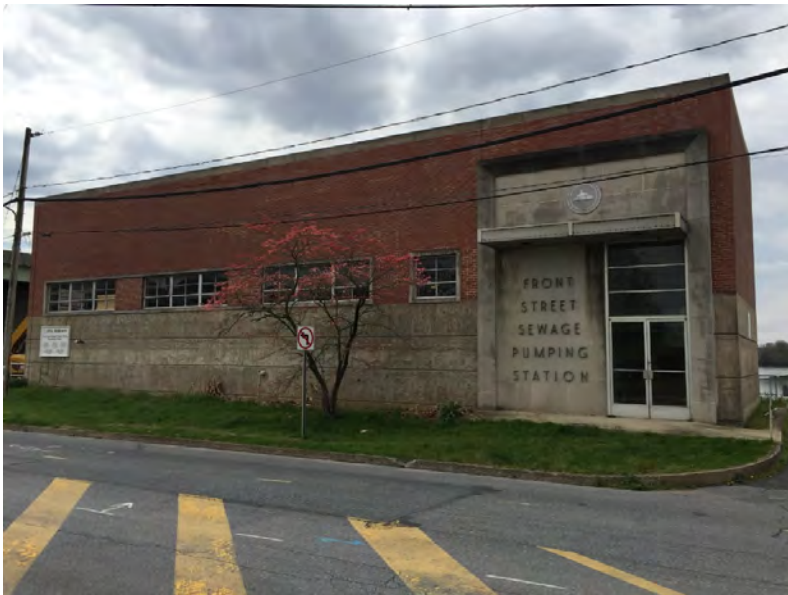
International Style (1940-Present)

Known as a modern style of building, International style architecture rebukes the ornamentation of earlier architecture and utilizes modern materials in a simple yet modern way. This type of style emphasizes strong horizontal and vertical lines usually with concrete, brick, and glass and typically have flat roofs. Furthermore, this style is typically used for office and apartment buildings. The International Style became very common following the aftermath of WWII in the rebuilding of Europe. There are several examples of this style in Harrisburg's historic districts, primarily in the downtown neighborhood.

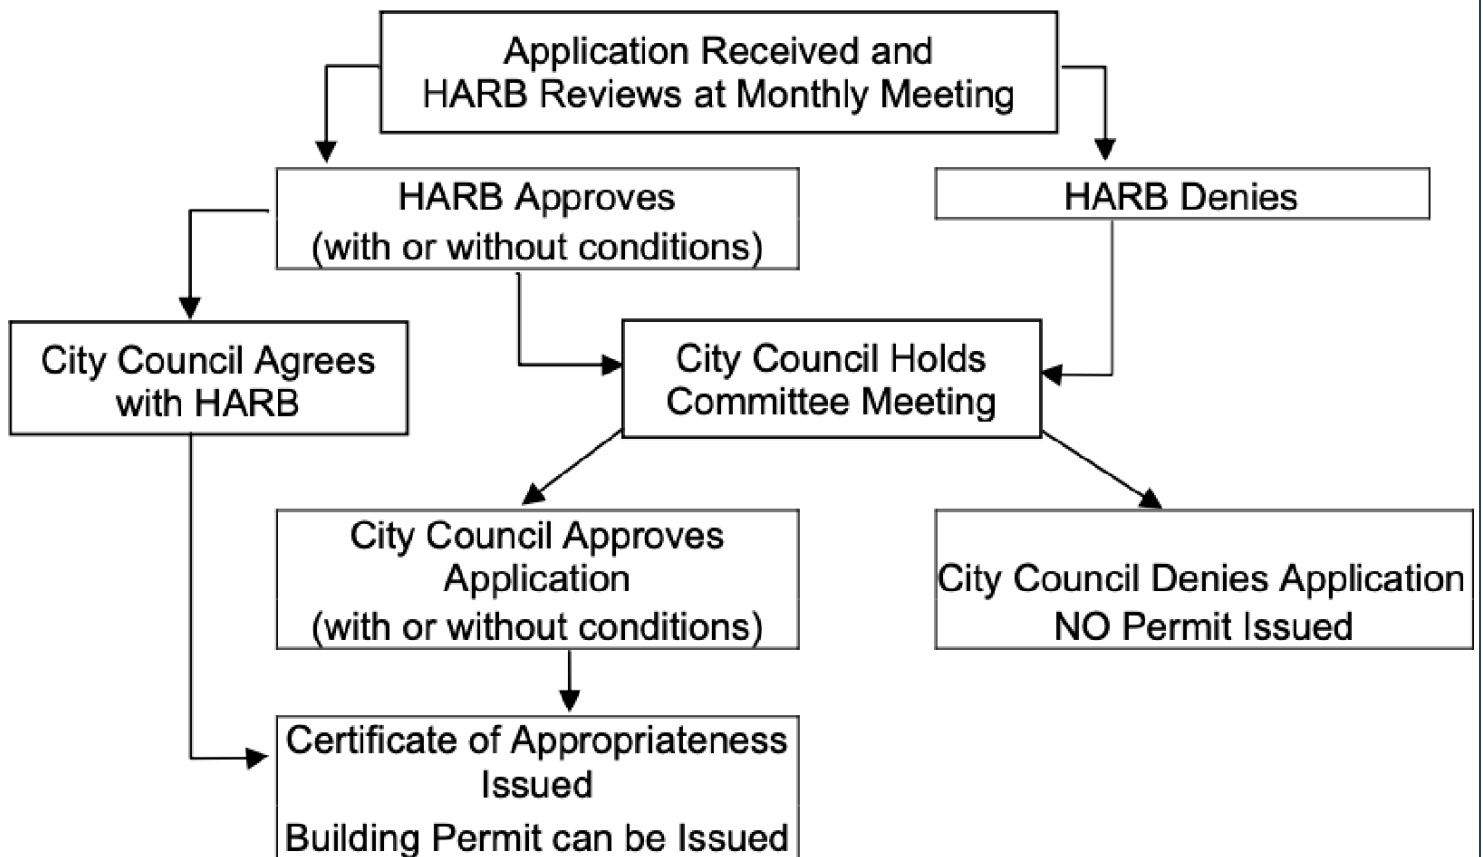
HARB REVIEW PROCESS

The HARB votes on each application at the meeting, thus establishing their recommendation to City Council. Decisions are based on the merits of each individual application. City Council then makes the final decision on each application, usually within 30 days from the HARB meeting. If the HARB has recommended approval of your application, and City Council agrees, you will receive your Certificate of Appropriateness and the Bureau of Codes will issue your Building Permit.

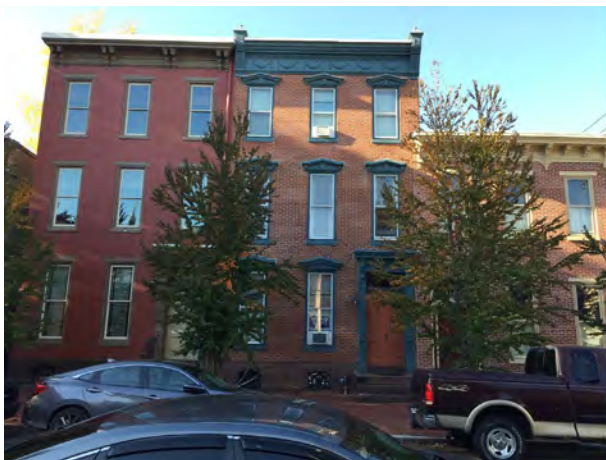
Example of Primary Facades

The Historical Architectural Review Board (HARB) regulates any facade which is visible from a public right-of-way in a designated Historic District. Facades are categorized as primary and secondary. Facades that are visible from a public street or sidewalk and include the front entrance or historically significant architectural features are considered primary facades. Corner properties have two primary facades. Facades that are considered the rear of a building and are not visible from a primary or major street are secondary facades. Primary facades generally have the most character defining features and therefore will be reviewed more closely by the HARB than secondary facades.

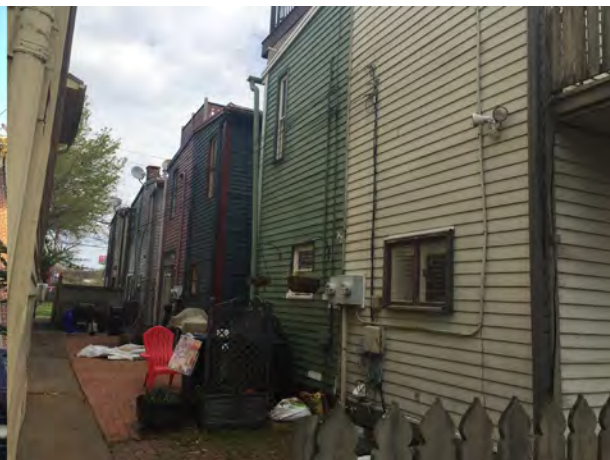
Example of Secondary Facades

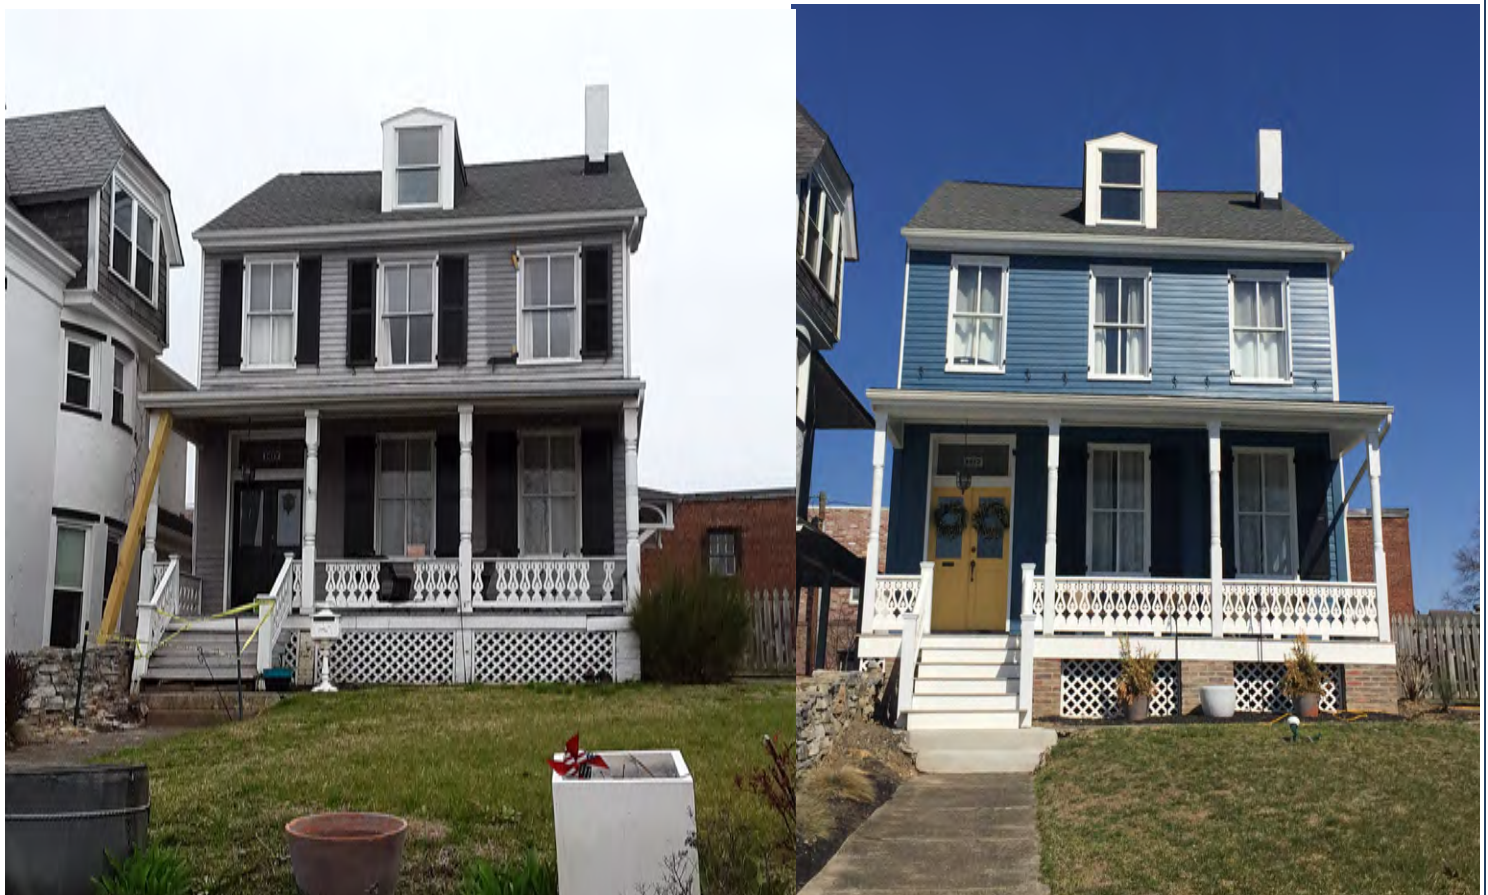
This historic Front Street residence has undergone extensive rehabilitation to its exterior including a porch restoration and a fresh paint job.

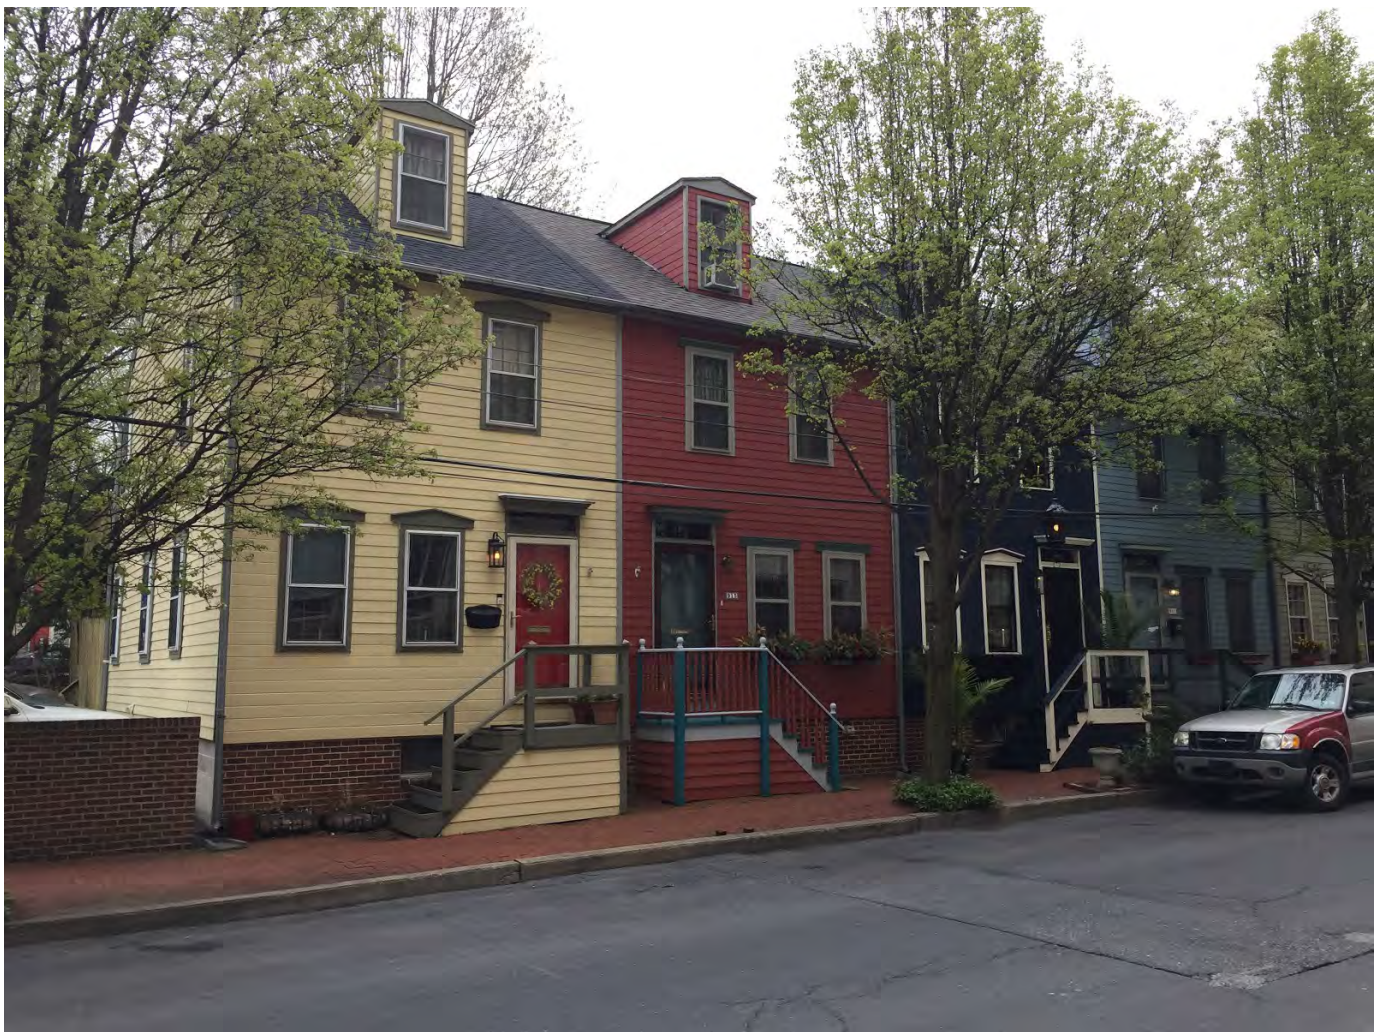
A series of late federal vernacular style row houses on Capital Street in Fox Ridge municipal historic district. Notice the texture and character defining appearance of the historic wooden siding. Also notice the variation of colors, brick sidewalks, and tree lined streets which makes this neighborhood a cozy and inviting place to be.

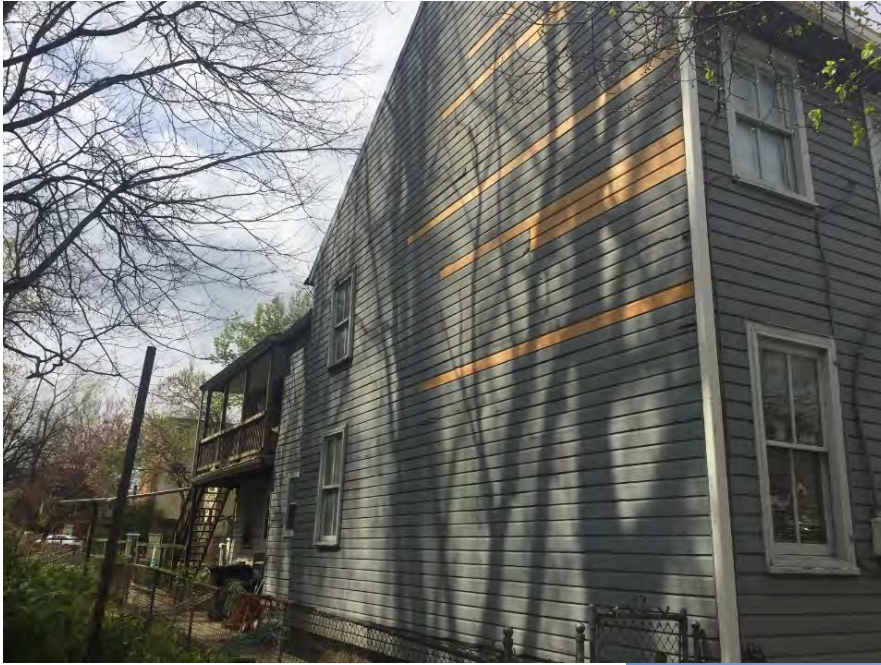
This homeowner on 2nd Street has replaced deteriorated wooden siding in-kind with new wood siding.

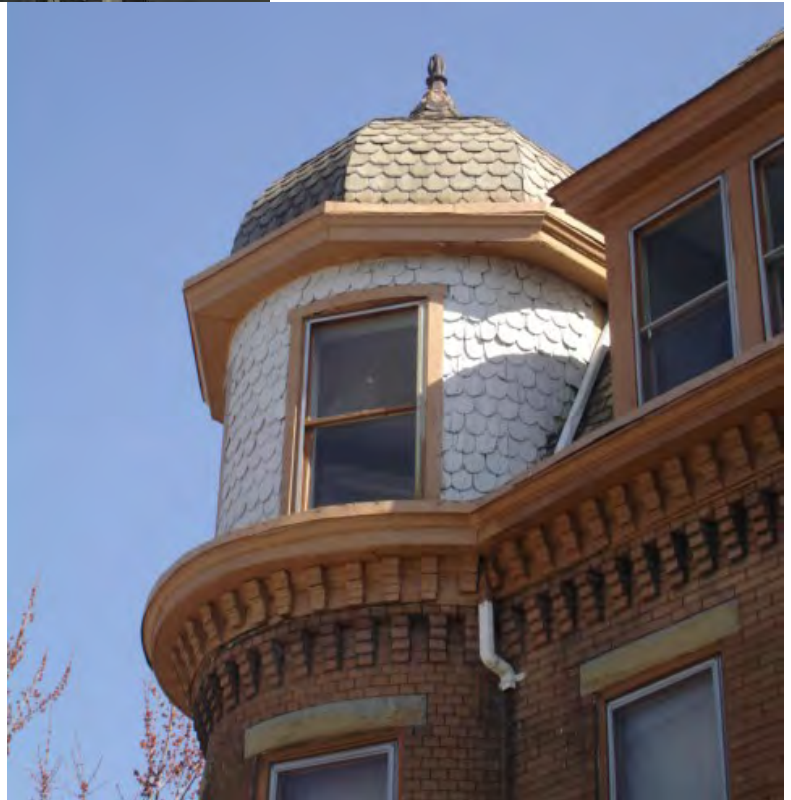
Wood shingles should be treated the same as wood siding. They should be maintained, repaired, or replaced in-kind. Historically a variety of different styles and types of wood shingles were used where the majority of them were used on Queen Anne and Shingle style homes. Be sure to match the existing style and type of wood shingle.

The wooden shingles on this turret have been properly maintained and repaired.

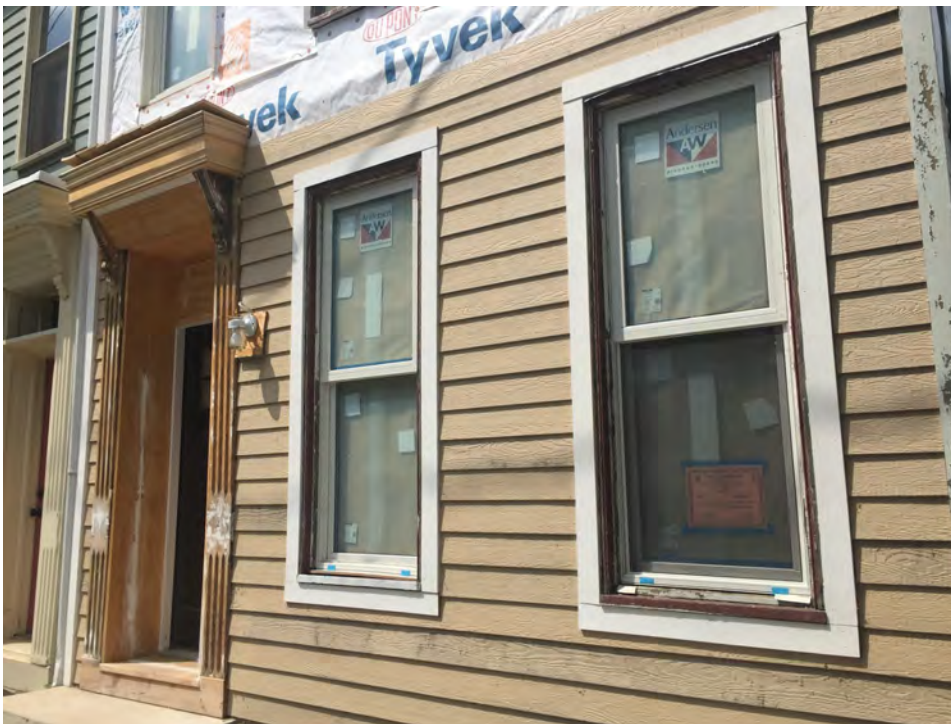
This once blighted Uptown property has cementitious fiberboard installed where wooden clapboard once existed. This product has a strong resemblance to historic wood siding.

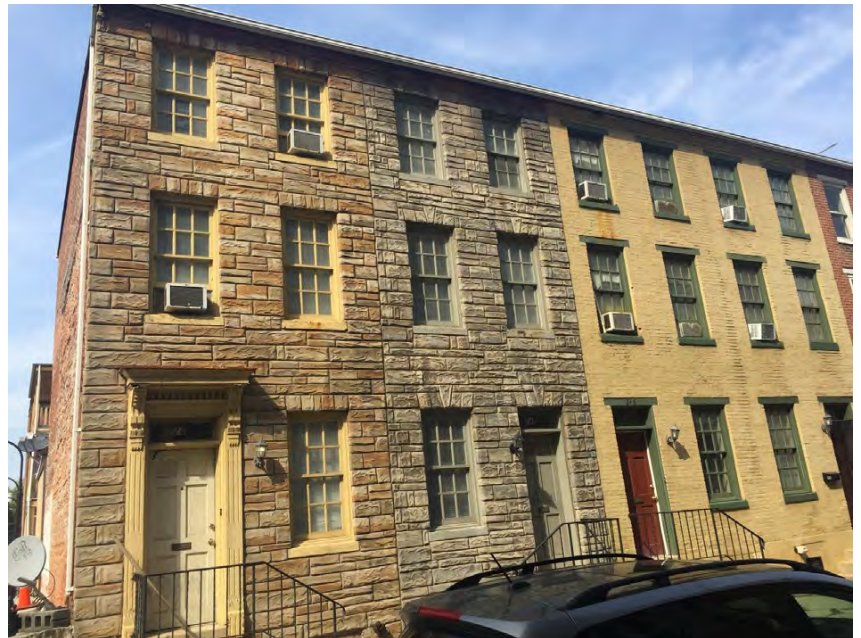
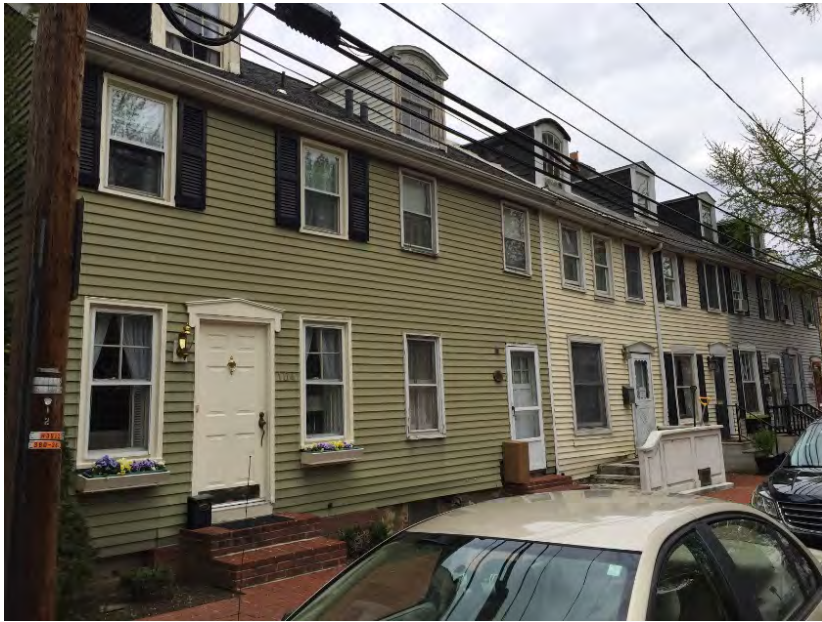
Here is a row of homes which have lost much of their historic integrity. many of these homes had vinyl and aluminum siding installed. These contemporary materials have eliminated and destroyed original historic features.

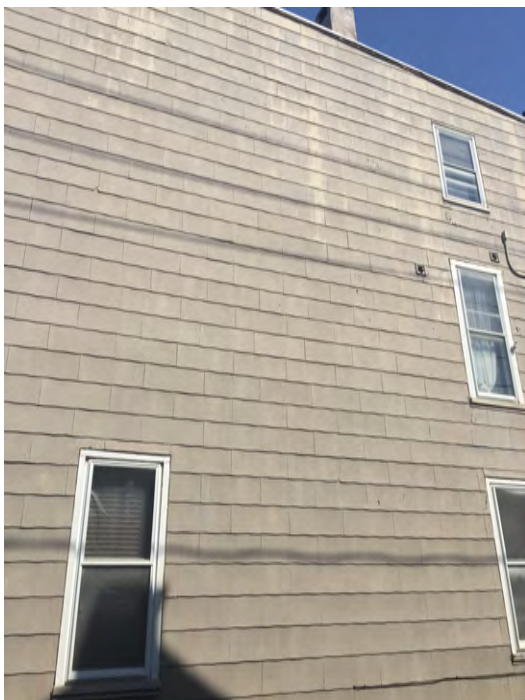
Asbestos-Cement shingles are long lasting and durable. Preservation treatments for this material depend upon the context of the building.

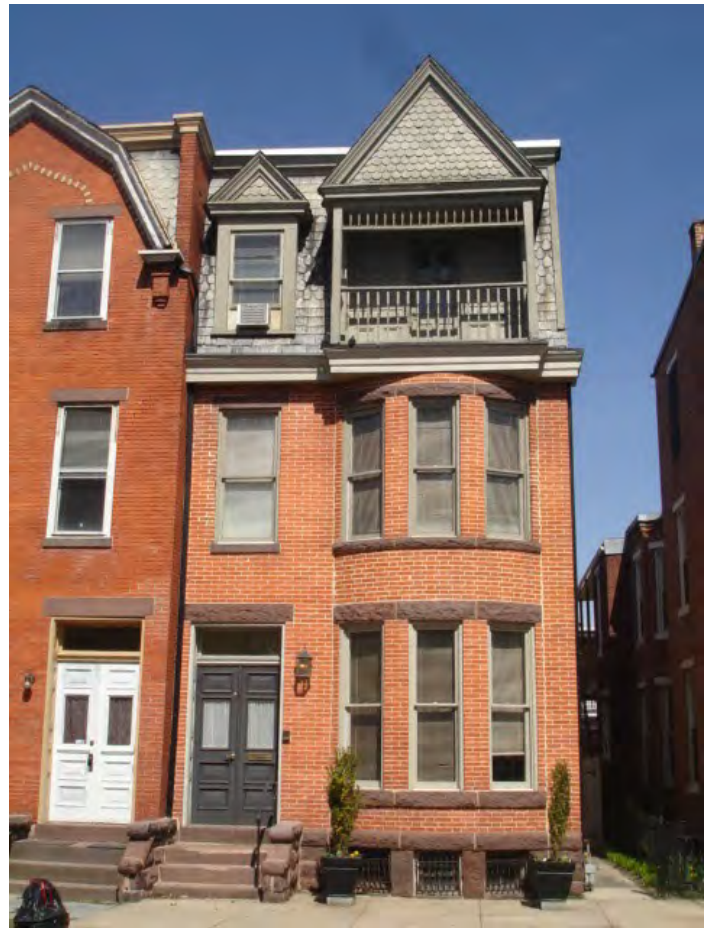
This wonderfully preserved home in Midtown still boasts many of its original exterior features. These exterior wooden details should always be maintained and preserved.

Some of the most character defining features of historic buildings are the exterior details such as trim, wood shingles, corner boards, pediments, cornices, fascia, and brackets. These architectural features are often subject to deterioration as they are largely exposed to the elements. It is important to inspect these features for deterioration such as rot and paint failure on an annual basis. All exterior details should be regularly painted to protect them from water infiltration, pest infestation, and UV exposure.

If these architectural details are rotting, they should be repaired. The type of repair can vary depending on the severity of rot, but a wood epoxy filling has been a widely successful technique in repairing historic wooden detailing. If they are deteriorated beyond repair, details should be replicated with the same size, texture, materials, and texture as the original. The covering or capping of exterior details with modern materials, such as vinyl or aluminum, is not recommended.

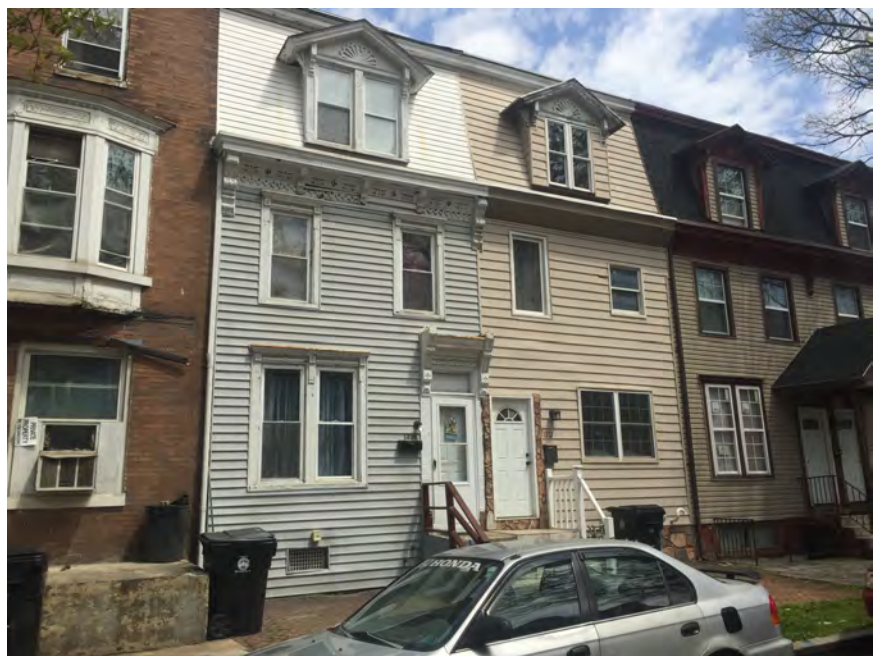
Notice the detrimental impact on the neighborhood when historic exterior features are removed and historic buildings are encapsulated with modern materials. Once historic buildings are encapsulated they are no longer contributing features to the historic streetscape.

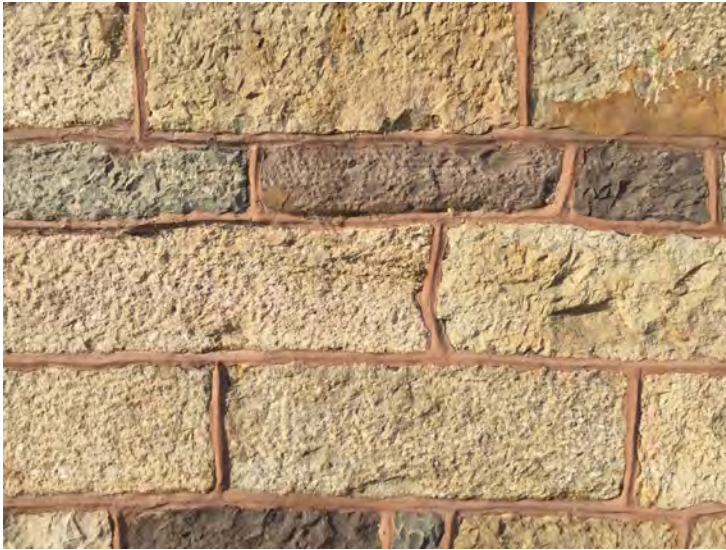
This fieldstone structure was properly repointed by an experienced mason. The original mortar joints were accurately replicated.

Repointing masonry where the mortar has deteriorated or is missing is a common maintenance procedure on all historic masonry. It is not as simple as it may appear and only experienced masons should be employed for such work. If not done correctly, the appearance of the masonry can be significantly altered and damaged. Inexperienced masons often expand historic mortar joints thus resulting in the loss of historic integrity and increasing the potential of masonry failure.

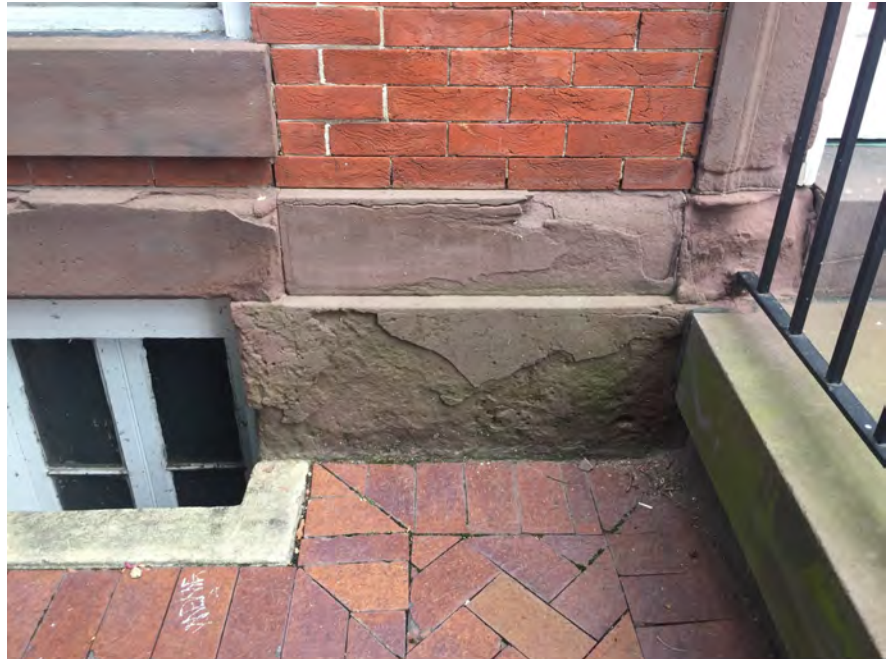
Brownstone and other natural sandstones are naturally porous and are susceptible to spalling and deterioration. Acid rain and the freeze thaw cycle are main causes of failure. Sidewalk and road salt also accelerate deterioration of soft masonry.

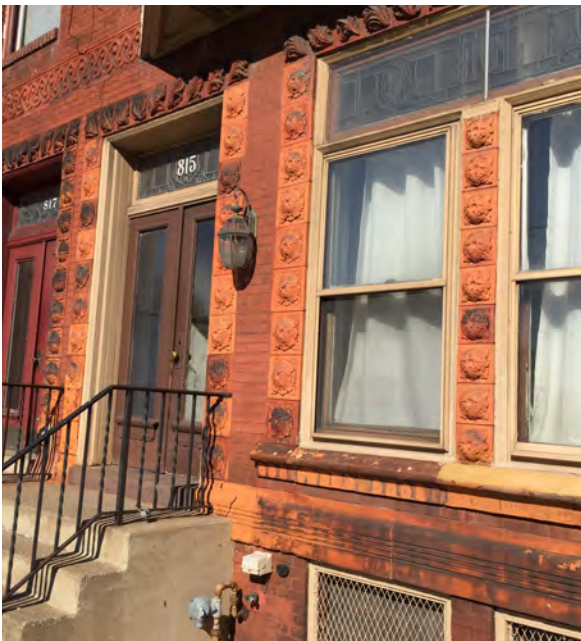
Architectural features made from glazed terra-cotta are prone to deterioration. Repair or replacement of terra-cotta with appropriate alternatives may be necessary due to the availability of these features.

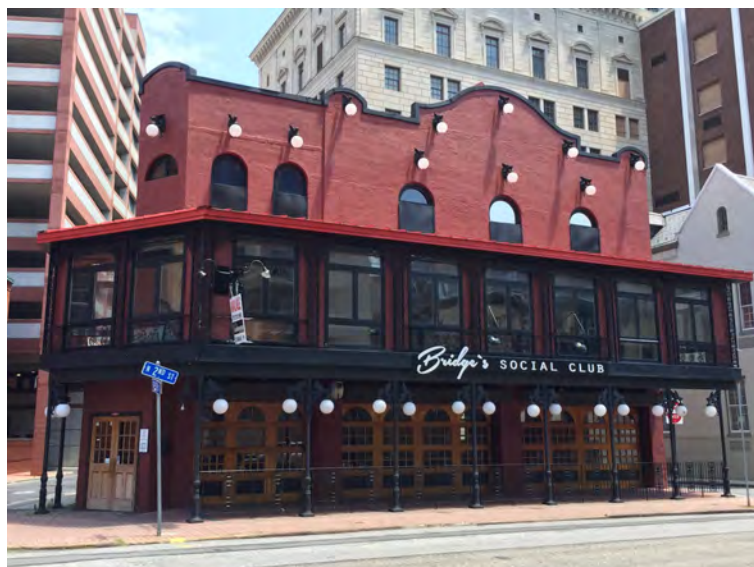
Although severely altered, the original Methodist Church and Ohev Sholom Temple on North 2nd Street was constructed in 1820. The building maintains its original stucco exterior.

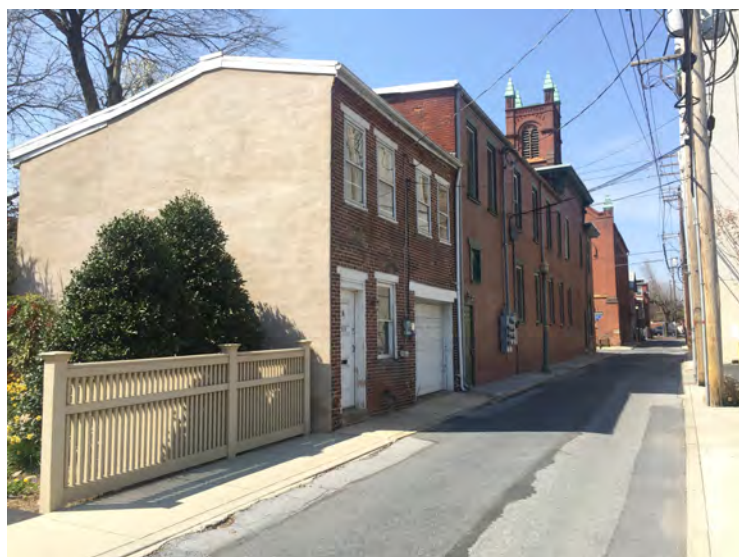
An example of a stucco party wall in Midtown. These walls can be repaired and maintained as needed.

If an historic building was originally constructed with stucco or the stucco has retained historic integrity or significance, it should be maintained and repaired using lime mortar to match the existing stucco.

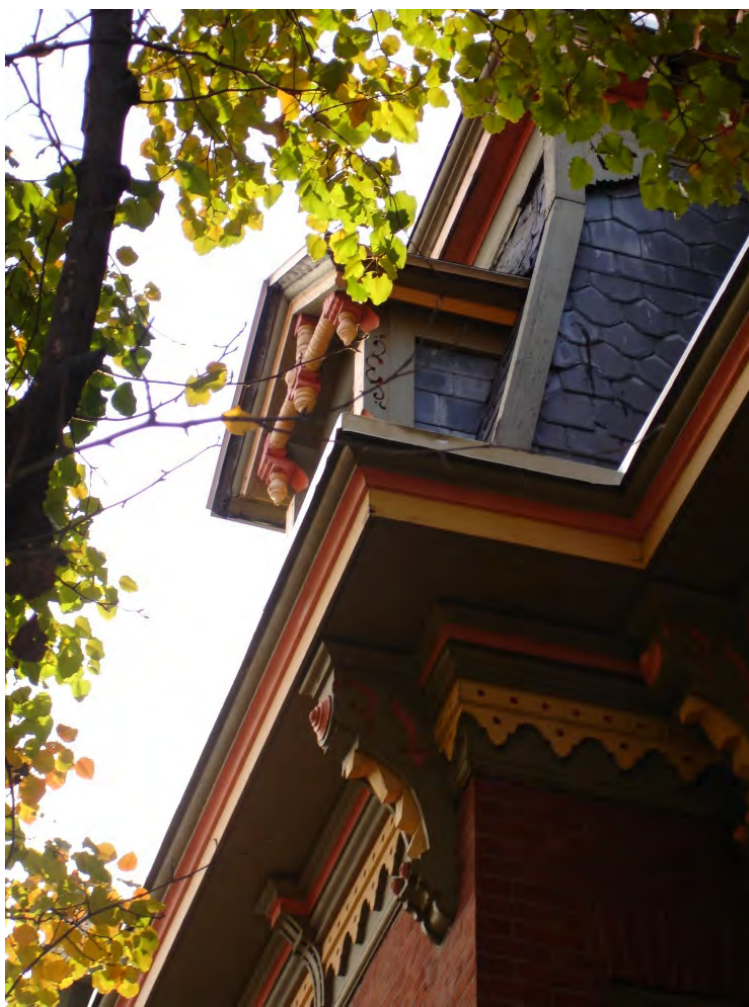
This roof and its decorative features have been properly maintained and preserved.

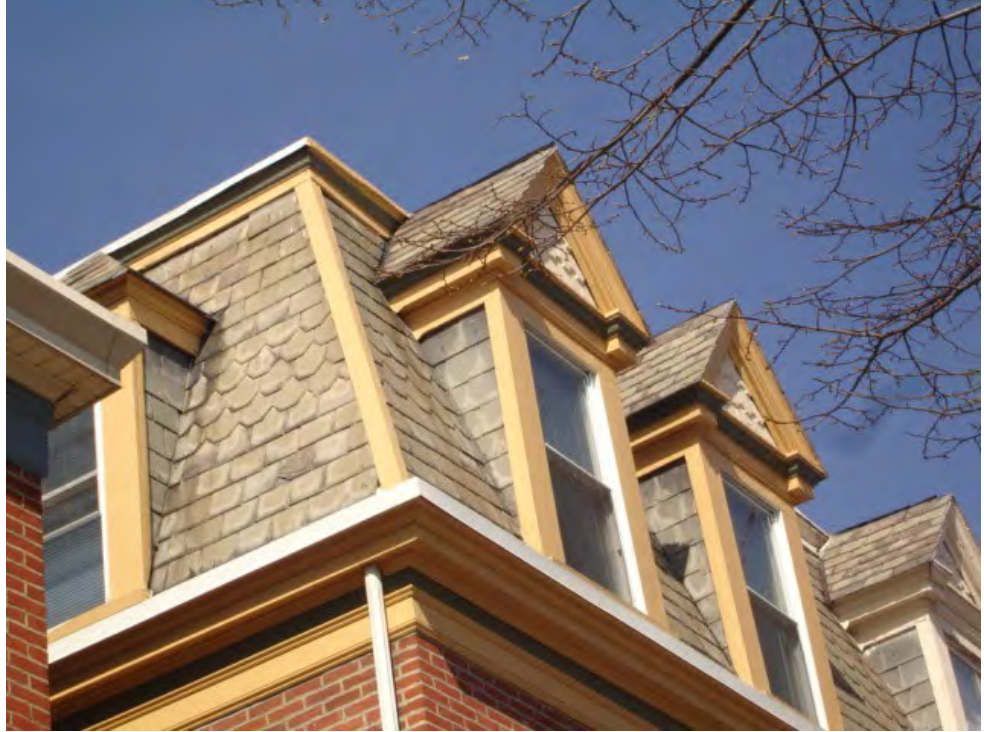
A pair of gabled dormers projecting from a slate Mansard roof. Mansard roofs were usually constructed with built-in box gutters.

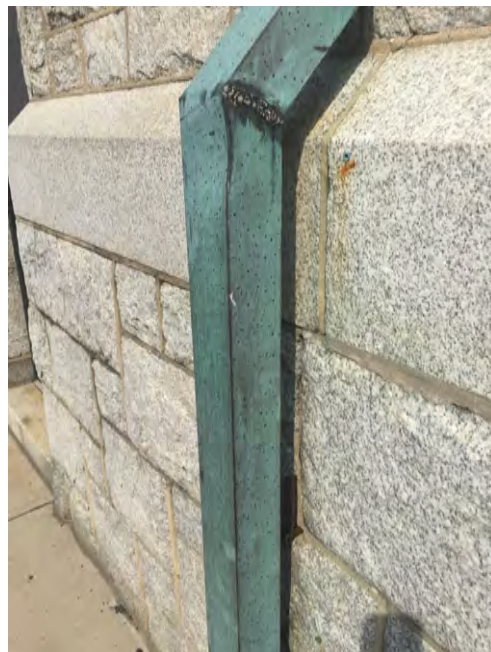
This historic copper gutter is a character defining feature and should be preserved.

Historic metal ridge caps and valleys should be preserved if possible. Many of them are composed of historic copper with a unique green patina. Caps and valleys can be character defining features of the roof. These features can be repaired or replaced in-kind with the same material. Drip edges are often a necessary functional part of a roof and should be installed where needed. Drip edges should not alter or damage existing historic materials or features.
