LEGISLATIVE APPROVAL FORM/CERTIFICATE OF ACCEPTANCE

A Resolution of the Council of the City of Harrisburg to approve the adoption of updated Historic District Design and Preservation Guidelines.

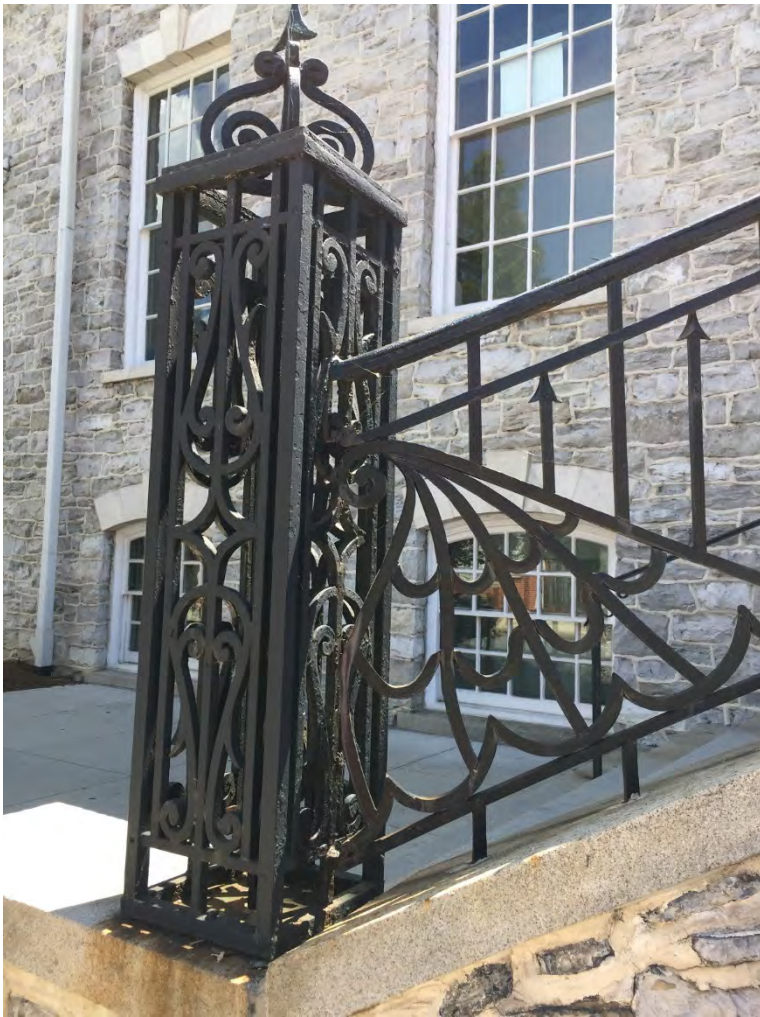
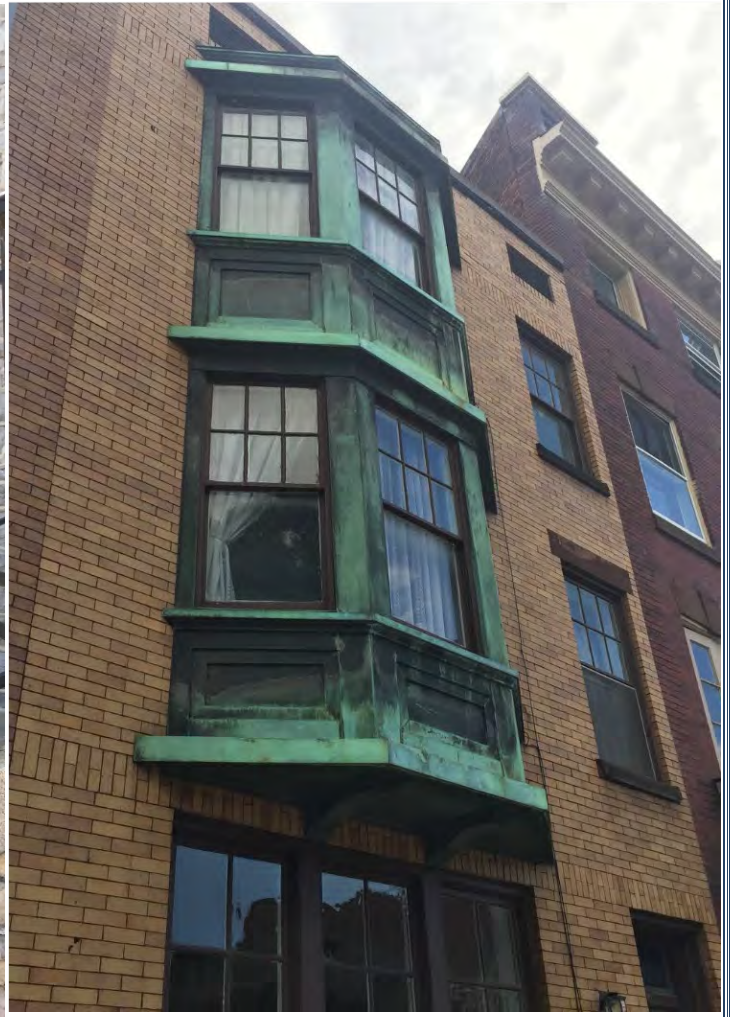
Architectural metals are usually found in railings, fences, grates, cornices, bay windows, and roof ornamentation.

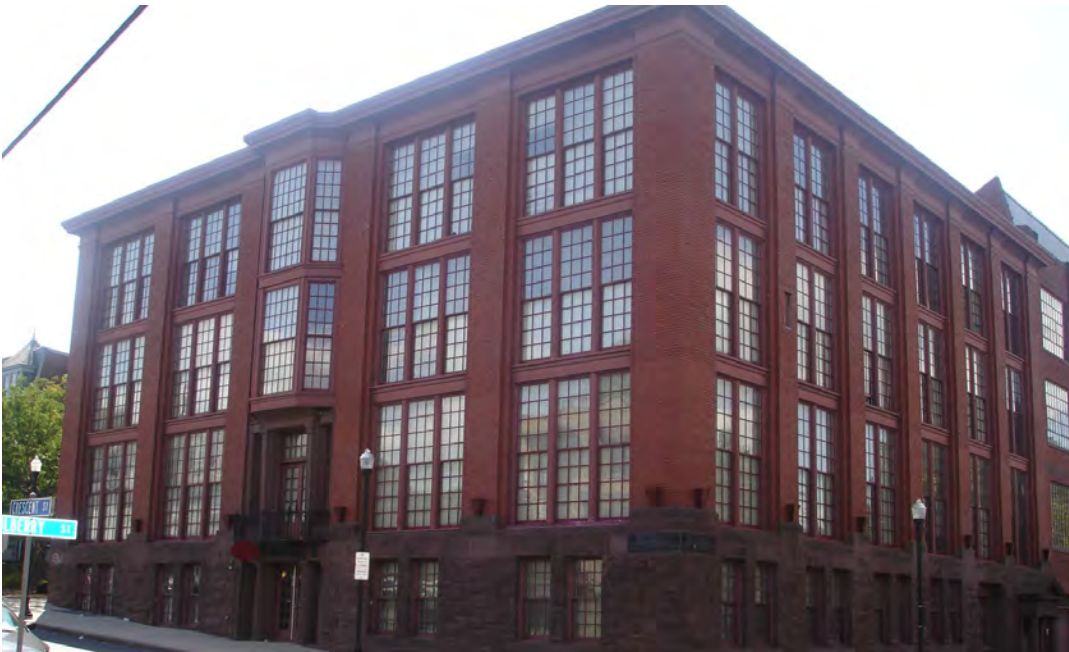
The McFarland Press Building constructed in 1906 was meticulously rehabilitated in the 1990's. Notice that the character defining windows have been repaired and replaced in-kind.

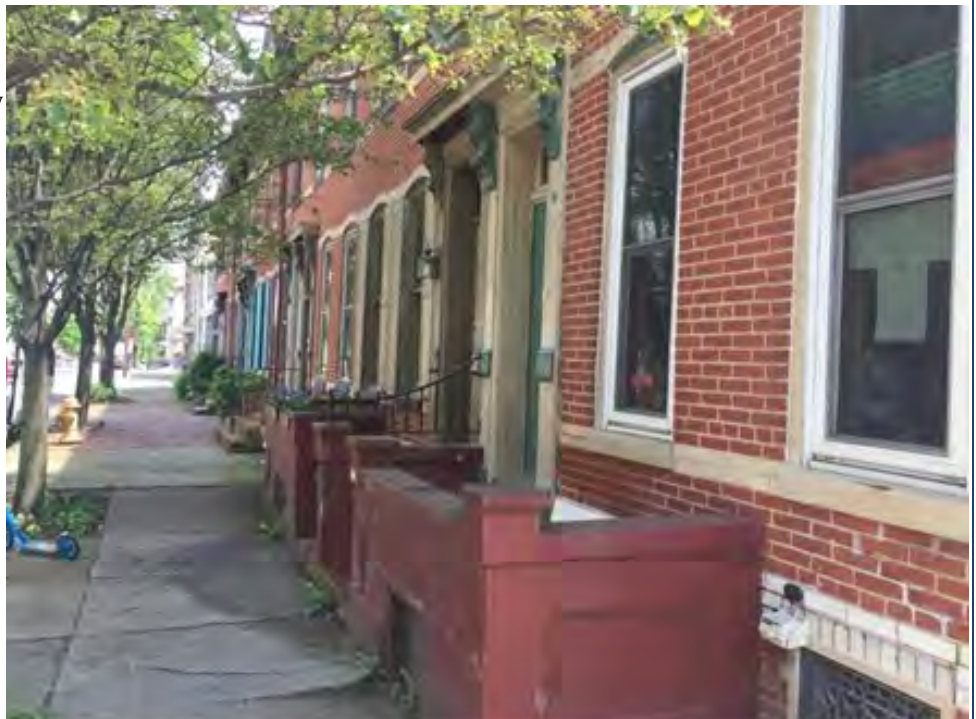
Notice the visible incompatibility of these vinyl windows in this historic streetscape on Calder Street. The size of the glass is too small for the opening and the reveal of the vinyl windows are not appropriate for the building. Vinyl windows have a negative impact on the integrity of an historic neighborhood.

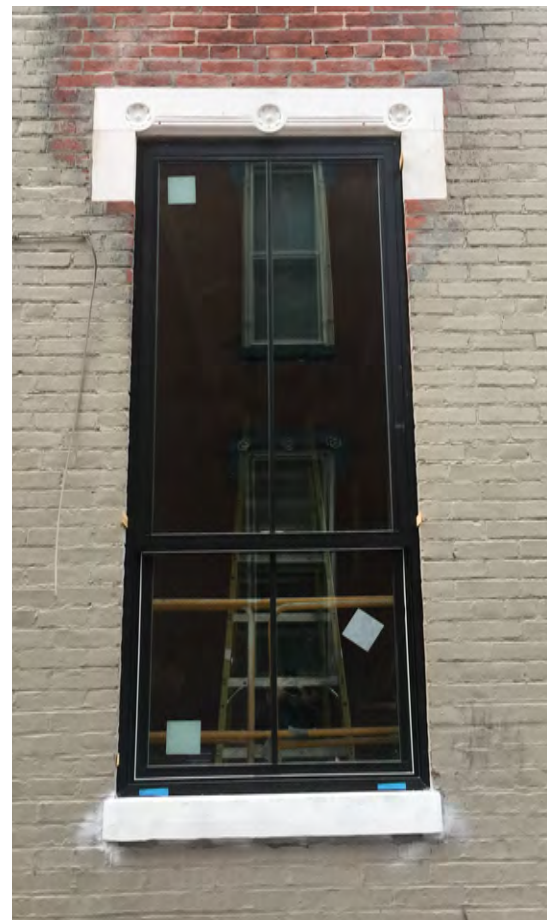
Recently installed wood composite window with a reconstructed header and sill.

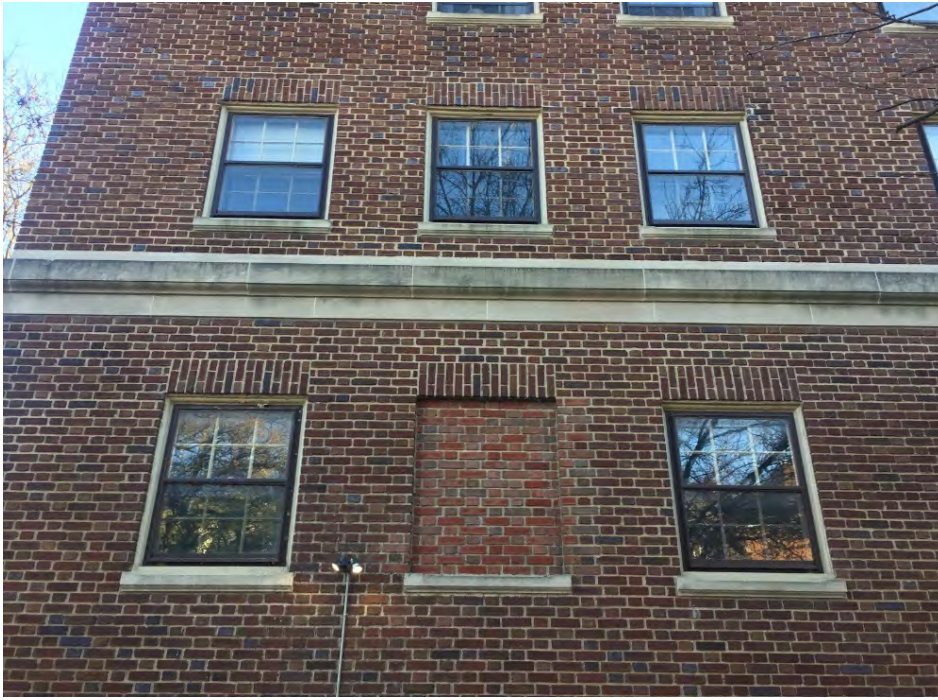
The infill of this historic window opening severely disrupts the rhythm and pattern of the building's exterior.

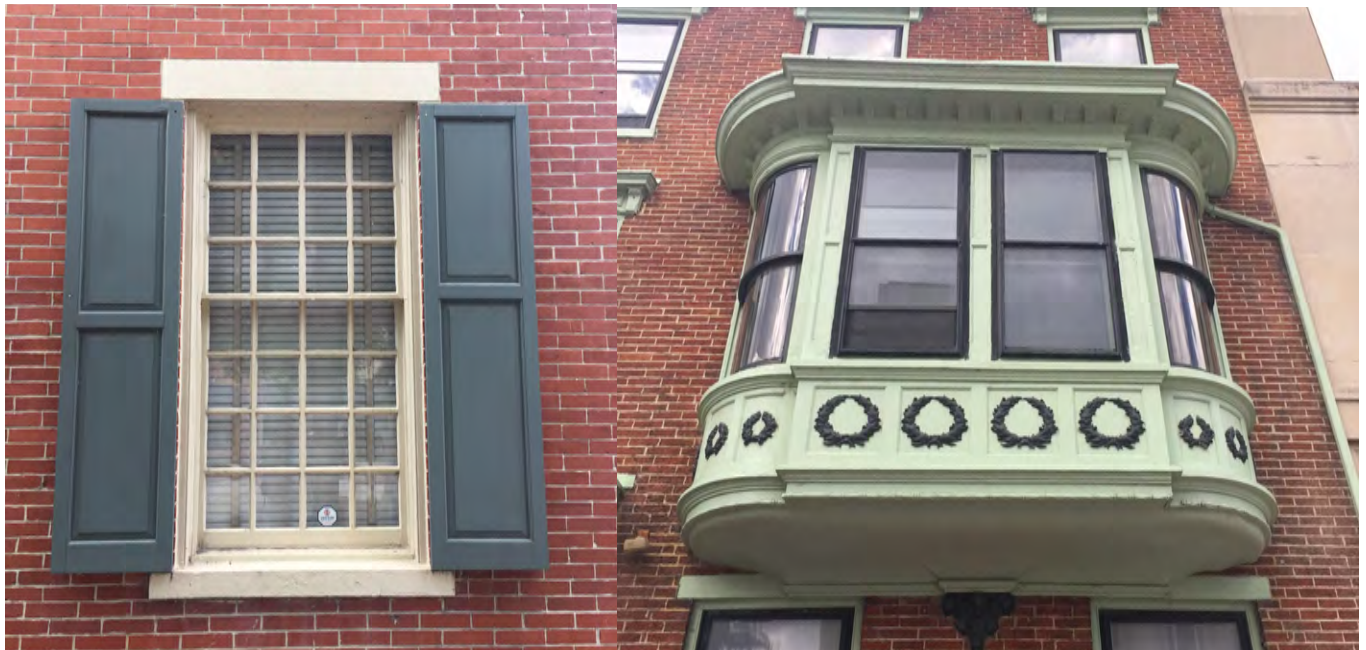
Character defining historic windows should be maintained and repaired as necessary. Replacing curved bow windows or multi-lite windows can be difficult and expensive thus making it important to take preventative measures to preserve them.

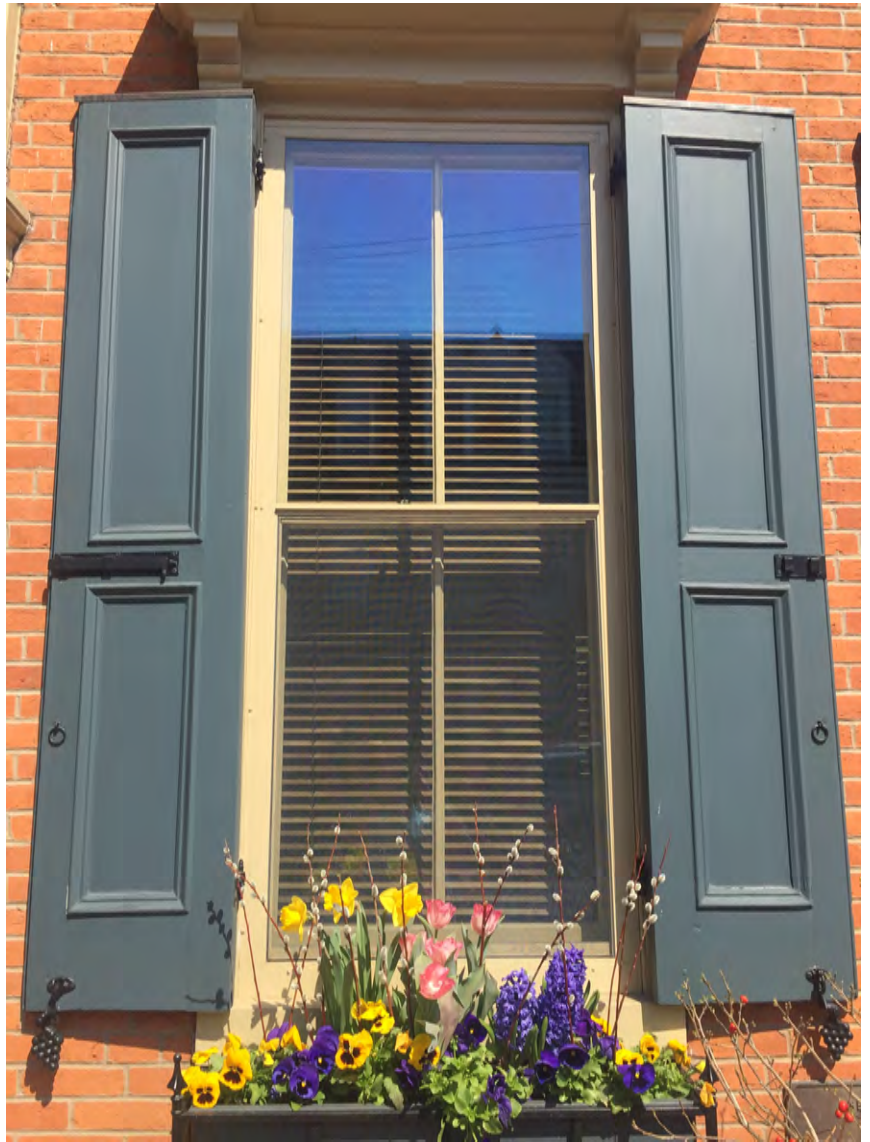
This historic window has been restored and is complemented by historic wooden shutters, hardware, and a new storm window.

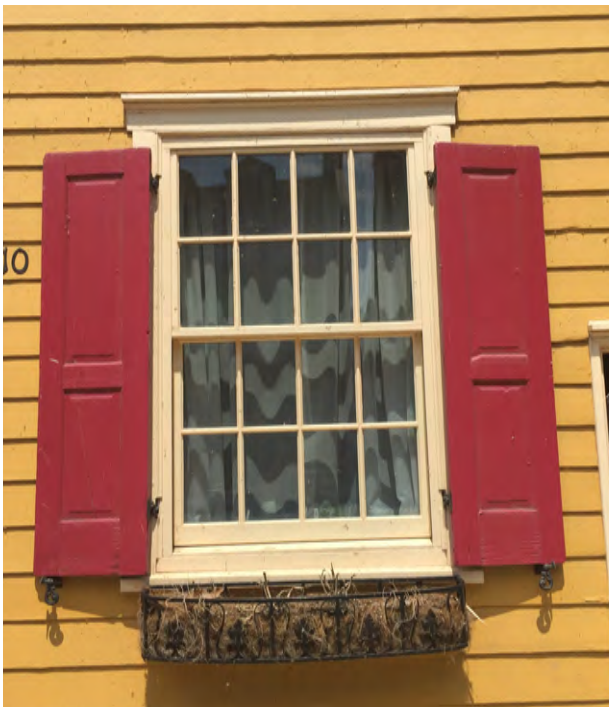
This wood replacement window closely matches the original window in size, lite pattern, and sash configuration. This would be considered an in-kind replacement and only requires staff level review.

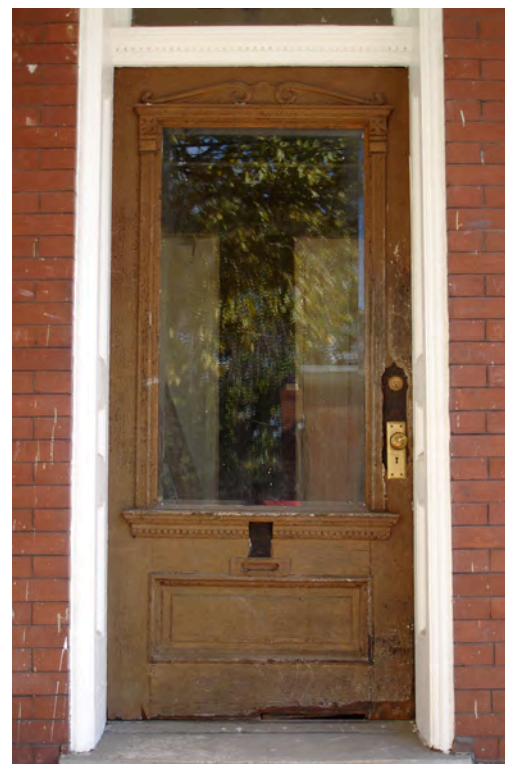
This damaged historic door should be repaired rather than being replaced. The cost to replace this ornate door would be far greater than repairing it.

Doors, entrances, and door surrounds should be inspected annually to ensure there is no hidden deterioration or dry rot. Wooden elements should be painted or stained on a cyclical basis to ensure their long term preservation. It is encouraged that all historic features of doors and entrances are repaired rather than replaced. Repair methods can involve splicing, dutchman joints, or epoxy repair of wood. If repair is not possible due to loss or extensive deterioration, then architectural elements must be replaced in-kind. The new architectural element must match the original in appearance, size, scale, texture, and material. Alternative materials may be appropriate if original materials are not available.

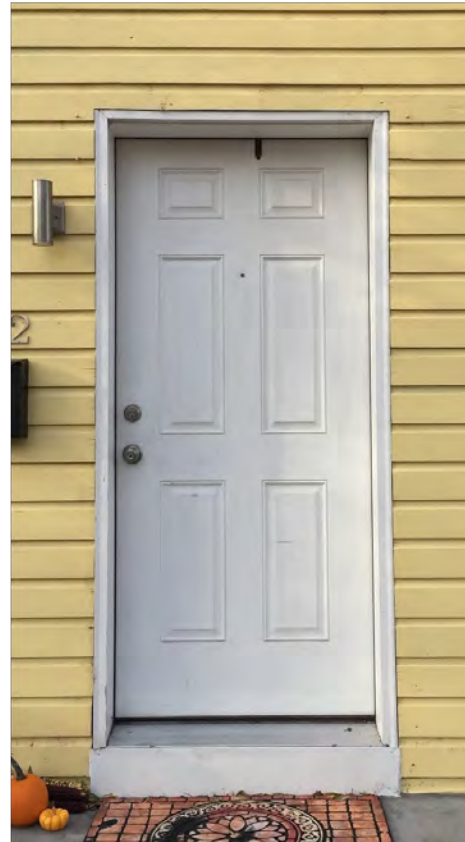
This historic entrance has been severely altered by the removal of its original surround and door. The new steel door is not appropriate replacement.

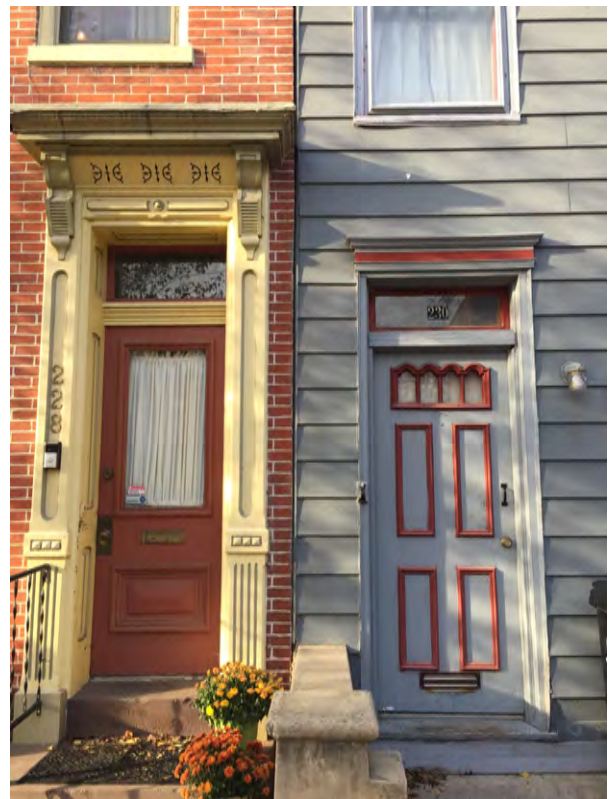
The door and surround on the left has been maintained and preserved whereas the door and surround on the right has been severely altered.

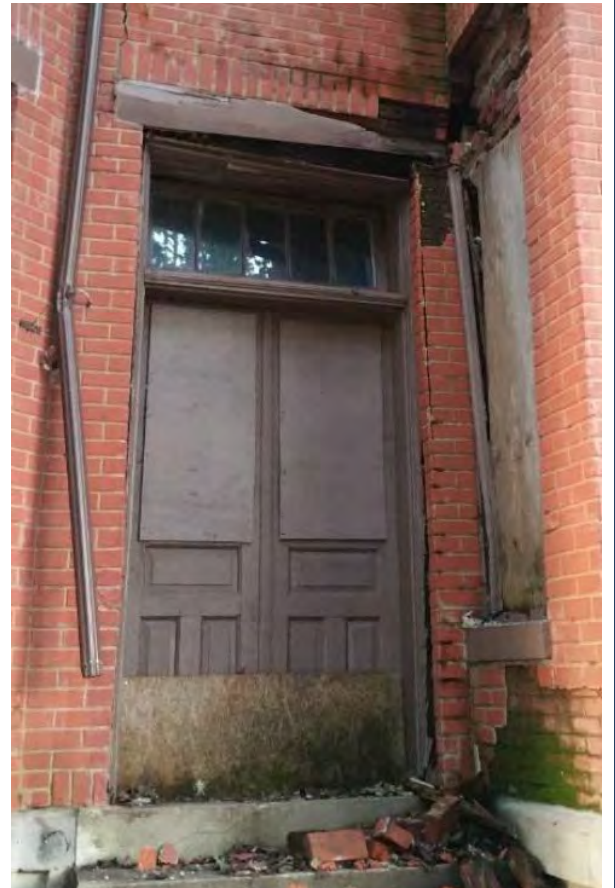
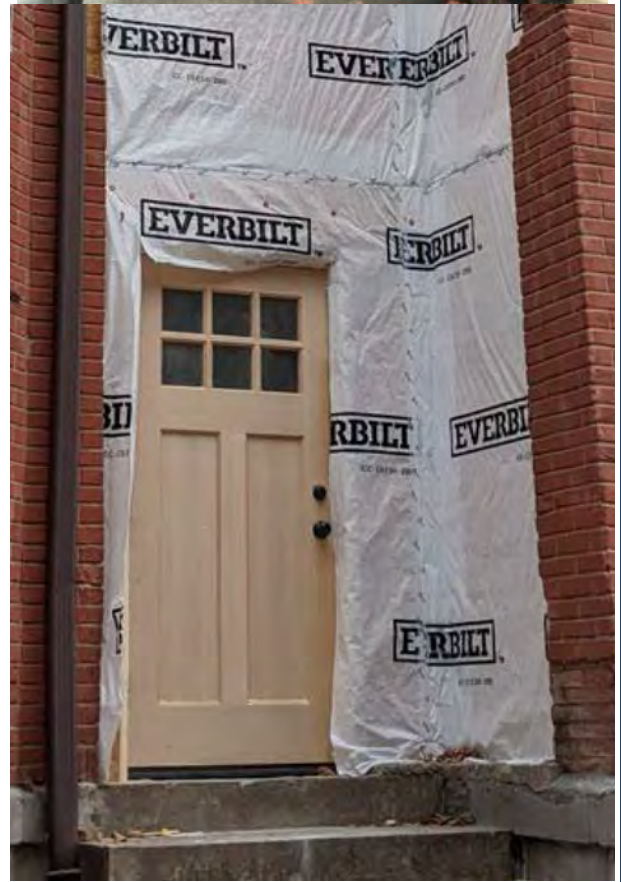
This pair of historic double doors and transom were removed to install a contemporary door. This type of change is never appropriate for historic buildings.

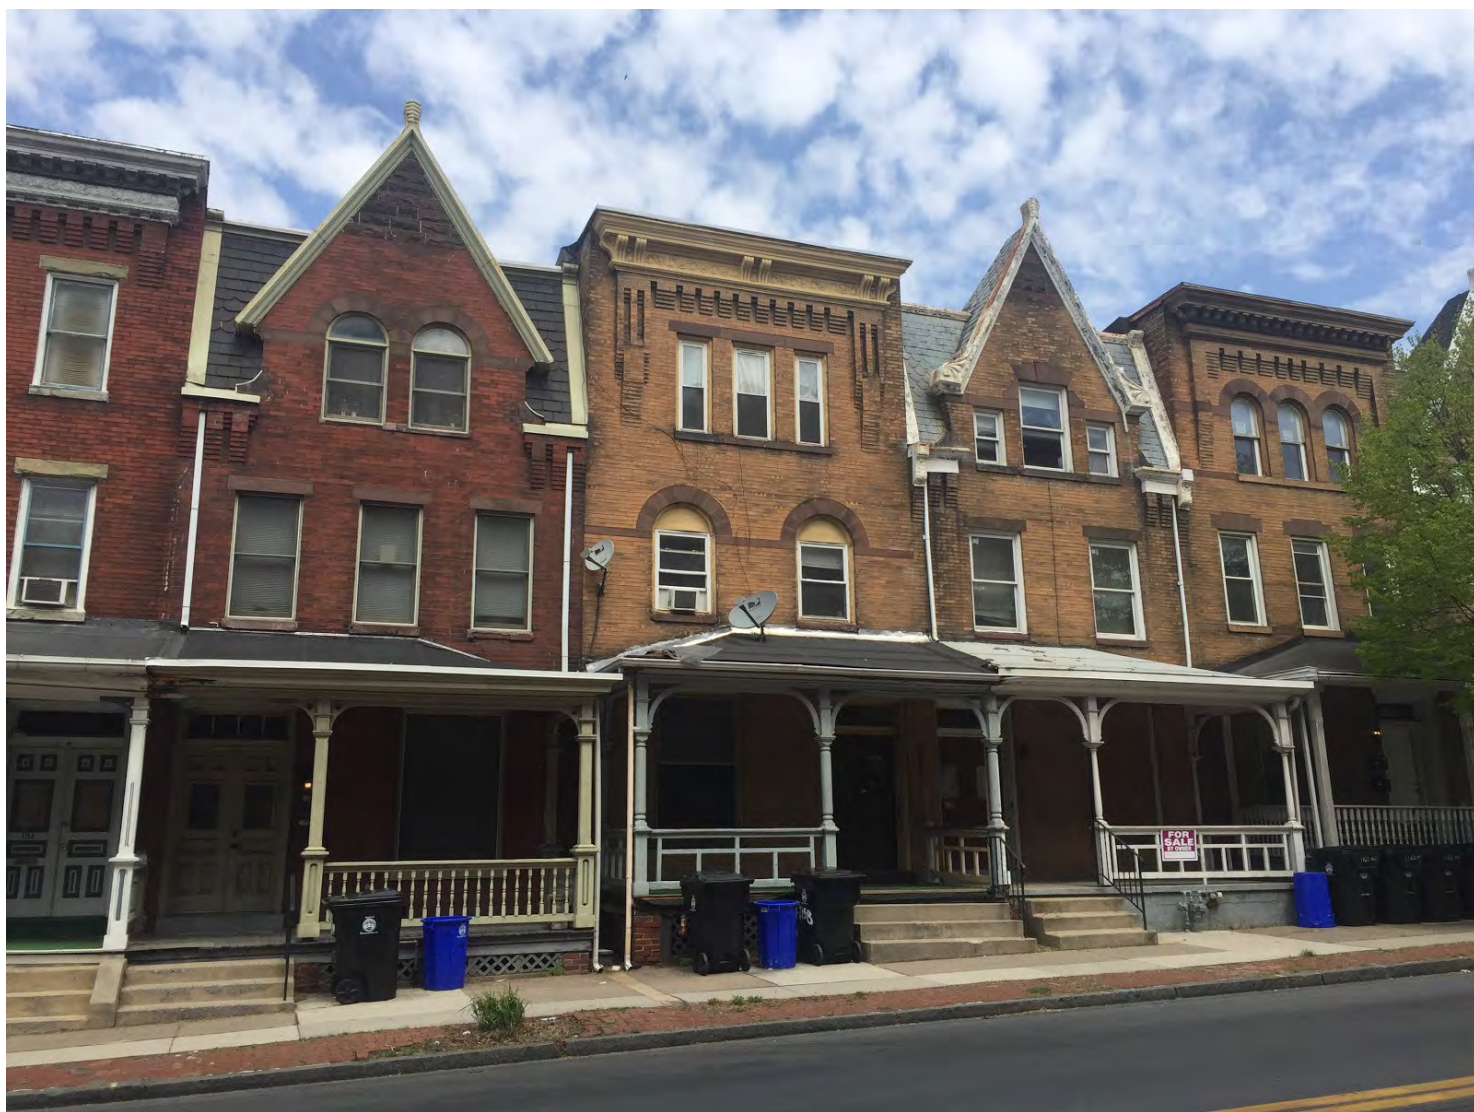
A series of historic porches in the Allison Hill historic district have been maintained and preserved. Maintained and preserved historic porches add depth and texture to a neighborhood and gives communities a sense of place.

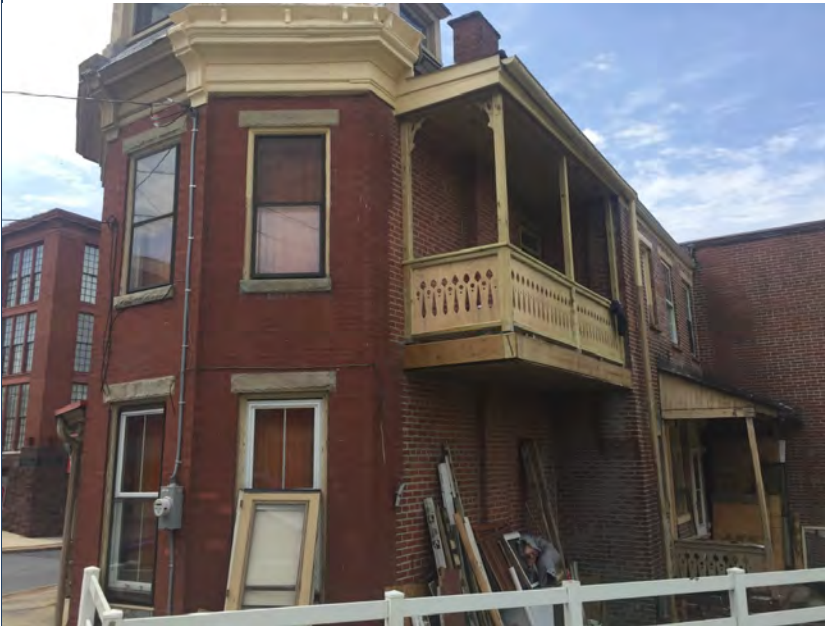
Here is an example of an historic porch rehabilitation project in the Allison Hill historic district. Notice the rails, balustrades, and posts match the original materials and design.

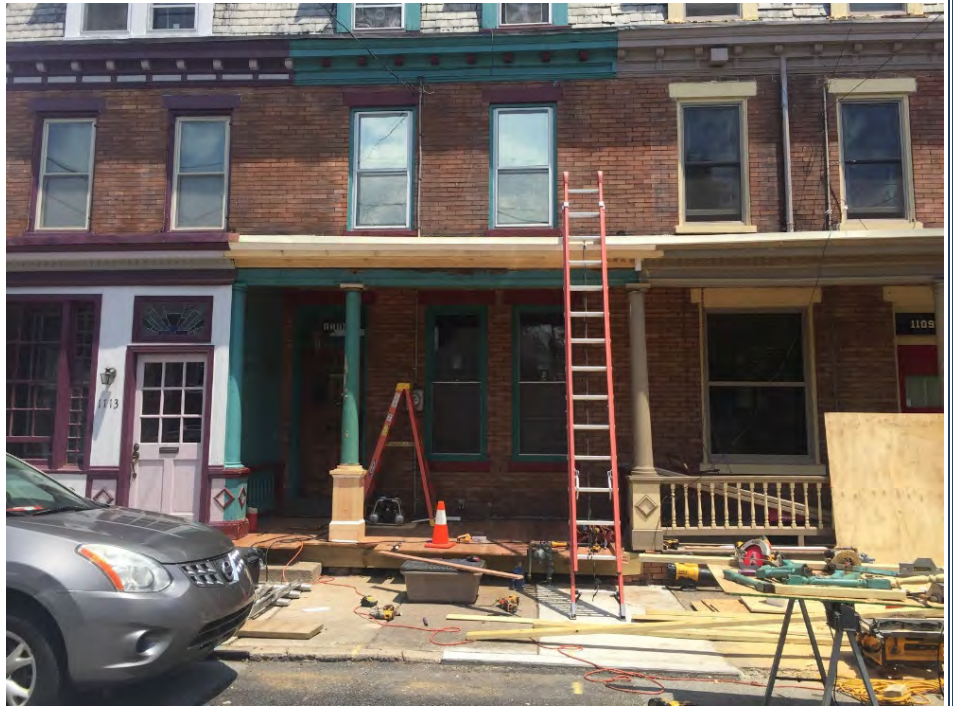
Shown in this photo is an historic Midtown porch undergoing a full in-kind rehabilitation. The new porch will match the original in appearance, material, and texture.

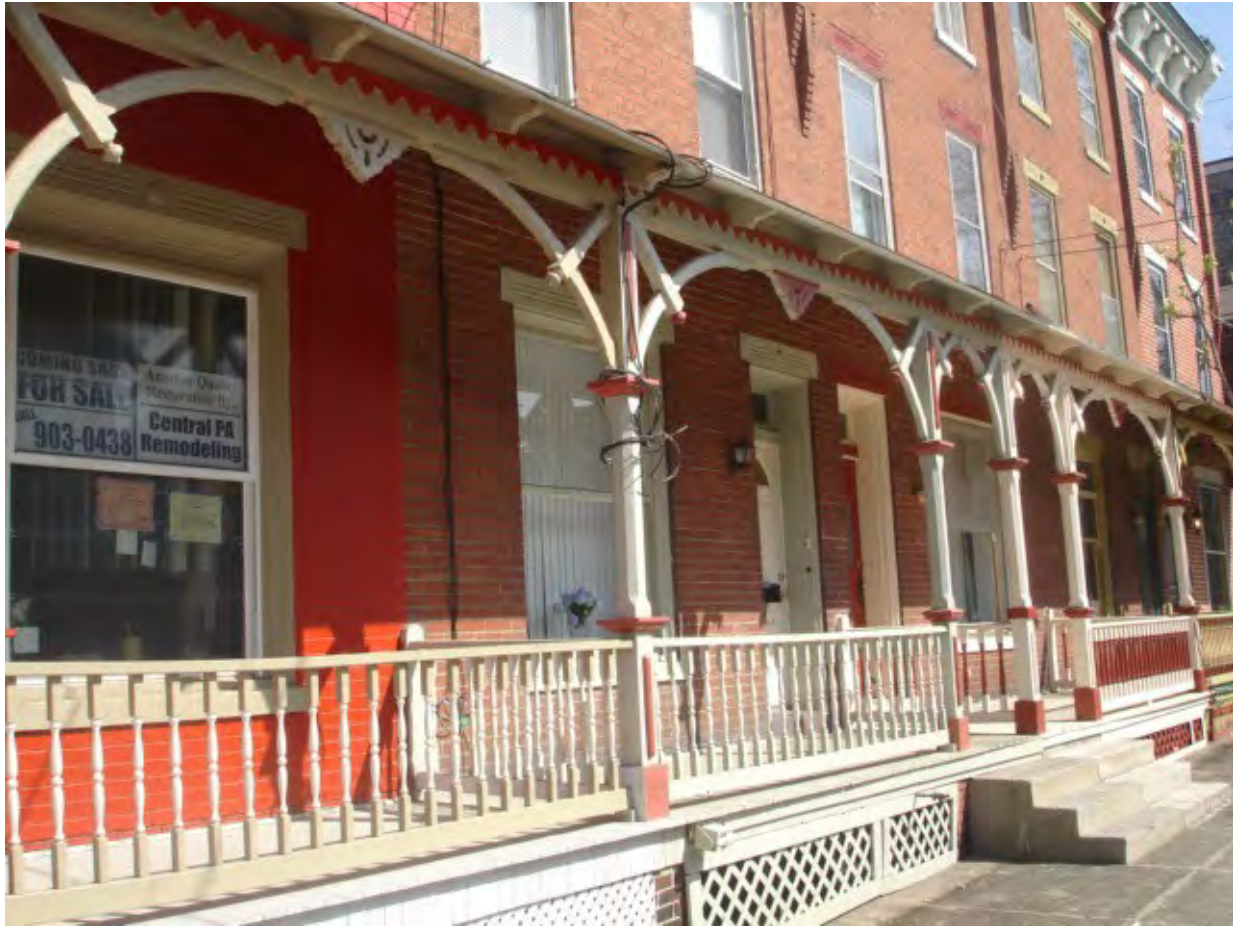
These historic Uptown porches have been maintained and still have most of their original character defining features. Urban porches engage both residents and visitors with historic streetscapes.

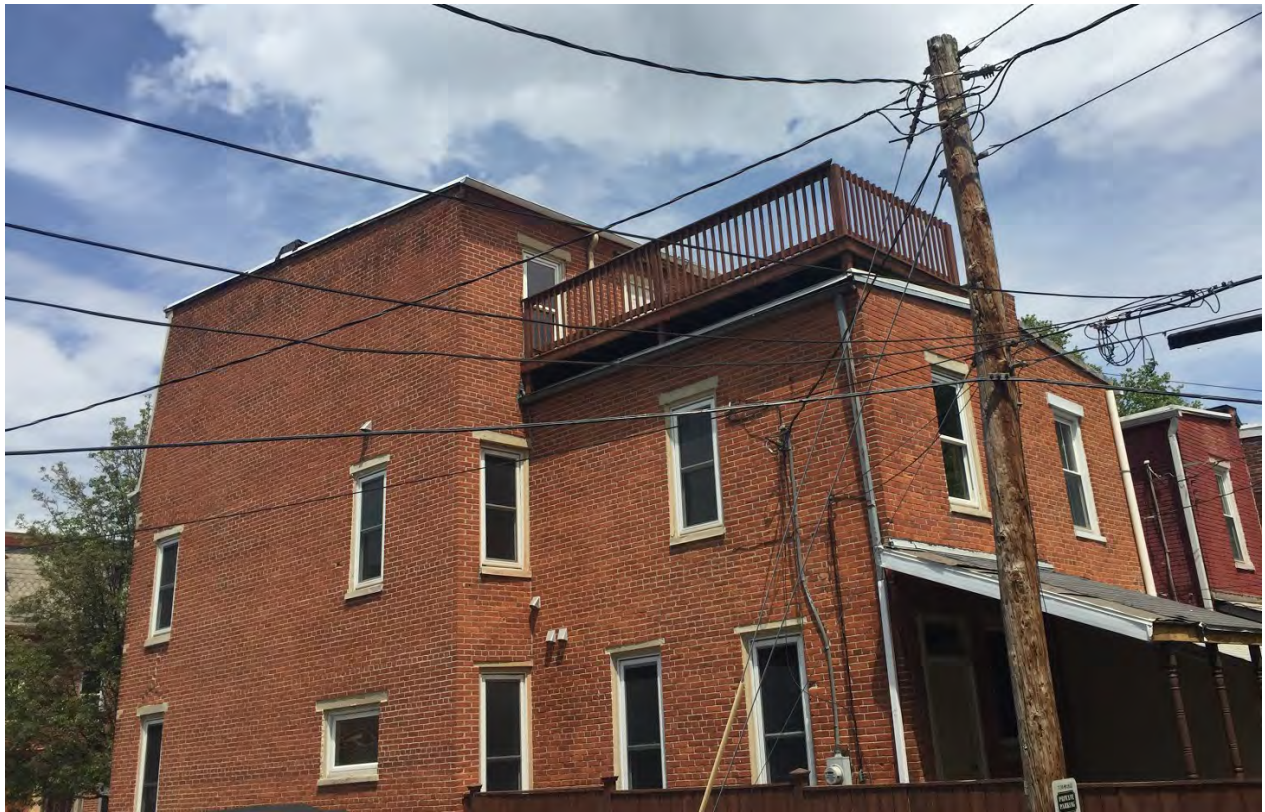
A rooftop deck was recently installed on this Uptown home. Rooftop decks can have an impact on property values. Rooftop decks have a large visual impact on the historic district and usually require HARB review.

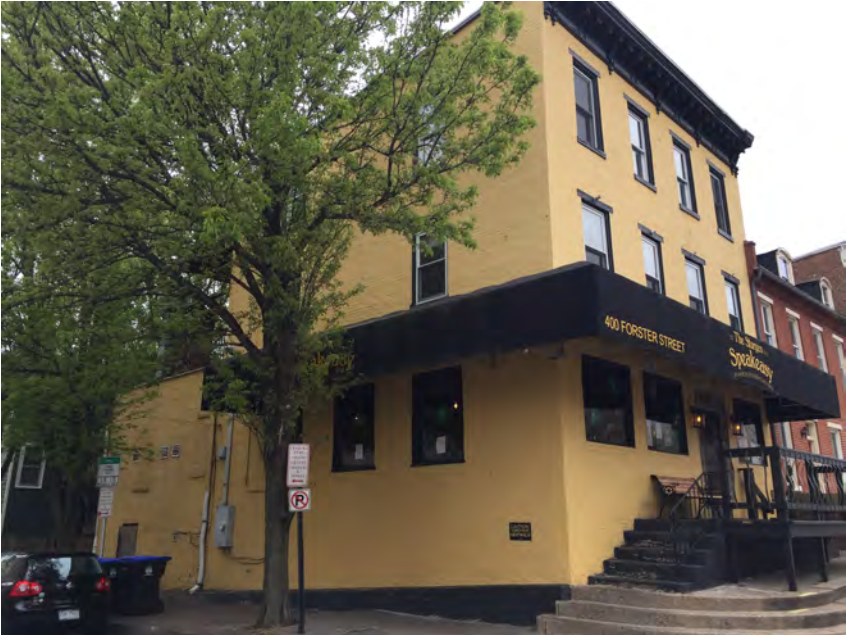
This awning is appropriate for the building and its setting as it blends in with the neighborhood while serving a function.

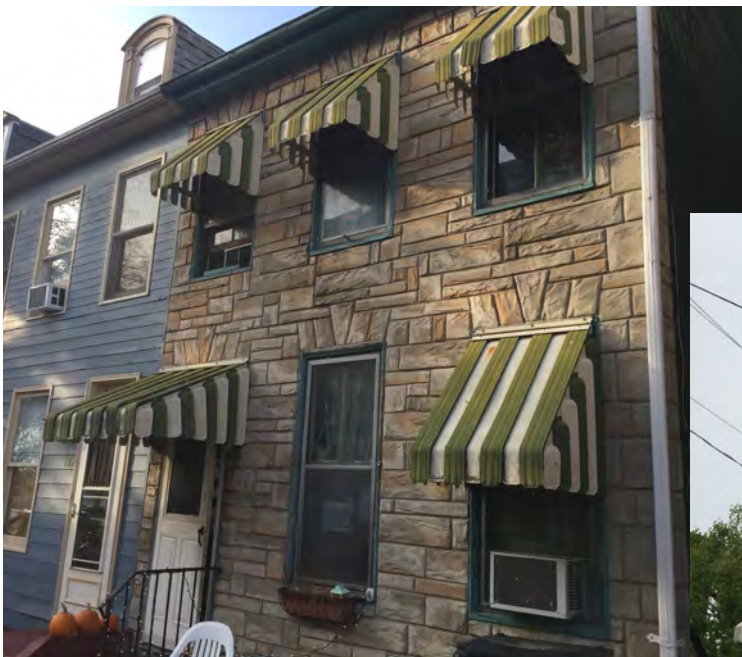
Aluminum awnings are not original to most building and their removal is encouraged to reveal historical details. If removed, the aluminum can be recycled.

Aluminum awnings popular in the mid- 20th century generally are not appropriate for historic buildings. Removing metal awnings (circa 1945-1970's) from historic buildings not of that era is encouraged. Doing so removes the distraction of the metal awning and reveals the historic character of buildings. Adding a metal awning to an historic building today is generally not appropriate, whereas the removal of metal awnings does not require HARB approval. If metal awnings are an original design feature of a 20th century building, then the awnings should remain.

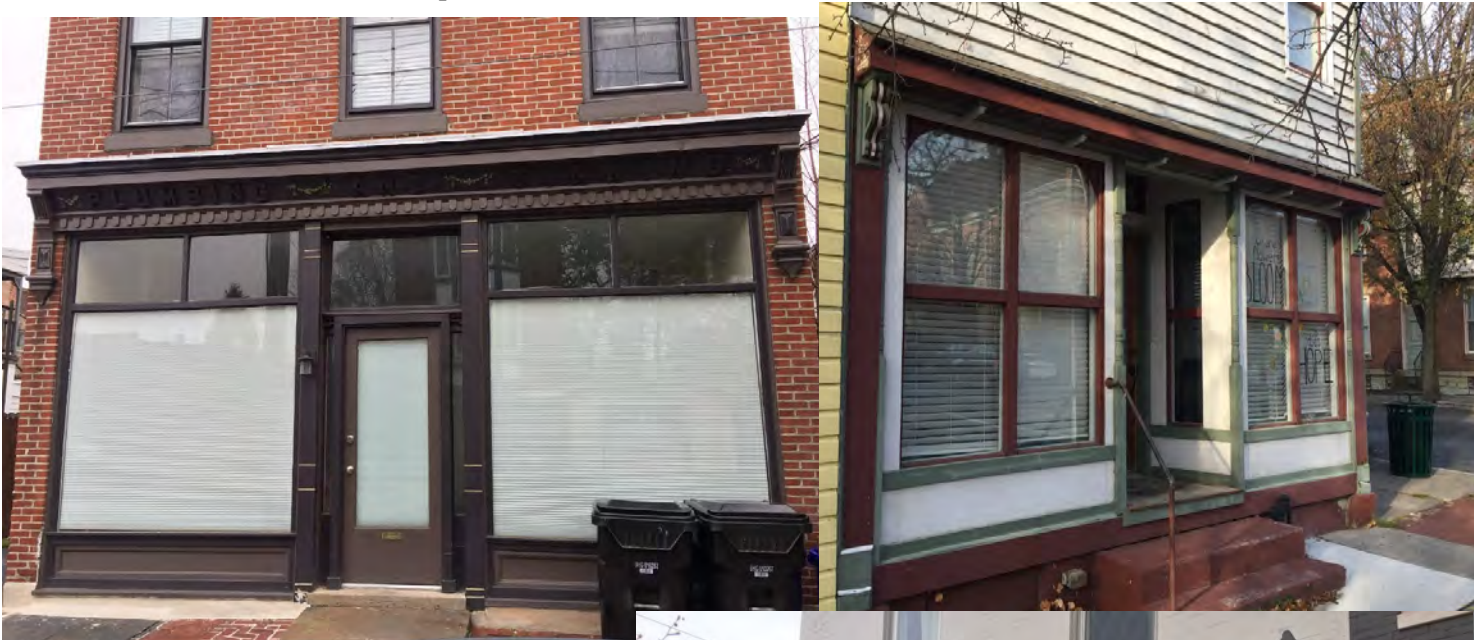
The above historic storefront in Fox ridge Historic District has been retained despite its function as a residence. Once the retail location of "Fisher Brothers Plumbing and Tinning." Other similar storefronts in Midtown have been retained but are no longer in use. It is important to retain historic storefronts as character defining features, but also reserves the storefront for potential future use as a functional businesses again.

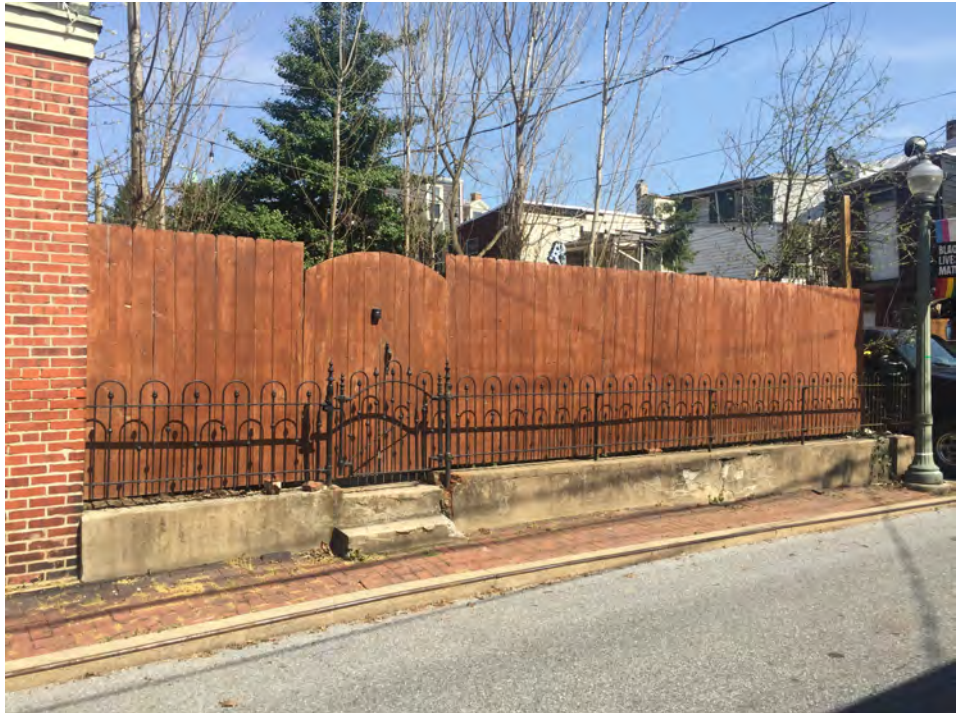
The desire for more privacy did not negatively impact the original cast iron fence on this property. The original fence was preserved while a compatible wood fence was installed behind it.

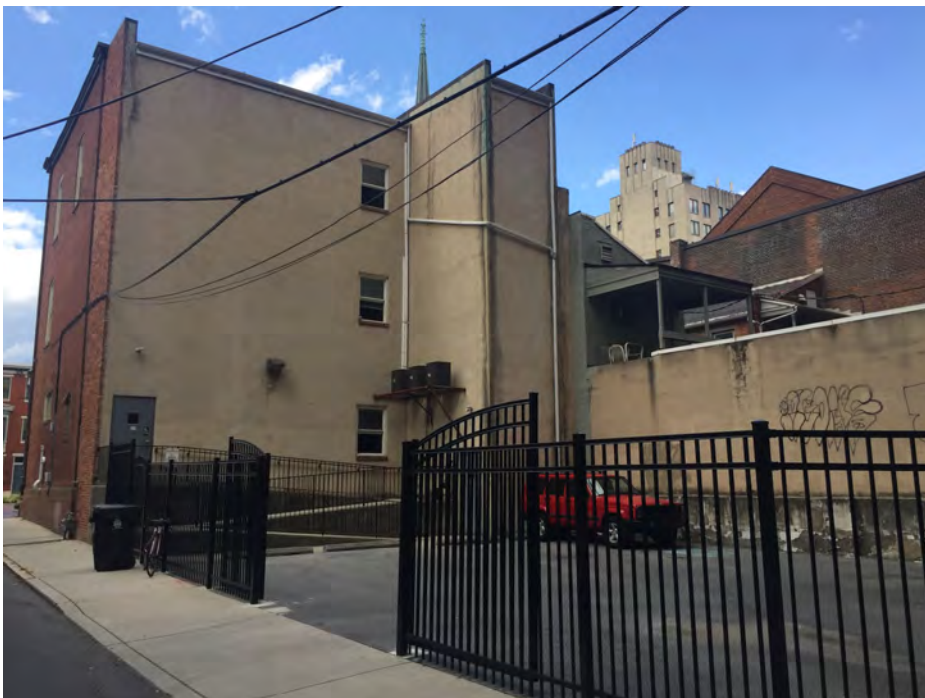
Contemporary powder coated metal fences are generally appropriate for use in historic districts. The material blends in with existing historic materials and is appropriate for the setting.

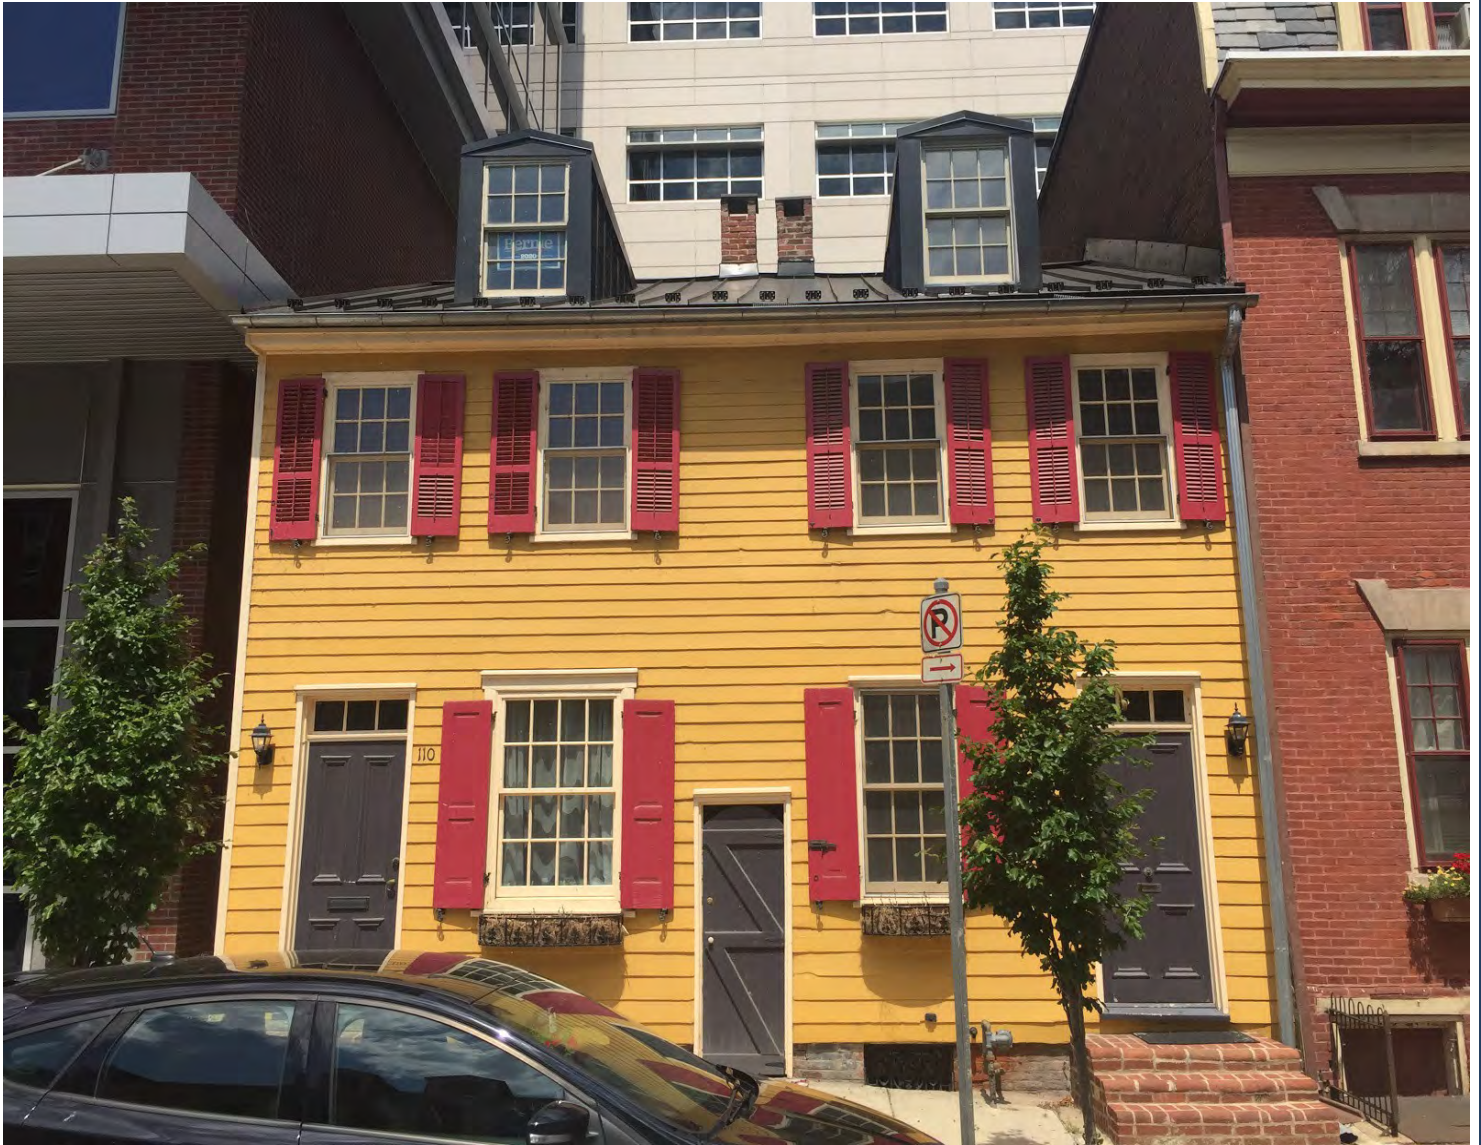
This pair of early 19th century Federal style homes have been painted with a polychromatic color scheme that is historically appropriate for the period and visually striking.

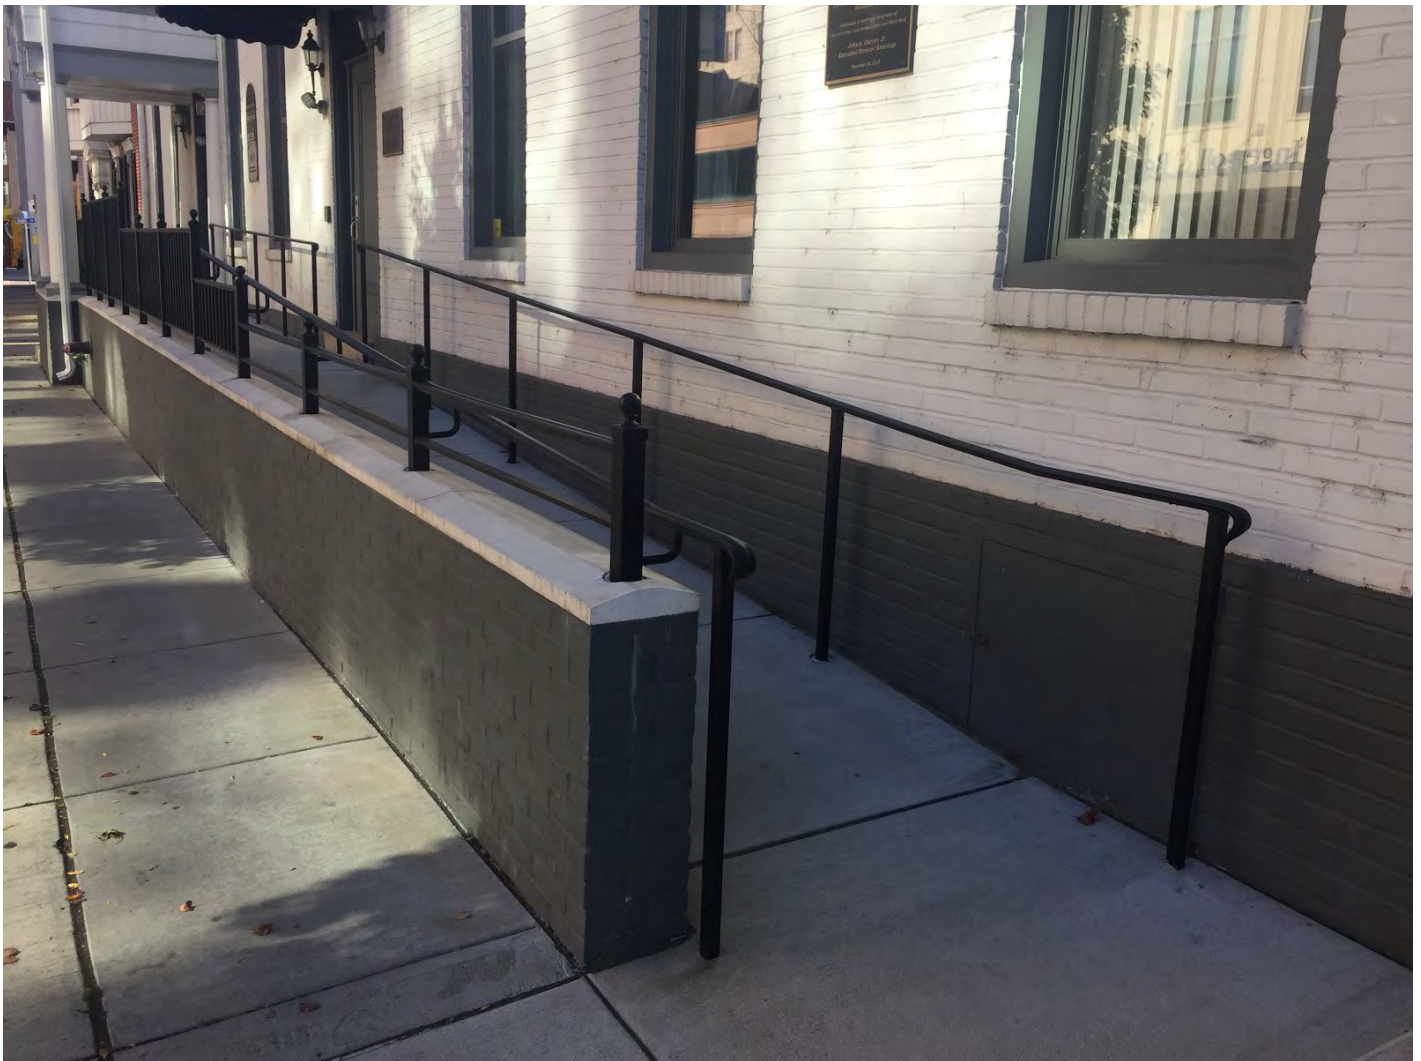
This ramp was constructed on the primary facade of the building and is minimally intrusive on the character and integrity of the building.

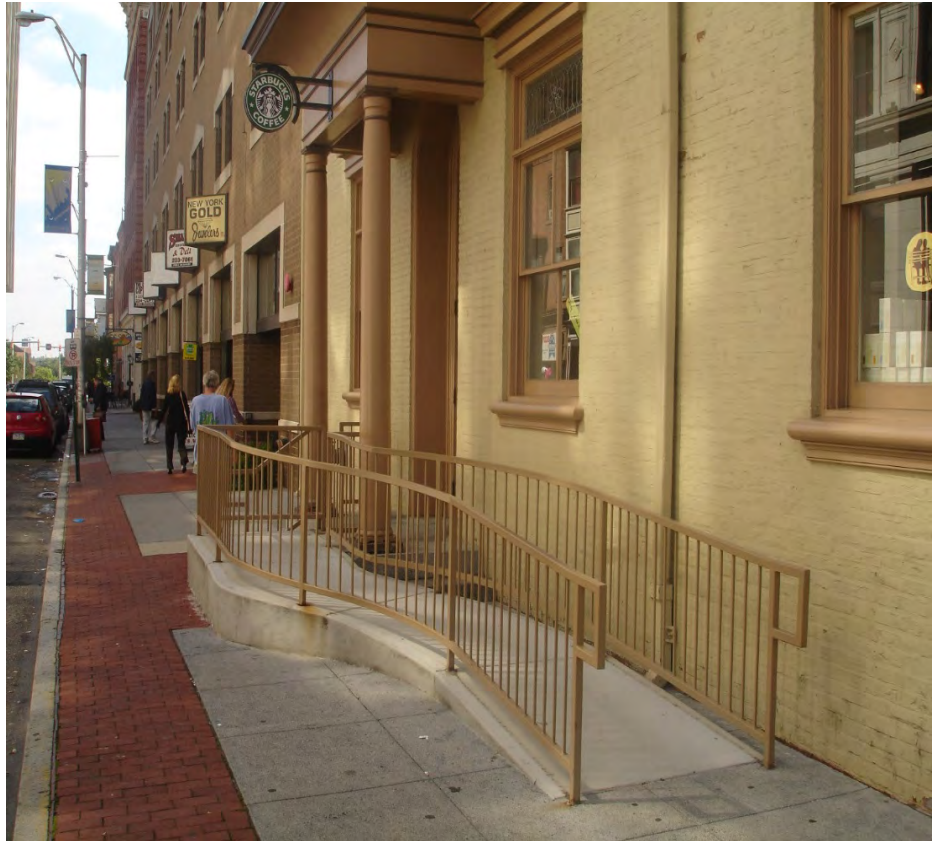
This ramp was installed on a secondary facade and it blends in with the historic neighborhood without causing any adverse effects on historic materials.

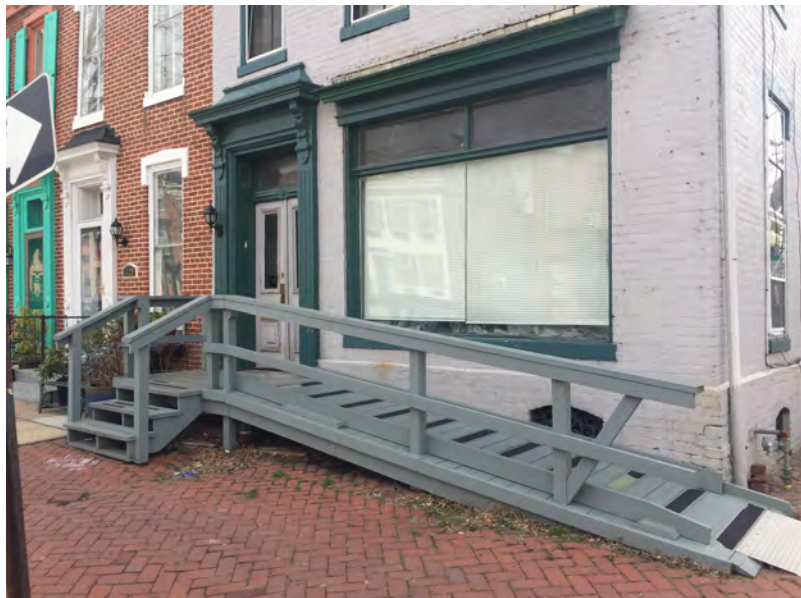
This wooden ramp located on a primary facade is an incompatible ramp for the building and the streetscape. The ramp does not blend in with the built environment.
