LEGISLATIVE APPROVAL FORM/CERTIFICATE OF ACCEPTANCE

A Resolution of the Council of the City of Harrisburg to approve the adoption of updated Historic District Design and Preservation Guidelines.

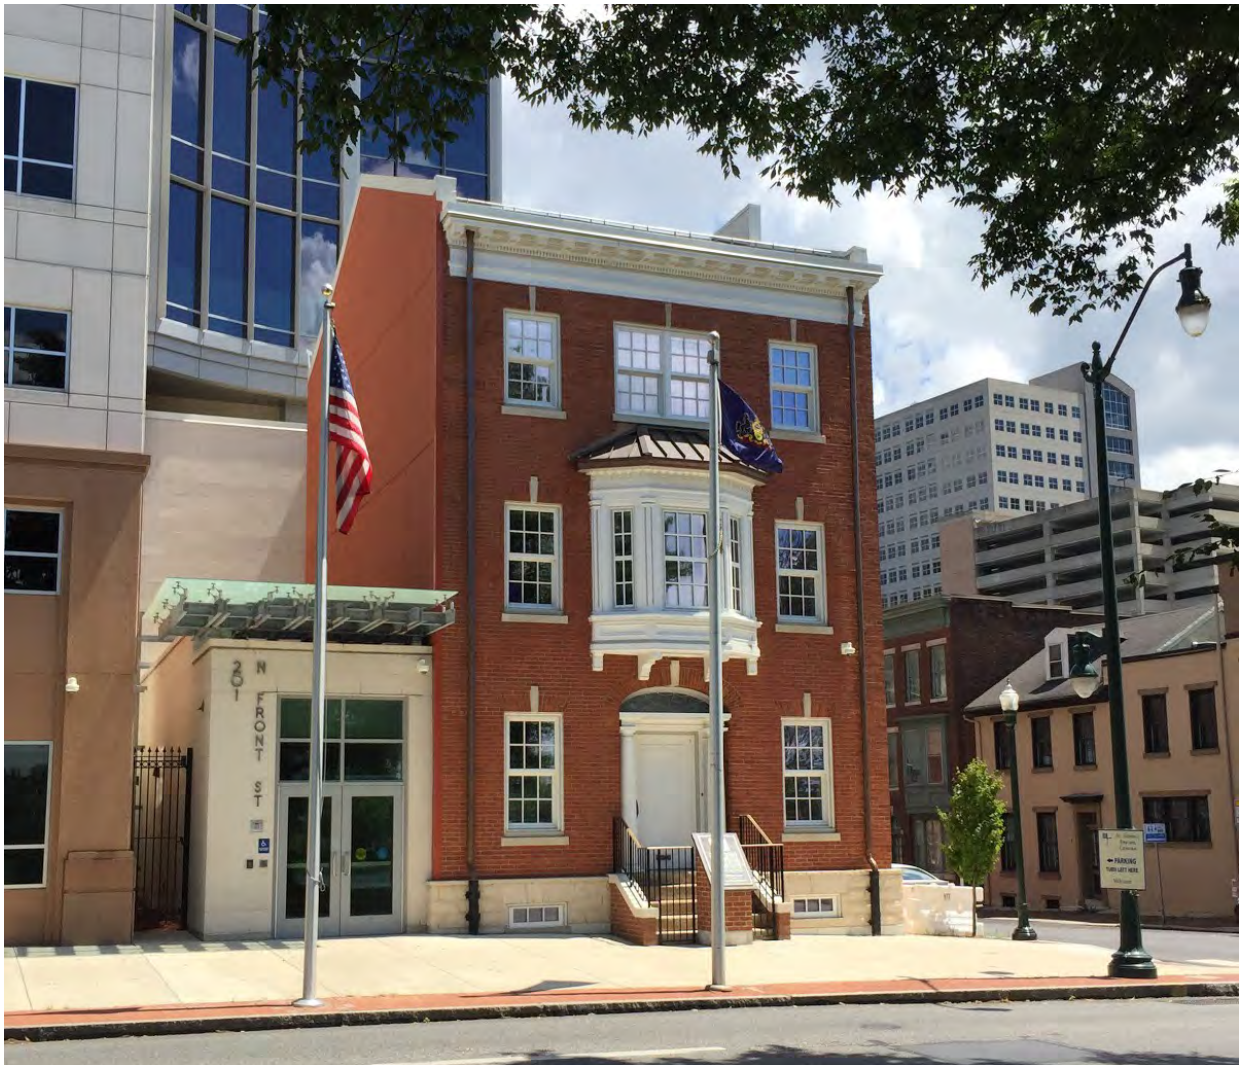
The Hickok Mansion on North Front Street was rehabilitated and required a new addition for continued use. The small addition to the left of the mansion is a compatible yet subordinate to the historic building.

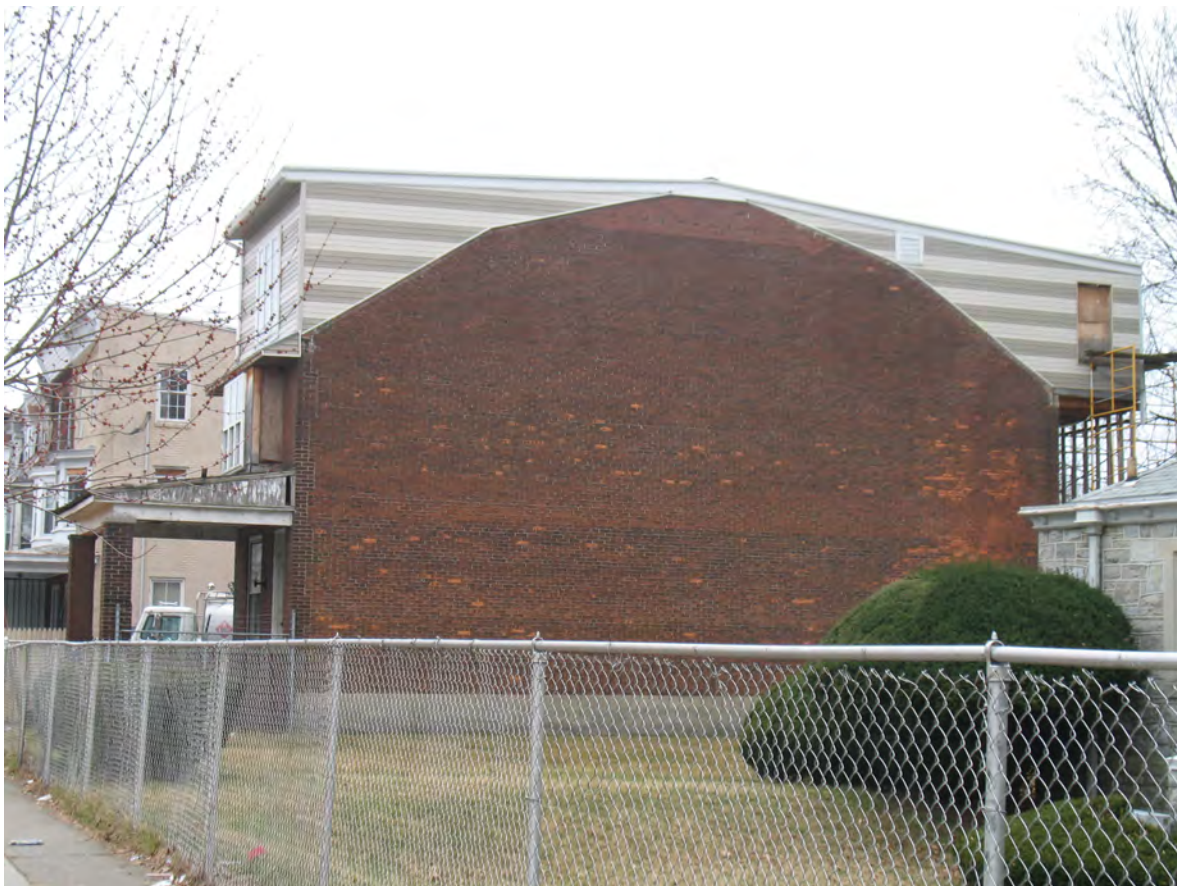
Even though not in a historic district, this large roof addition on this property on North 6th Street is wildly inappropriate as it destroys the form of the original gambrel roof. The addition removes the original features on the primary facade and destroys the historic integrity of the property. This addition is not appropriate.

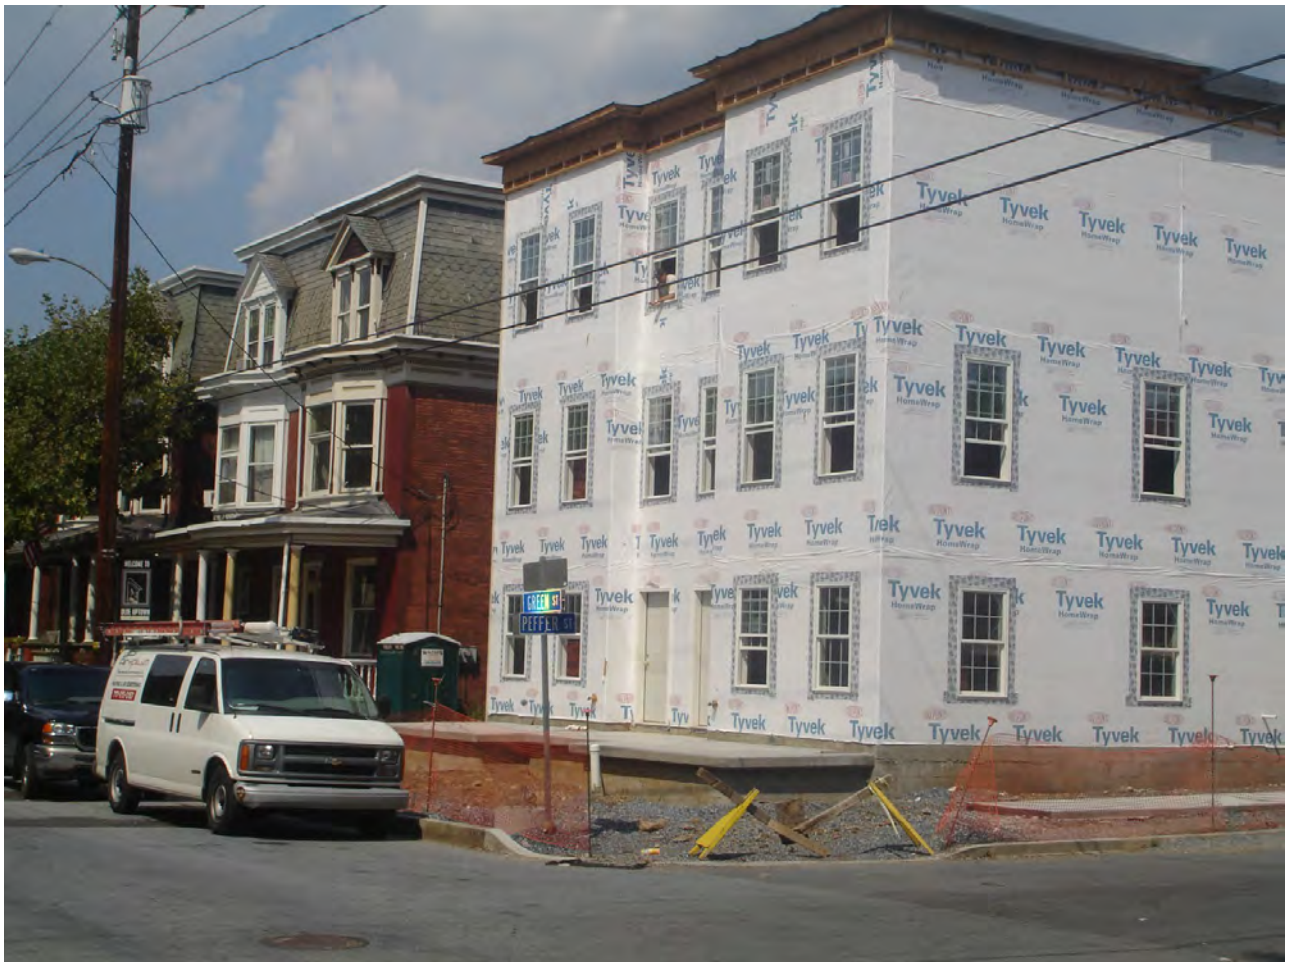
The newer infill construction on Green Street is compatible with the scale of the existing historic building stock.

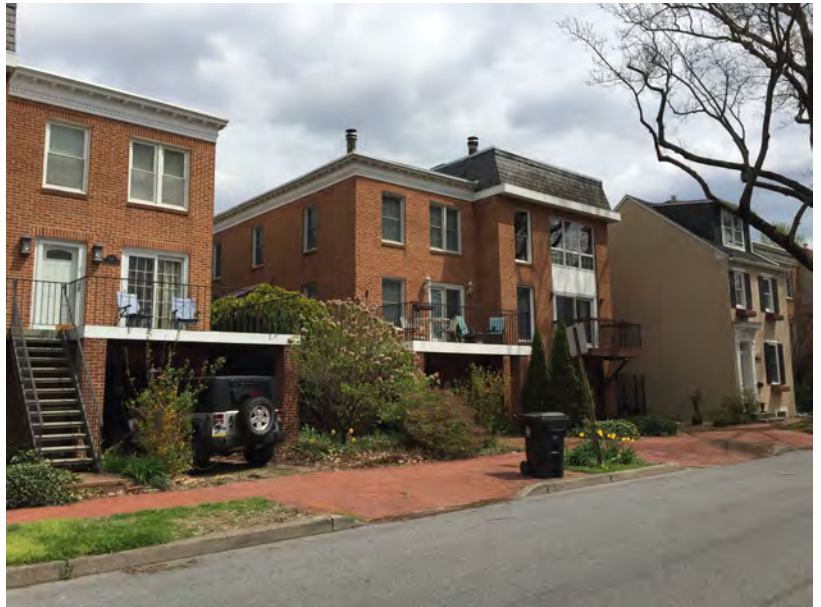
Above is an example of new construction infill within Shipoke municipal historic district. These buildings are sympathetic and compatible with neighboring historic structures but are clearly differentiated.

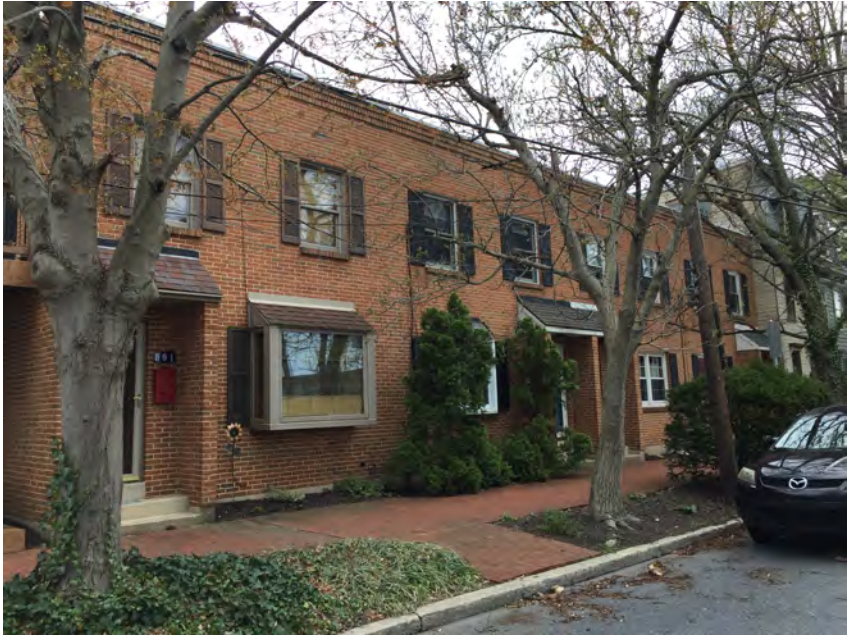
These new infill row-homes in Shipoke reference historic architecture of the neighborhood but are clearly differentiated. Referencing the local building stock is recommended to maintain the continuity of texture, materials, and feeling of the historic district. This type of new infill is recommended.

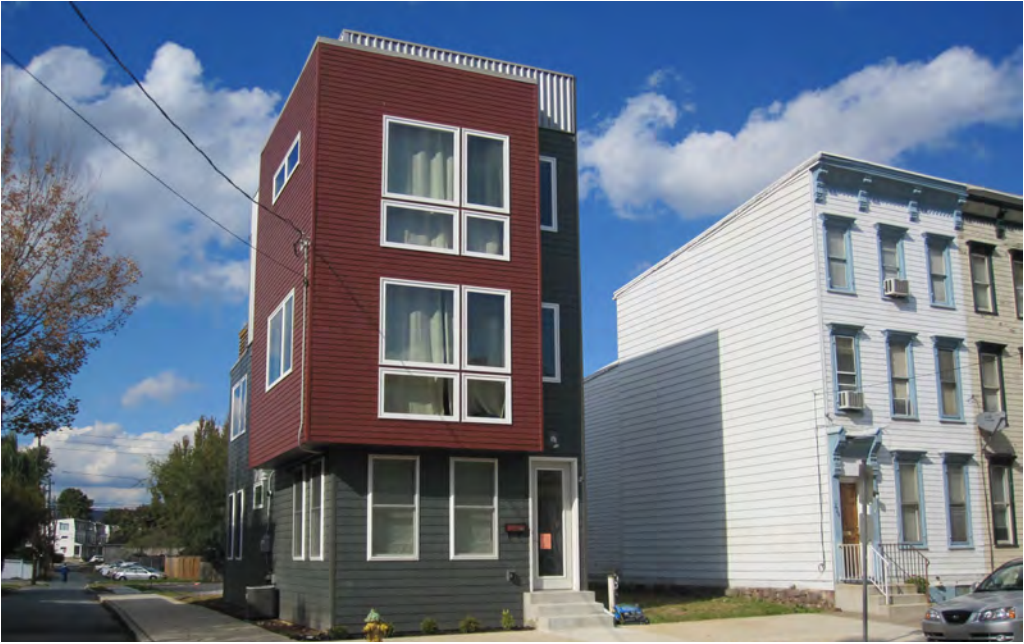
This dwelling in Uptown is clearly differentiated as it is an attempt to intentionally oppose local historic architecture and materials. This type of infill is not recommended as it is an intentional design intrusion on an otherwise historic street.

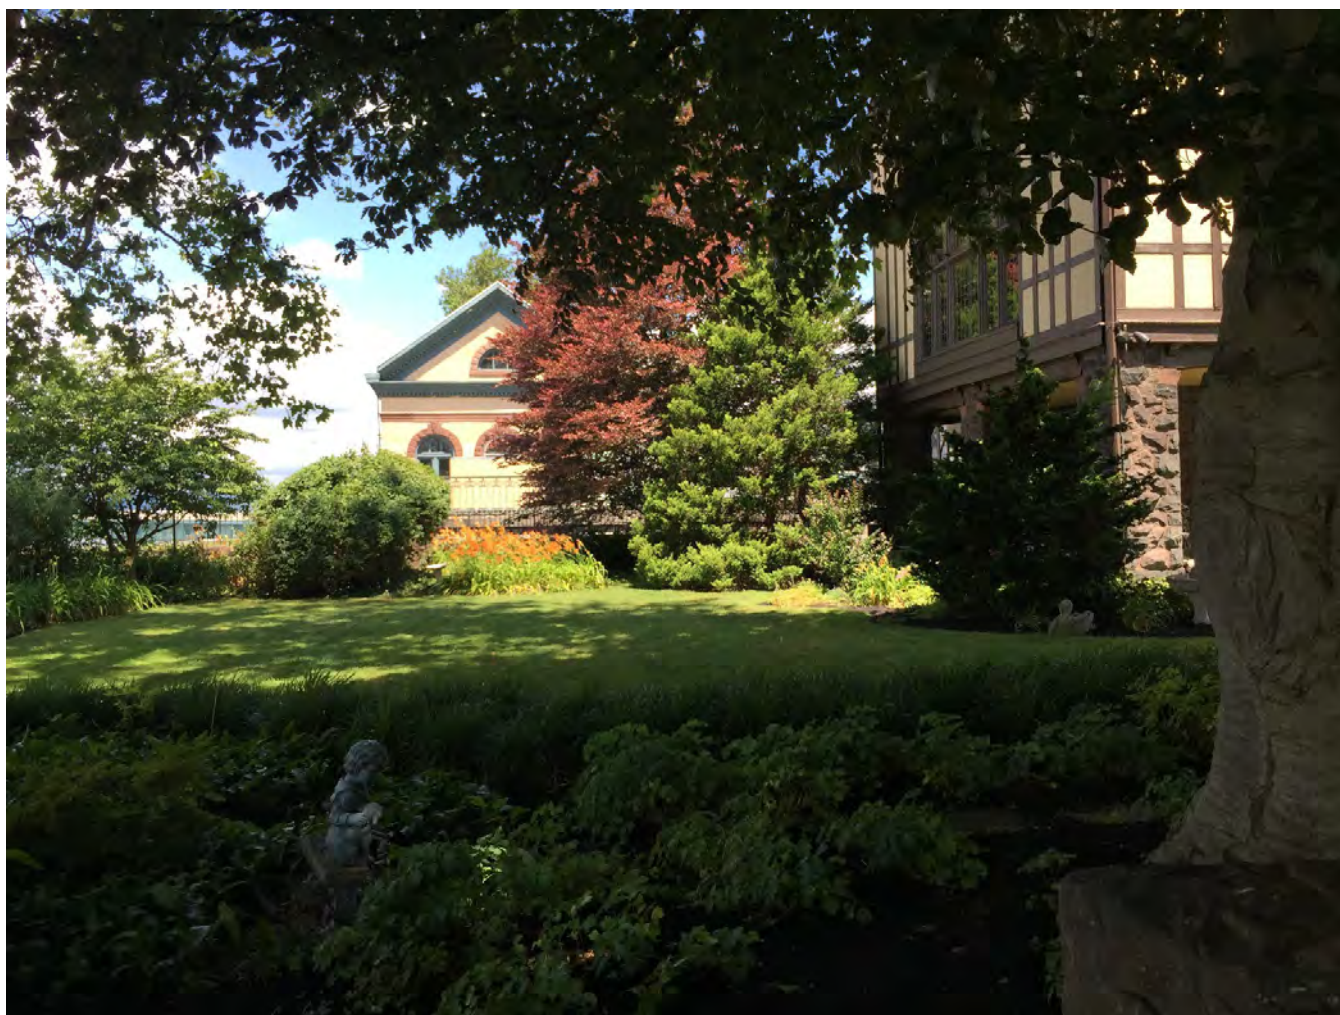
The site and setting of the Civic Club of Harrisburg retains great integrity as it has been maintained and preserved over the past century. Mature trees, shrubs, and other species make this an attractive space for wildlife as well.

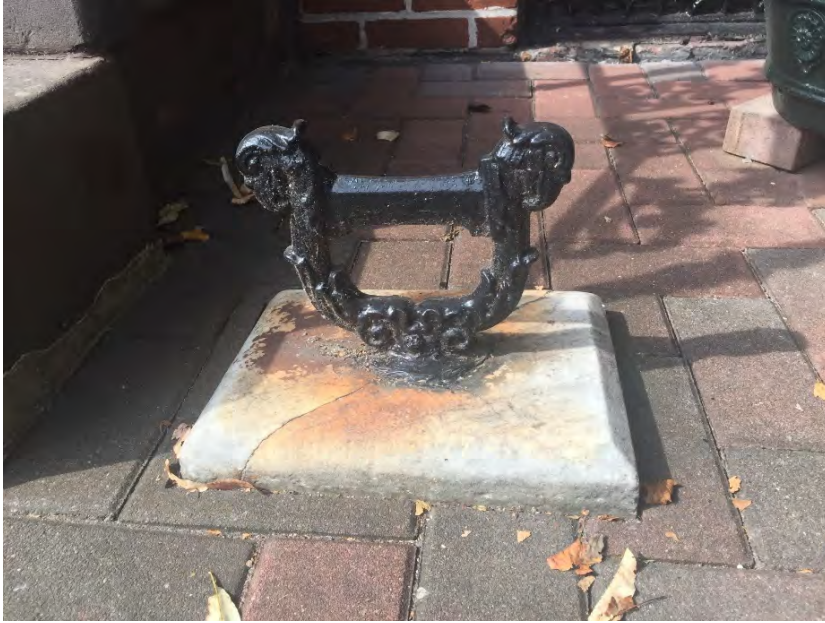
Cast iron boot scrapers were once common on Harrisburg sidewalks. The few that remain should be maintained preserved.

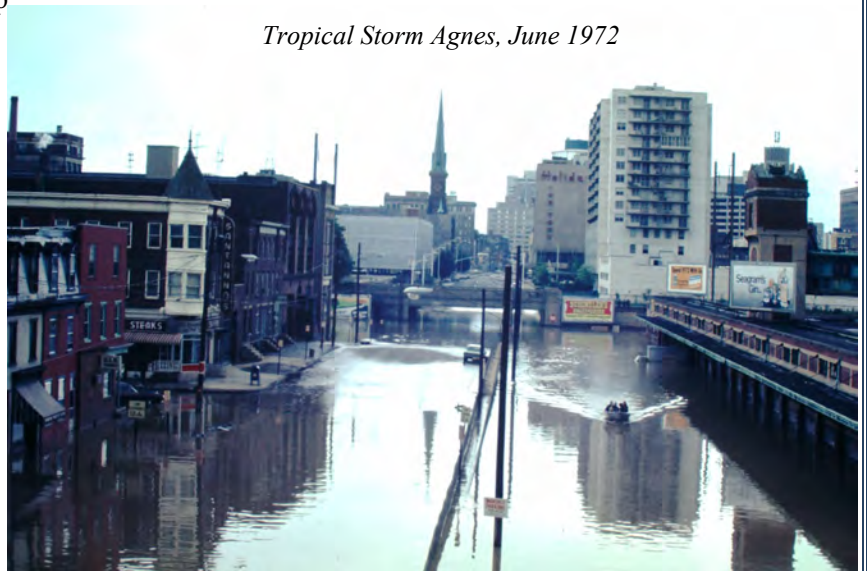
Tropical Storm Agnes, June 1972

with the Susquehanna River and the Paxton Creek have created several major flood events in the past two centuries. Many of the City's historic districts, particularly Uptown and Shipoke, have experienced catastrophic flood events in 1936 and 1972. Historic buildings and resources within the City's floodplains are vulnerable to loss due to flooding and climate change. Flood and storm events in the future may become more common and severe thus accelerating the potential loss of our cultural resources.

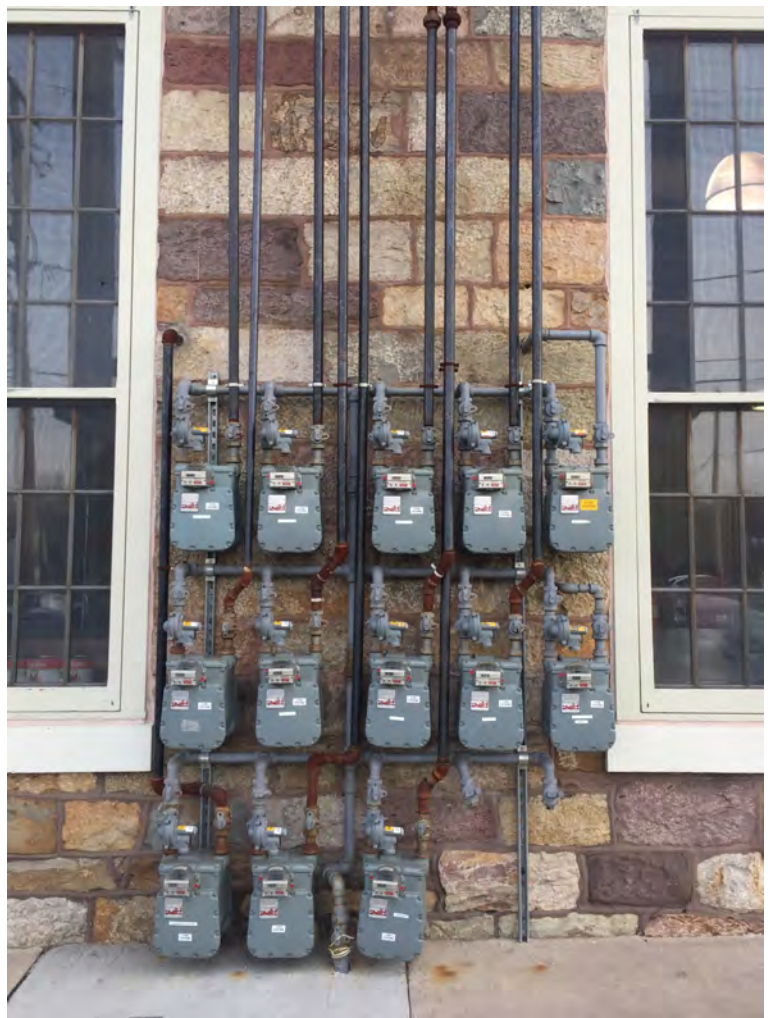
The modern convenience of air conditioning can be installed in historic buildings. Such projects must be done cautiously and with care so as not to cause permanent damage to historic materials. Window air conditioners are popular and usually fit well into double-hung windows. They can usually be padded with weather-stripping foam to ensure minimal damage to the window and sill. They should be installed on a

secondary elevation whenever possible to minimize their visual impact. Be aware of water dripping from the unit. Ensure that it is dripping in such a way that water is not running directly down a wall, causing damage. Additionally, a window should never be removed to install an air conditioner, especially on a primary elevation. They should also never be installed through holes cut into exterior walls. Doing so destroys historic masonry and clapboard and has a negative impact on the historic character of a building.

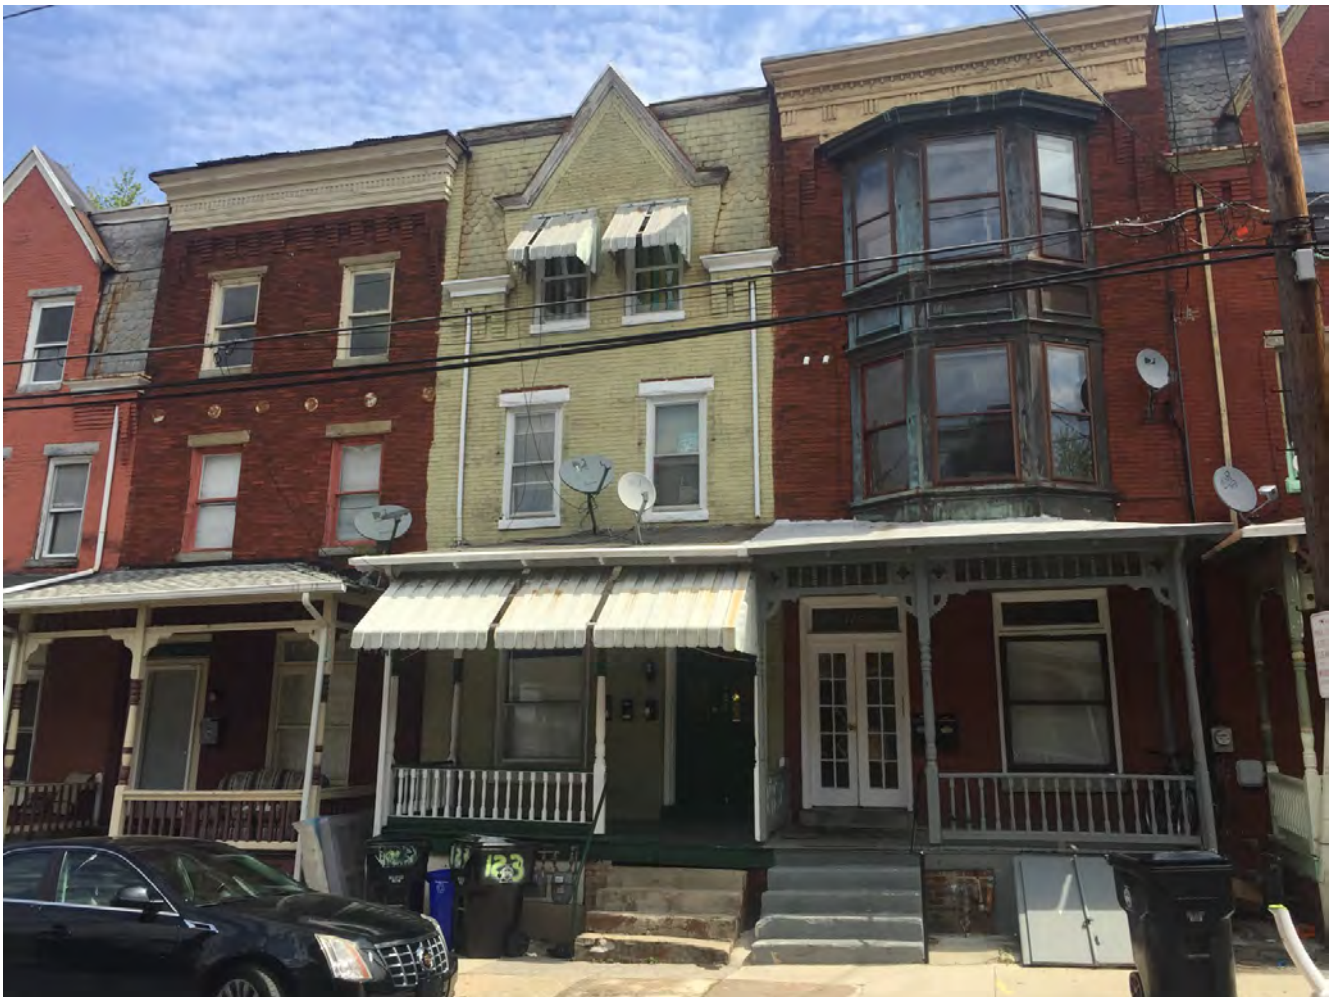
This historic streetscape is diminished by the installation of several satellite dishes. Such utilities should not be mounted on primary facades.

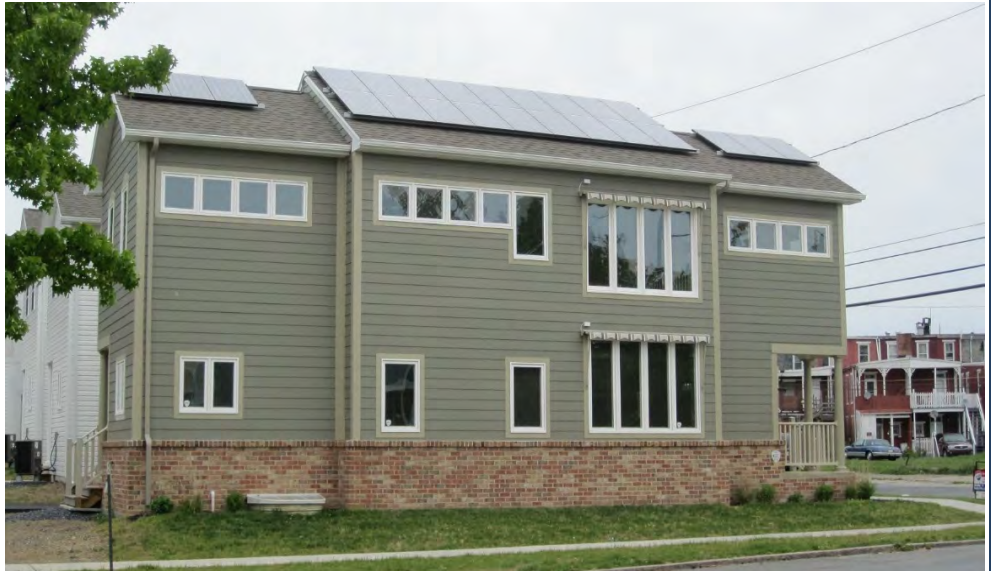
A newly constructed home in the Mount Pleasant neighborhood fitted with solar panels.

In keeping with the *Standards*, ensuring that a solar panel array is not visible from the public right-of-way is highly encouraged. By doing so, there is no negative visual effect on the property or surrounding district’s character. Short of not being visible from the right-of-way, the HARB will consider solar panels with the following recommendations on their placement and design. Not all properties will be viable candidates for the subtle installation of solar arrays, but when invisible or minimally visible, such an installation would be supported by the HARB.

- Panels may not be located on the primary roof elevation.
- Panels should be positioned on secondary and rear roof elevations.
- Low profile panels must be used to minimize the visibility of the array.
- Historic roofing materials that are difficult to replace, such as slate or terra-cotta tile, should not be permanently damaged or removed in order to install the solar panels.
- The visual impact of the array must be minimal.
